Main decommissioning works and steps

All fuel has been removed from Unit 4 SFP by December 22, 2014. Work continues toward fuel removal and debris (Note 1) retrieval from Unit 1-3.

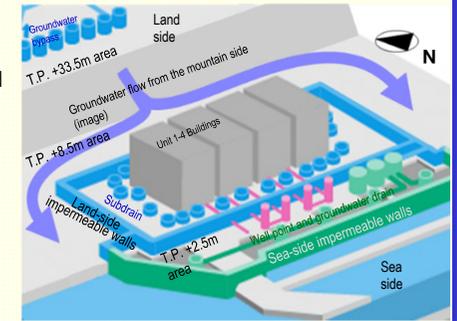
Overview of the multi-layered contaminated water management

Based on these results, we consider that the land-side impermeable walls have effectively worked, the multi-layered contaminated water management measures, including subdrains and facing, have stably controlled the groundwater level and that consequently, a water-level management system to isolate the buildings from groundwater has been established. These evaluation results will be reviewed by the Committee on Countermeasures for Contaminated Water Treatment.

We are committed to continuing multi-layer contaminated water management to further reduce generated contaminated water.

- We consider that the land-side impermeable walls have effectively worked, the multi-layered contaminated water management measures, including subdrains and facing have stably controlled the groundwater level and consequently, a water-level management system to isolate the buildings from groundwater has been established.

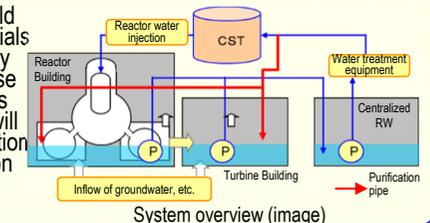
System overview (image)

To accelerate efforts to reduce the radiation density in stagnant water inside the buildings, circulating purification of stagnant water inside the buildings started on the Unit 3 and 4 sides on February 22. For circulating purification, a new pipe divided from the water treatment equipment outlet line was installed to transfer water purified at the water treatment equipment to the Unit 1 Reactor Building and the Unit 2-4 Turbine Buildings.

It was estimated that the operation could reduce the density of radioactive materials in stagnant water inside the buildings by up to approx. 40% compared to the case without circulation purification. The risks of stagnant water inside the buildings will continue to decline in addition to reduction of its storage. The circulating purification on the Unit 1 and 2 side will go into operation in March.

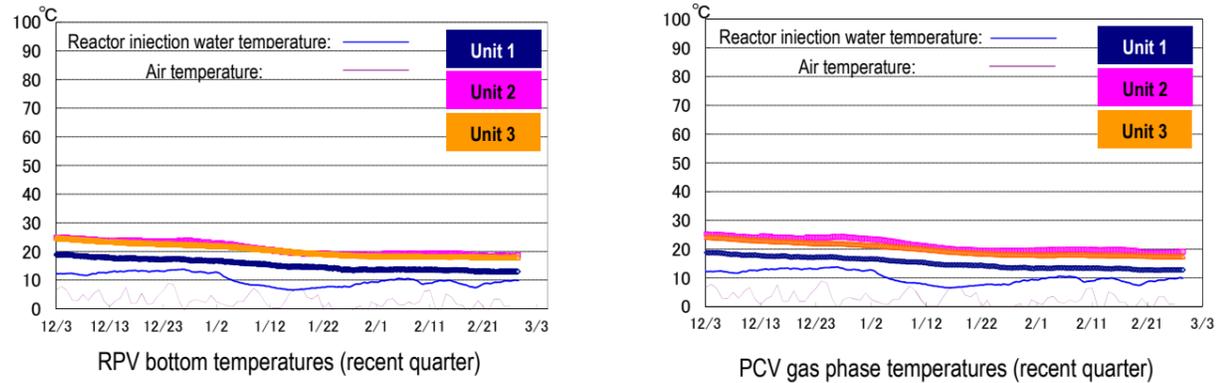
Through continuous reactor cooling by water injection, the temperatures of the Reactor Pressure Vessel (RPV) bottom and the Primary Containment Vessel (PCV) gas phase were maintained within the range of approx. 15 to 35°C for the past month, though it varied depending on the unit and location of the thermometer.

* The trend graphs show part of the temperature data measured at multiple points.

◆ The temperatures of the Reactor Pressure Vessel (RPV) and Primary Containment Vessel (PCV) of Units 1-3 have been maintained within the range of approx. 15-35°C¹ over the past month. There was no significant change in the density of radioactive materials newly released from Reactor Buildings in the air². It was evaluated that the comprehensive cold shutdown condition had been maintained.

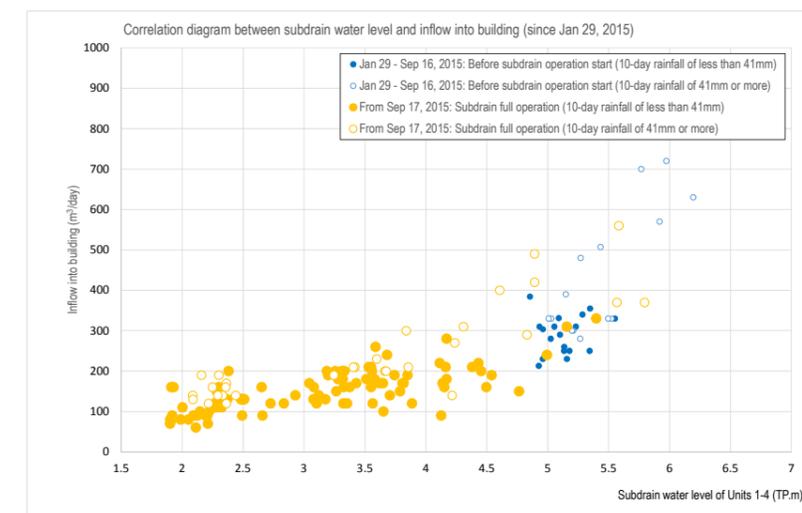
Figure 1: Correlation between inflow such as groundwater and rainwater into buildings and the water level of Unit 1-4 subdrains

- Since the subdrains went into operation, the inflow into buildings tended to decline to less than 150 m³/day when the subdrain water level declined below T.P. 3.0 m, while the inflow increased during rainfall.

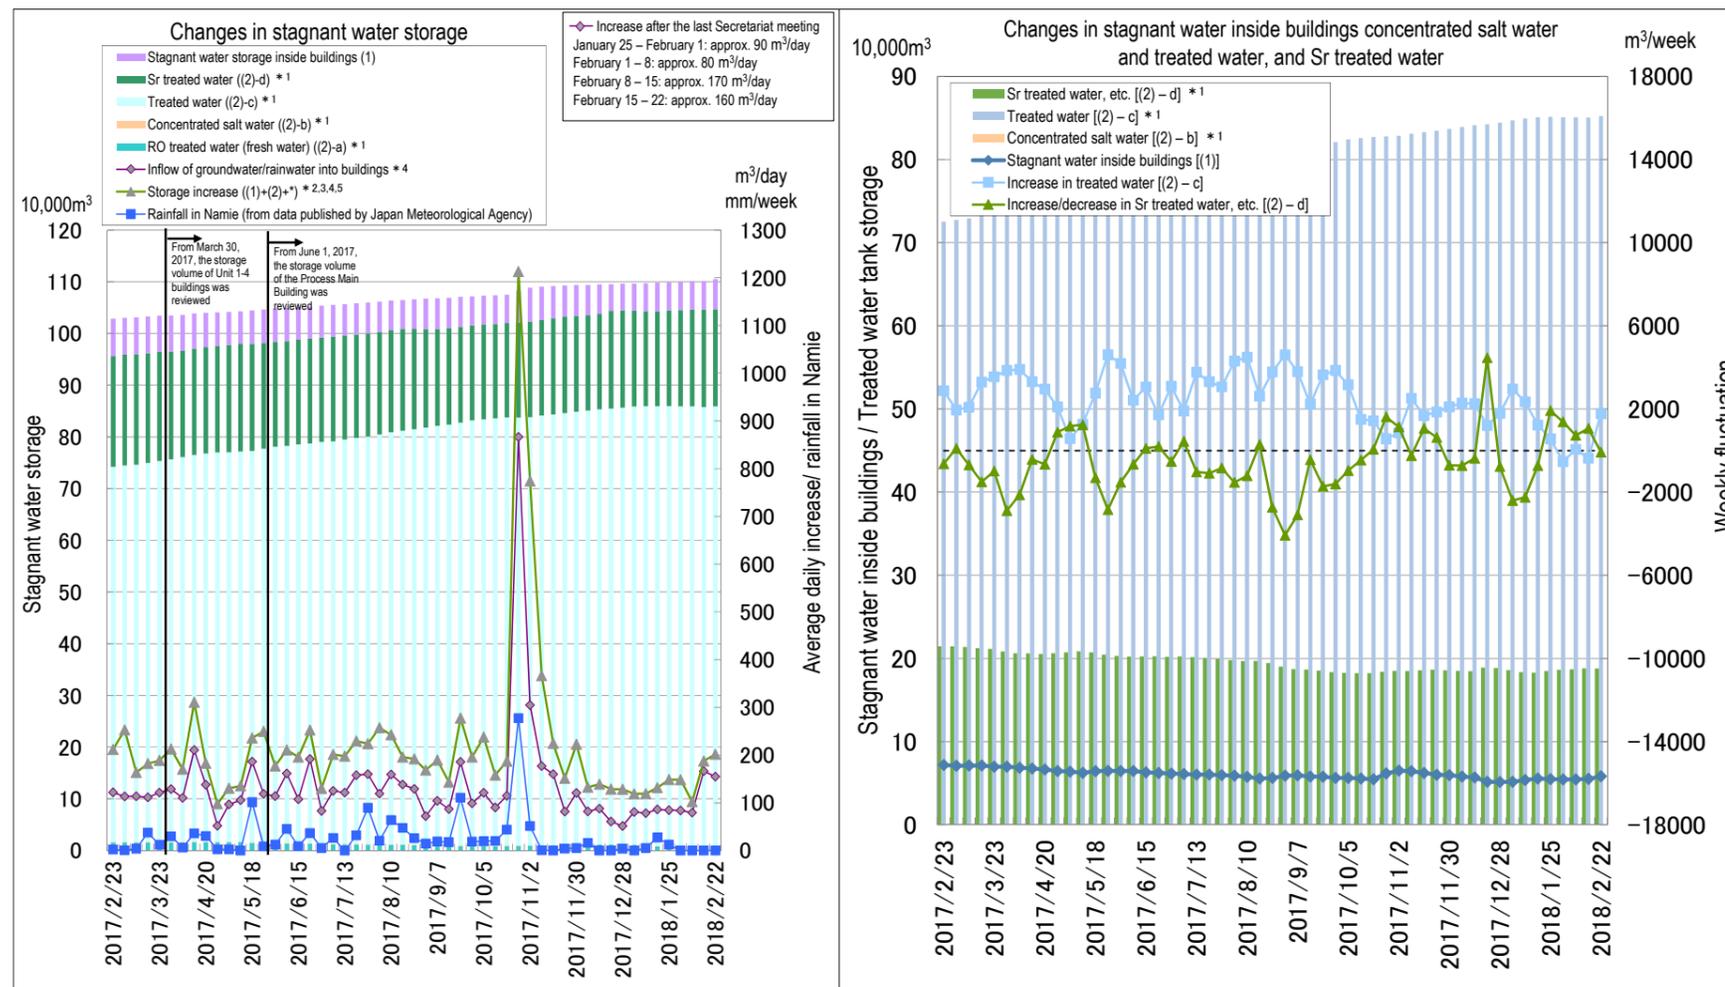
Figure 3: Status of stagnant water storage

As of February 22, 2018

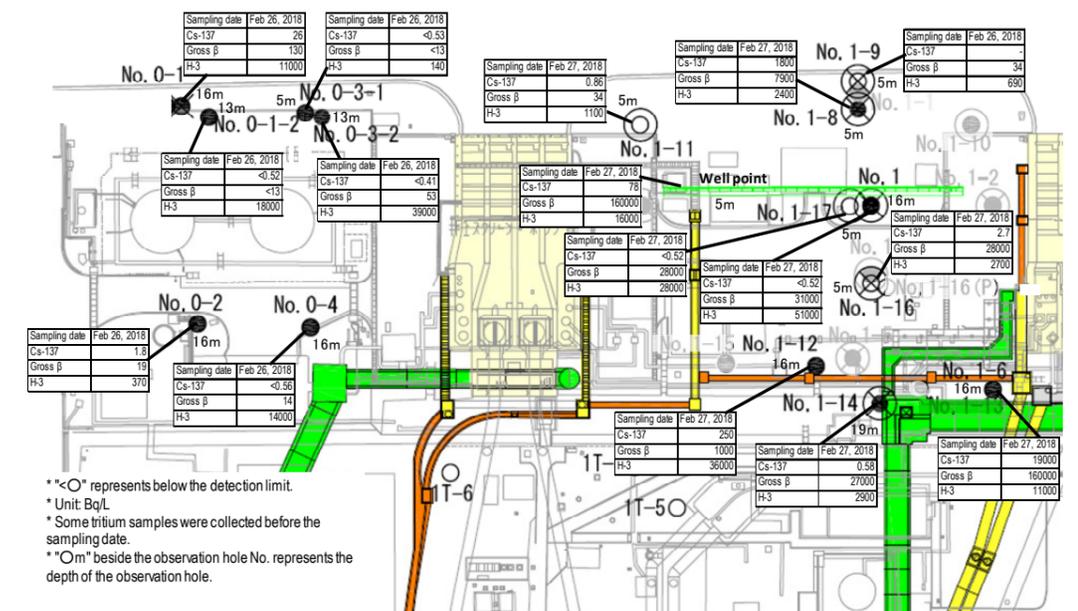
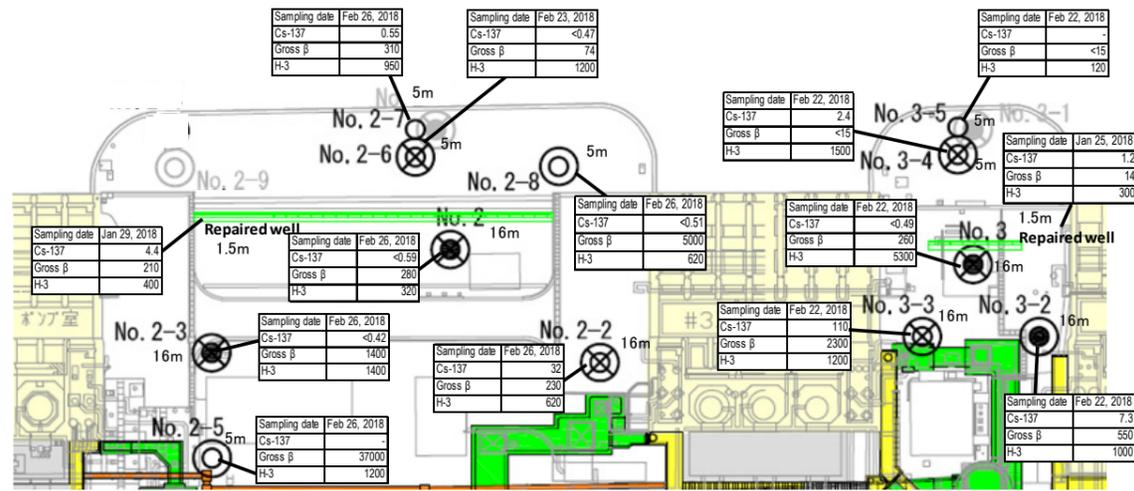
<Between Unit 2 and 3 intakes, between Unit 3 and 4 intakes>
Figure 4: Groundwater density on the Turbine Building east side

- Regarding radioactive materials in the groundwater near the bank between the Unit 3 and 4 intakes, the H-3 density at No. 3-4 had been increasing from 1,000 Bq/L since October 2017 and currently stands at around 1,500 Bq/L. Since April 1, 2015, pumping of groundwater continued (at the well point between the Unit 3 and 4 intakes: April 1 – September 16, 2015; at the repaired well: from September 17, 2015).

<Unit 1 intake north side, between Unit 1 and 2 intakes>

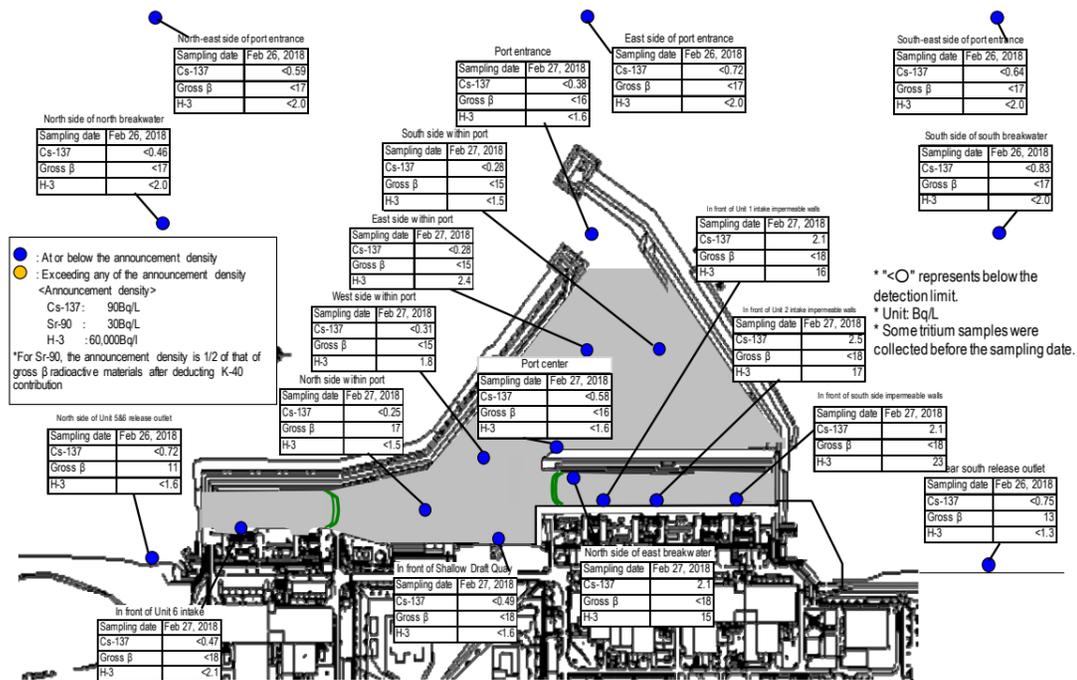
Figure 5: Seawater density around the port

- Regarding the radioactive materials in seawater in the area within the port, densities have remained below the legal discharge limit except for the increase in cesium 137 and strontium 90 during heavy rain. They have been declining following the completed installation and the connection of steel pipe sheet piles for the sea-side impermeable walls.

- Regarding the radioactive materials in seawater in the area outside the port, densities of cesium 137 and strontium 90 have been declining and remained below the legal discharge limit without no variation following the completed installation and the connection of steel pipe sheet piles for the sea-side impermeable walls.

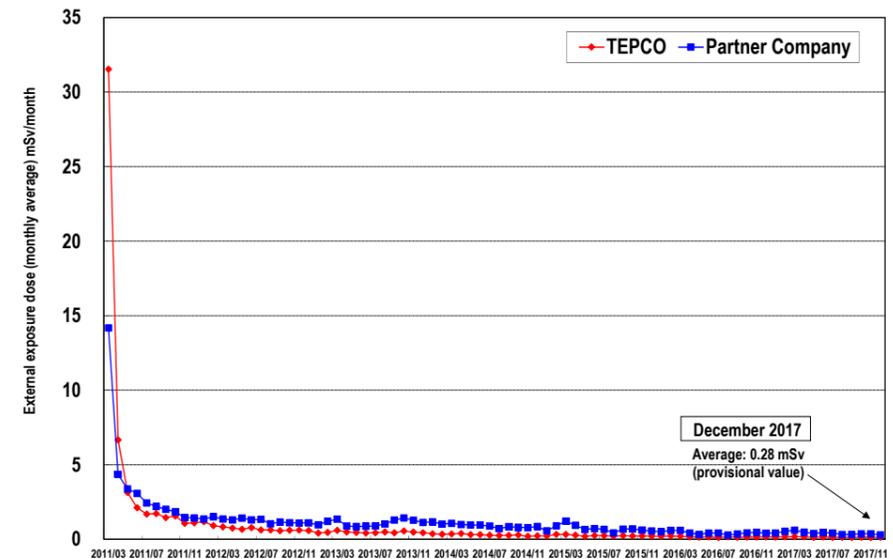
Figure 7: Changes in monthly individual worker exposure dose (monthly average exposure dose since March 2011)

- The monthly average exposure dose of workers remained at approx. 0.81 mSv/month during FY2014, approx. 0.59 mSv/month during FY2015 and approx. 0.39 mSv/month during FY2016. (Reference: Annual average exposure dose 20 mSv/year \div 1.7 mSv/month)

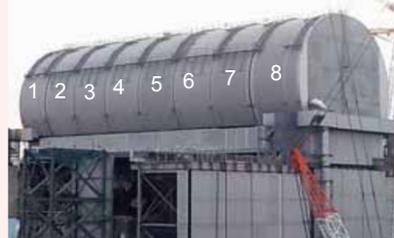
Installation of dome roof (February 21)

Installation of the fuel removal cover was completed on February 23, 2018. Work will continue with safety first toward fuel removal around mid-FY2018.

As measures to reduce the dose on the Reactor Building operating floor, the decontamination and installation of shields were completed in June and December 2016 respectively. Installation of a fuel removal cover started from January 2017 and installation of all dome roofs was completed in February 2018.

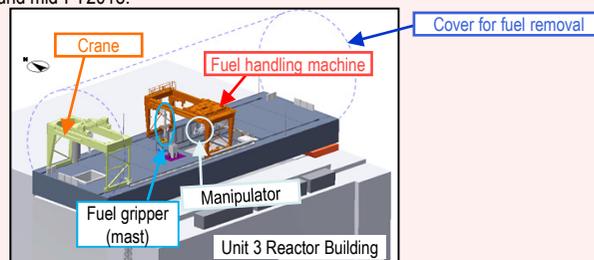
Image of entire fuel handling facility inside the cover

Prior to the installation of a cover for fuel removal, removal of large rubble from the spent fuel pool was completed in November 2015. To ensure safe and steady fuel removal, training of remote control was conducted at the factory using the actual fuel-handling machine which will be installed on site (February – December 2015). Measures to reduce dose on the Reactor Building top floor (decontamination, shields) were completed in December 2016. Installation of a cover for fuel removal and a fuel-handling machine is underway from January 2017.

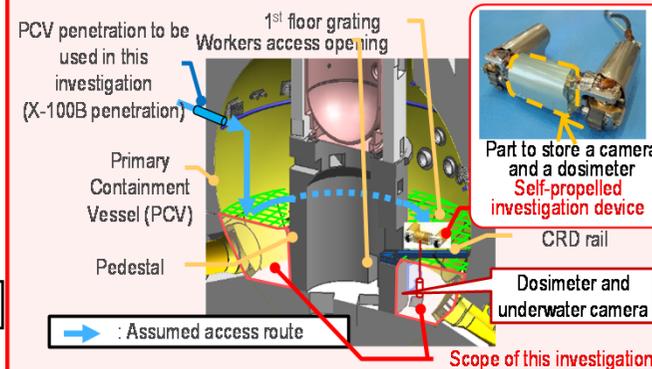
Image of hanging of dosimeter and camera

- In April 2015, a device, which entered the inside of the PCV through a narrow access opening (bore: ϕ 100 mm), collected information such as images and airborne dose inside the PCV 1st floor.
- In March 2017, the investigation using a self-propelled investigation device, conducted to inspect the spreading of debris to the basement floor outside the pedestal, took images of the PCV bottom status for the first time. The status inside the PCV will continue to be examined based on the collected image and dose data.

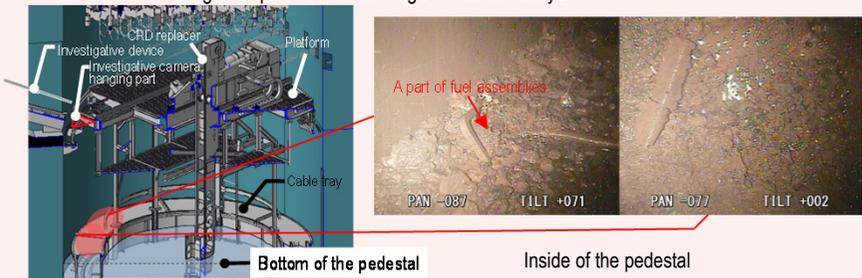
Capturing the location of fuel debris inside the reactor by measurement using muons

Period	Evaluation results
Mar - Jul 2016	Confirmed the existence of high-density materials, which was considered as fuel debris, at the bottom of RPV, and in the lower part and the outer periphery of the reactor core. It was assumed that a large part of fuel debris existed at the bottom of RPV.

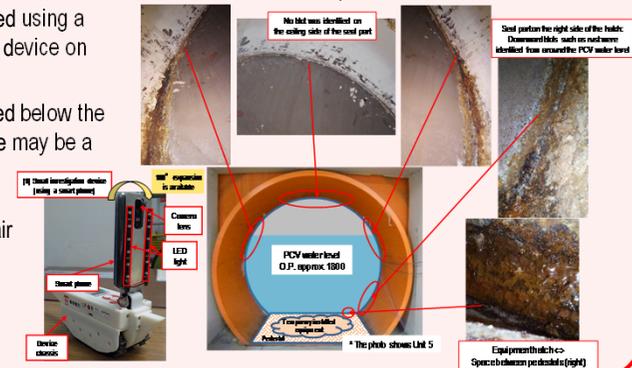
Investigative results into the Unit 3 PCV equipment hatch using a small investigation device

- As part of the investigation into the PCV to facilitate fuel debris retrieval, the status around the Unit 3 PCV equipment hatch was investigated using a small self-traveling investigation device on November 26, 2015.
- Given blots such as rust identified below the water level inside the PCV, there may be a leakage from the seal to the extent of bleeding. Methods to investigate and repair the parts, including other PCV penetrations with a similar structure, will be considered.

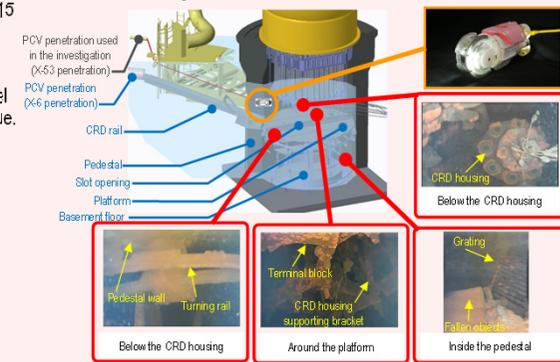
Status inside the pedestal

- In July 2017, the inside of the PCV was investigated using the underwater ROV (remotely operated underwater vehicle) to inspect the inside of the pedestal.

- Analysis of image data obtained in the investigation identified damage to multiple structures and the supposed core internals. Consideration about fuel removal based on the obtained information will continue.

- For the purpose of confirming the status inside the PCV, an investigation device was inserted into the PCV from X-53 penetration on October 20 and 22, 2015 to obtain images, data of dose and temperature and sample stagnant water. No damage was identified on the structure and walls inside the PCV and the water level was almost identical with the estimated value. In addition, the dose inside the PCV was confirmed to be lower than in other Units.

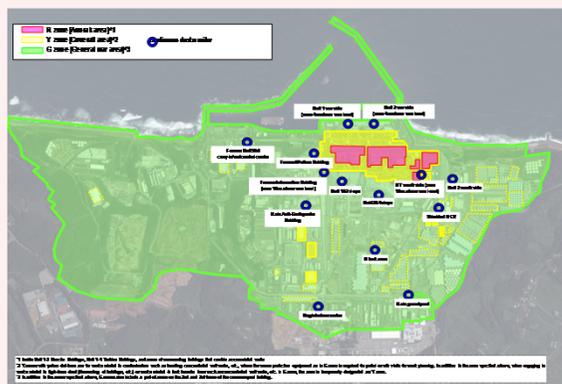
Based on the progress of measures to reduce environmental dosage on site, the site is categorized into two zones: highly contaminated area around Unit 1-4 buildings, etc. and other areas to optimize protective equipment according to each category aiming at improving safety and productivity by reducing load during work.

From March 2016, limited operation started. From March and September 2017, the G Zone was expanded.

R zone (Anorak area)	Y zone (Coverall area)	G zone (General wear)
Full-face mask
