Main decommissioning works and steps

All fuel had been removed from Unit 4 SFP by December 22, 2014. Work continues toward fuel removal and debris (Note 1) retrieval from Unit 1-3.

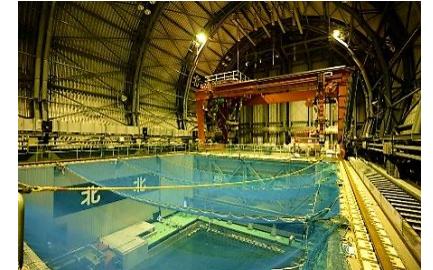
Status inside the cover for fuel removal (March 15, 2018)

As measures to reduce the dose on the Reactor Building operating floor, the decontamination and installation of shields were completed in June and December 2016 respectively. Installation of a fuel removal cover started from January 2017 and installation of all dome roofs was completed in February 2018.

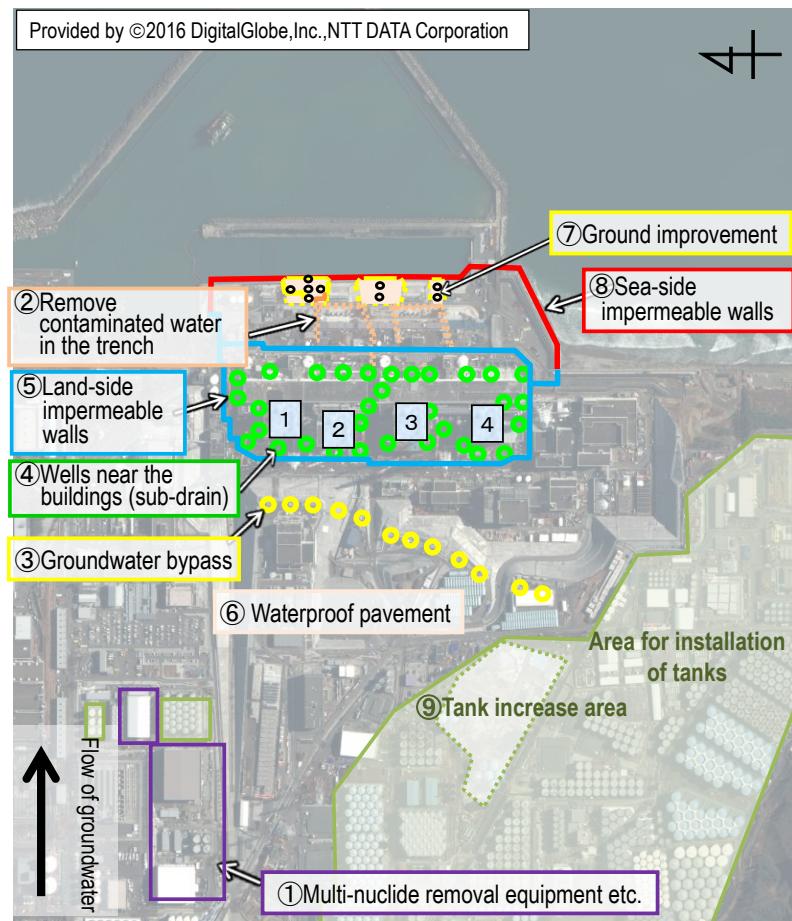
Three principles behind contaminated water countermeasures:

Countermeasures for contaminated water are implemented in accordance with the following three principles:

1. Eliminate contamination sources

- ① Multi-nuclide removal equipment, etc.
 - ② Remove contaminated water from the trench (Note 3)
- (Note 3) Underground tunnel containing pipes.

2. Isolate water from contamination

- ③ Pump up groundwater for bypassing
- ④ Pump up groundwater near buildings
- ⑤ Land-side impermeable walls
- ⑥ Waterproof pavement

3. Prevent leakage of contaminated water

- ⑦ Enhance soil by adding sodium silicate
- ⑧ Sea-side impermeable walls
- ⑨ Increase the number of (welded-joint) tanks

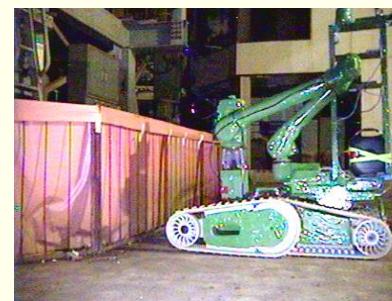
Investigation using a remote-controlled unmanned robot

Contamination of the robot was below the level that would prevent maintenance by workers in the front room.

These results confirmed the availability of future work to move and organize the remaining objects, and investigations of dose, contamination statuses, etc. on the operating floor.

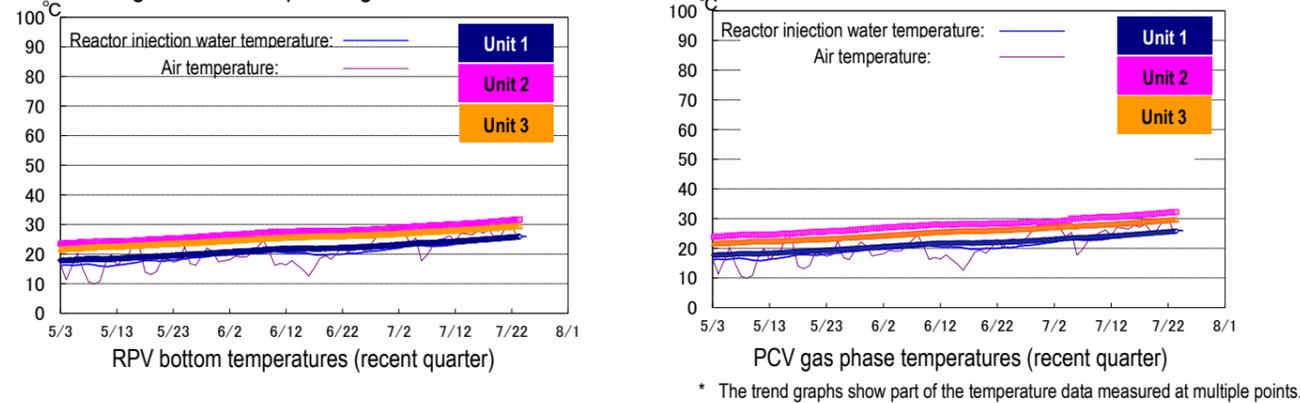
Through continuous reactor cooling by water injection, the temperatures of the Reactor Pressure Vessel (RPV) bottom and the Primary Containment Vessel (PCV) gas phase were maintained within the range of approx. 25 to 35°C for the past month, though it varied depending on the unit and location of the thermometer.

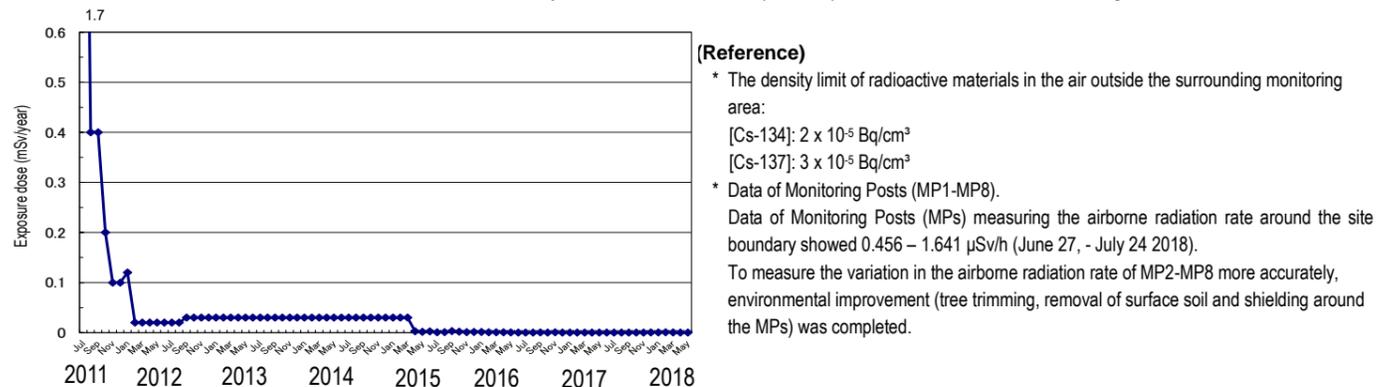
Annual radiation dose at site boundaries by radioactive materials (cesium) released from Reactor Building Units 1-4

As of June 2018, the density of radioactive materials newly released from Reactor Building Units 1-4 in the air and measured at the site boundary was evaluated at approx. 1.3×10^{-12} Bq/cm³ for Cs-134 and 5.1×10^{-12} Bq/cm³ for Cs-137, while the radiation exposure dose due to the release of radioactive materials there was less than 0.00022 mSv/year.

Note: Different formulas and coefficients were used to evaluate the radiation dose in the facility operation plan and monthly report. The evaluation methods were integrated in September 2012. As the fuel removal from the spent fuel pool (SFP) commenced for Unit 4, the radiation exposure dose from Unit 4 was added to the items subject to evaluation since November 2013. The evaluation has been changed to a method considering the values of continuous dust monitors since FY2015, with data to be evaluated monthly and announced the following month.

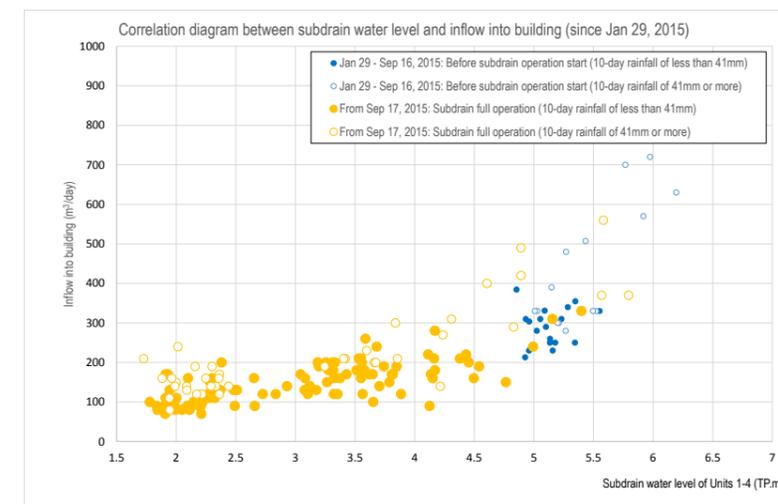
Figure 1: Correlation between inflow such as groundwater and rainwater into buildings and the water level of Unit 1-4 subdrains

- Since the subdrains went into operation, the inflow into buildings tended to decline to less than 150 m³/day when the subdrain water level declined below T.P. 3.0 m but increased during rainfall.

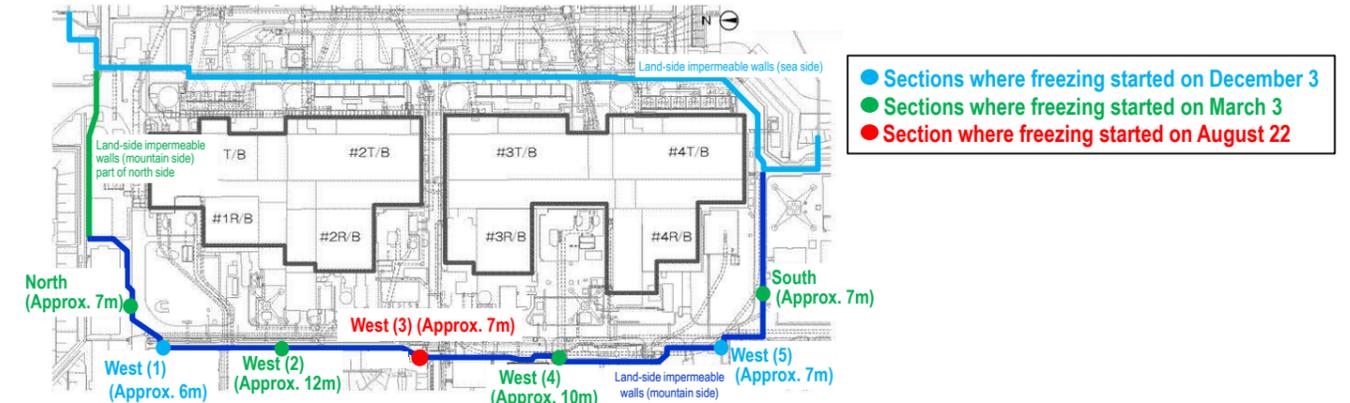
Figure 2: Closure of part of the land-side impermeable walls (on the mountain side)

- In March 2018, the land-side impermeable walls were considered completed except for a portion of the depths, based on a monitoring result showing that the underground temperature had declined below 0°C in almost all areas, while on the mountain side, the difference between the inside and outside increased to approx. 4-5 m. Multi-layered contaminated water management measures, including subdrains and facing, have kept the groundwater level stable. Consequently, a water-level management system to isolate the buildings from groundwater was considered to have been established. The Committee on Countermeasures for Contaminated Water Treatment, held on March 7, clearly recognized the effect of the land-side impermeable walls in shielding groundwater and evaluated that the land-side impermeable walls had allowed a significant reduction in the amount of contaminated water generated.

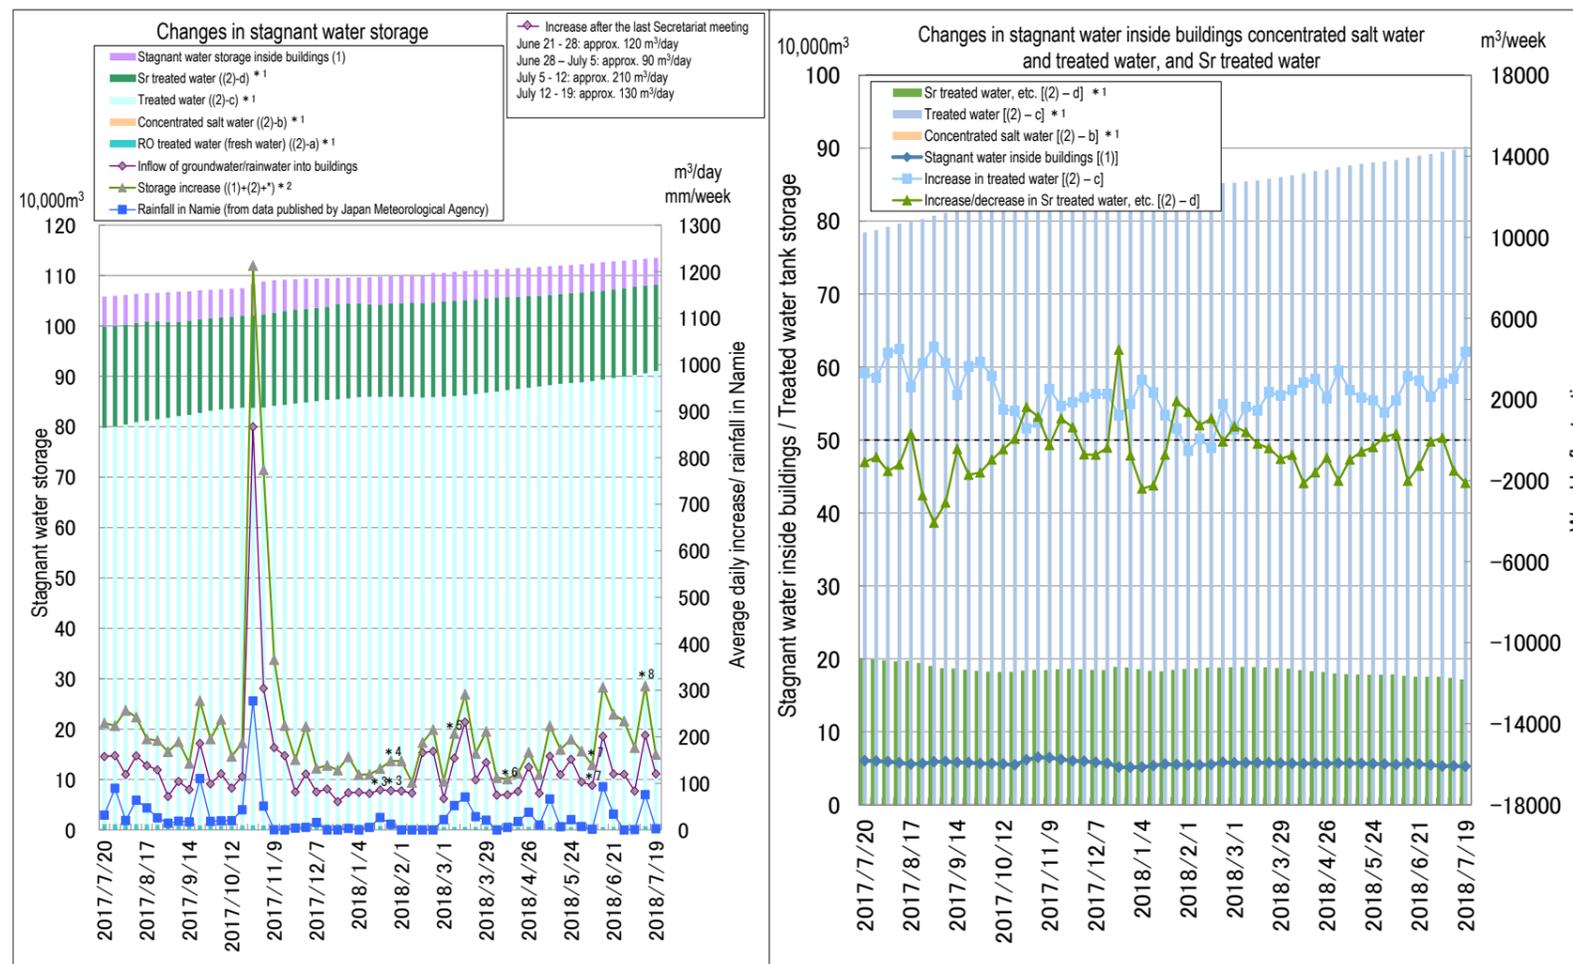
Figure 3: Status of stagnant water storage

- Measures are being implemented to prepare for an increase in contaminated water generated during heavy rain such as typhoons.
- Investigation and analysis to date confirmed that the actual value of the inflow to buildings differed from the estimated value during heavy rain such as typhoons.
- This difference is considered mainly attributable to inflows into buildings through the trench near the Unit 1 and 2 Turbine Buildings, from a damaged part of the Unit 2 Reactor Building roof drain and from a damaged part of the Unit 3 Turbine Building roof.

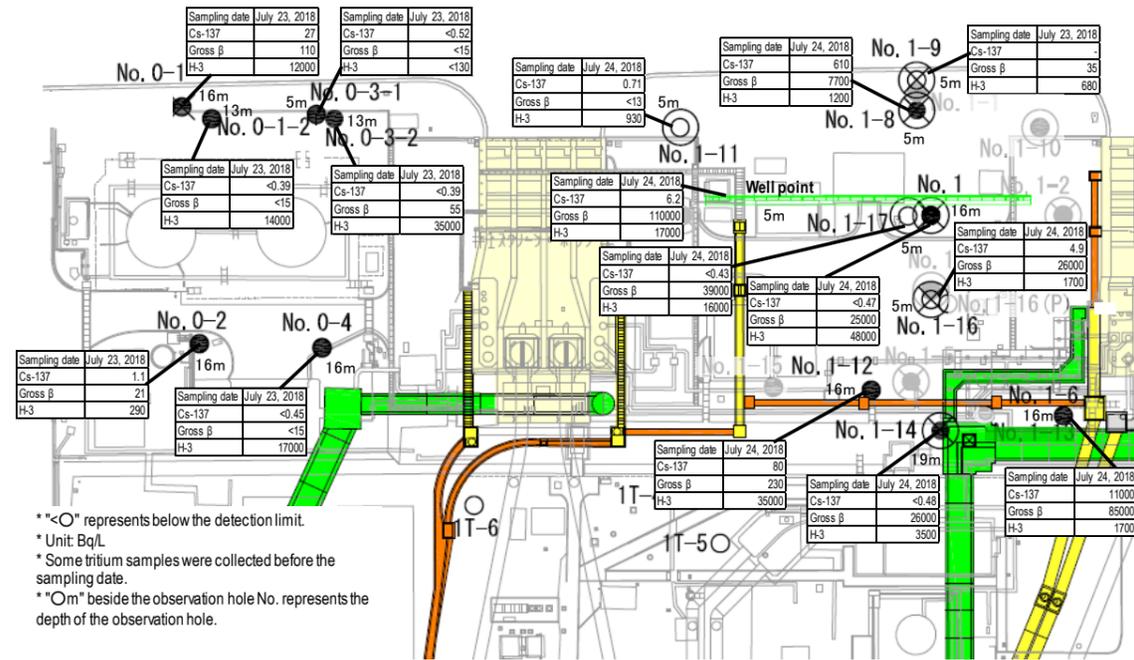
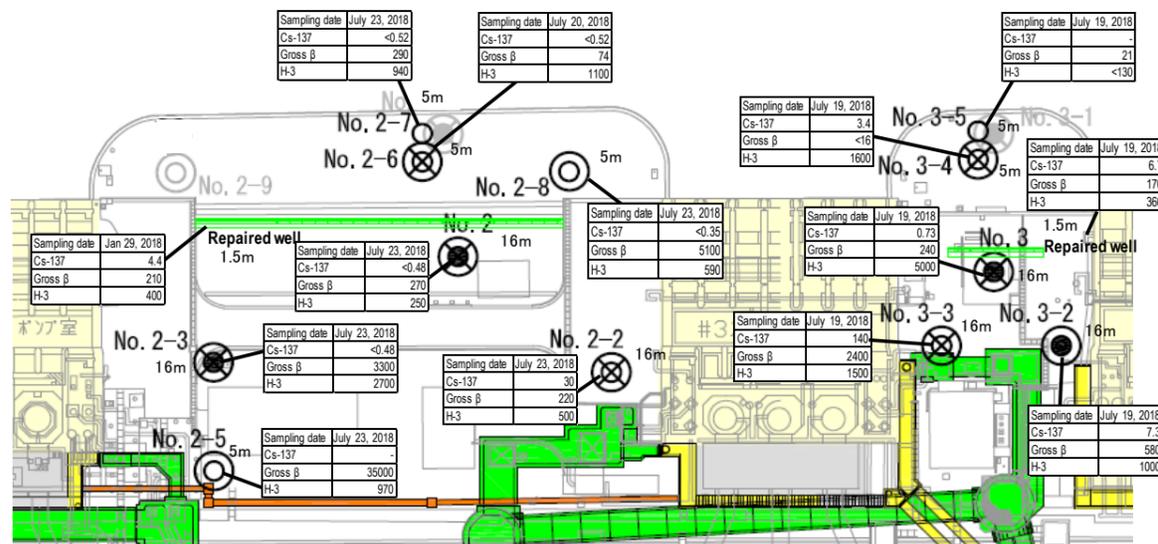
Figure 4: Groundwater density on the Turbine Building east side

<Unit 1 intake north side, between Unit 1 and 2 intakes>

<Between Unit 2 and 3 intakes, between Unit 3 and 4 intakes>

- The H-3 density at No. 1-17 had been declining from around 30,000 Bq/L since December 2017 and currently stands at around 16,000 Bq/L. Since August 15, 2013, pumping of groundwater continued (at the well point between the Unit 1 and 2 intakes: August 15, 2013 – October 13, 2015 and from October 24; at the repaired well: October 14 - 23, 2015).

- The H-3 density at No. 2-5 had been increasing from around 700 Bq/L since November 2017 to around 1,800 Bq/L, then declining and currently stands at around 1,000 Bq/L. The density of gross β radioactive materials at the same point had been increasing from around 30,000 Bq/L since March 2018 to around 70,000 Bq/L, then declining and currently stands at around 30,000 Bq/L. Since December 18, 2013, pumping of groundwater continued (at the well point between the Unit 2 and 3 intakes: December 18, 2013 - October 13, 2015; at the repaired well: from October 14, 2015).

- The H-3 density at No. 3-4 had been declining from around 2,000 Bq/L since January 2018 to around 900 Bq/L, then increasing and currently stands at around 1,500 Bq/L. Since April 1, 2015, pumping of groundwater continued (at the well point between the Unit 3 and 4 intakes: April 1 – September 16, 2015; at the repaired well: from September 17, 2015).

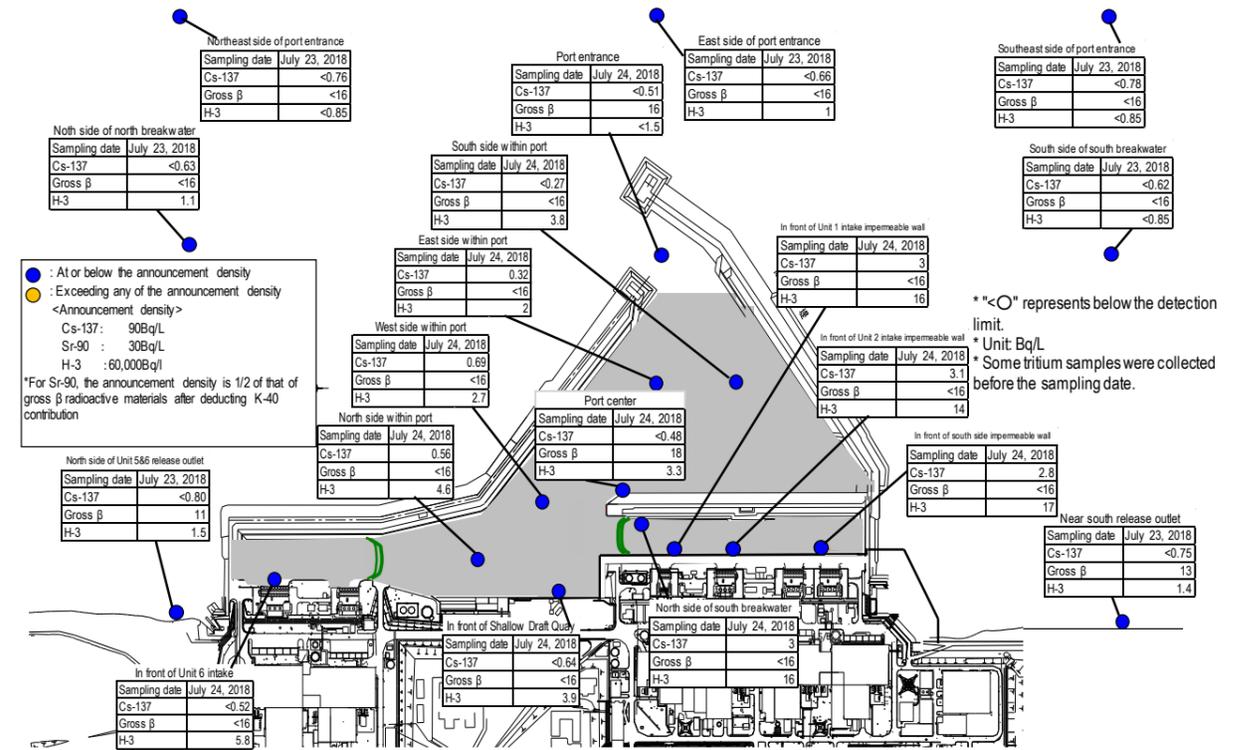
Figure 5: Seawater density around the port

- Regarding the radioactive materials in seawater in the area within the port, densities have remained below the legal discharge limit except for the increase in cesium 137 and strontium 90 during heavy rain but declining following the completed installation and the connection of steel pipe sheet piles for the sea-side impermeable walls.

- Regarding the radioactive materials in seawater in the area outside the port, densities of cesium 137 and strontium 90 have been declining, but remained below the legal discharge limit at an unchanged level following the completed installation and the connection of steel pipe sheet piles for the sea-side impermeable walls.

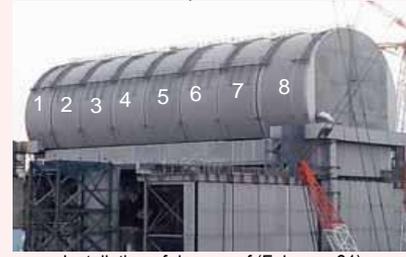
Installation of dome roof (February 21)

Prior to the installation of a cover for fuel removal, removal of large rubble from the spent fuel pool was completed in November 2015. To ensure safe and steady fuel removal, training of remote control was conducted at the factory using the actual fuel-handling machine which will be installed on site (February – December 2015). Measures to reduce dose on the Reactor Building top floor (decontamination, shields) were completed in December 2016. Installation of a cover for fuel removal and a fuel-handling machine is underway from January 2017. Installation of the fuel removal cover was completed on February 23, 2018. Work will continue with safety first toward fuel removal around mid-FY2018.

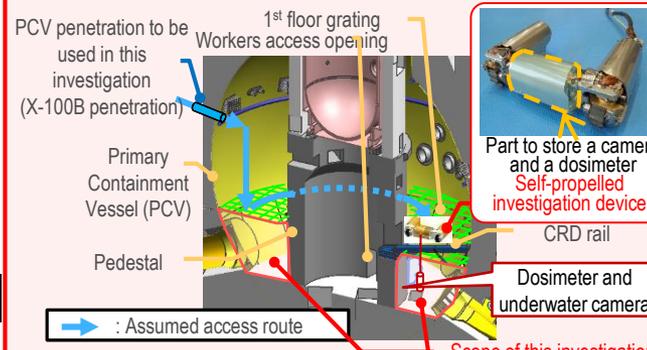
Image of hanging of dosimeter and camera

- In April 2015, a device, which entered the inside of the PCV through a narrow access opening (bore: ϕ 100 mm), collected information such as images and airborne dose inside the PCV 1st floor.
- In March 2017, the investigation using a self-propelled investigation device, conducted to inspect the spreading of debris to the basement floor outside the pedestal, took images of the PCV bottom status for the first time. The status inside the PCV will continue to be examined based on the collected image and dose data.

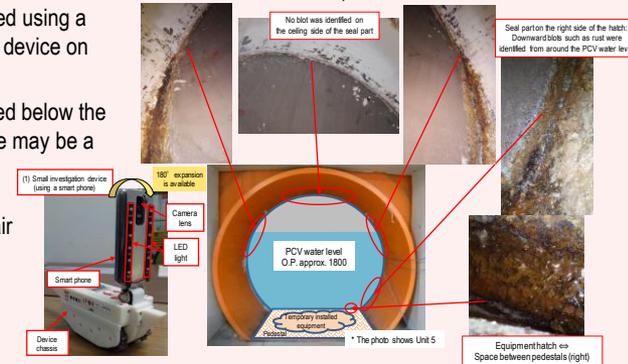
- Given blots such as rust identified below the water level inside the PCV, there may be a leakage from the seal to the extent of bleeding.

Methods to investigate and repair the parts, including other PCV penetrations with a similar structure, will be considered.

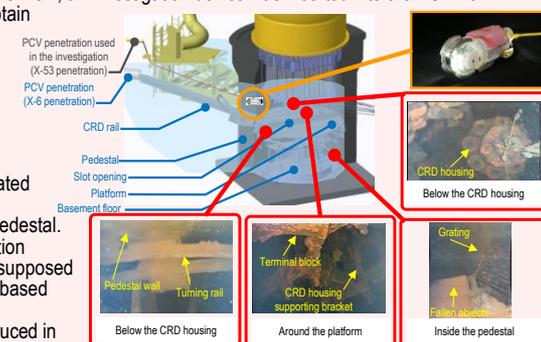
Status inside the pedestal

- Analysis of image data obtained in the investigation identified damage to multiple structures and the supposed core internals. Consideration about fuel removal based on the obtained information will continue.

- Videos obtained in the investigation were reproduced in 3D. Based on the reproduced images, the relative positions of the structures, such as the rotating platform slipping off the rail with a portion buried in deposits, were visually understood.

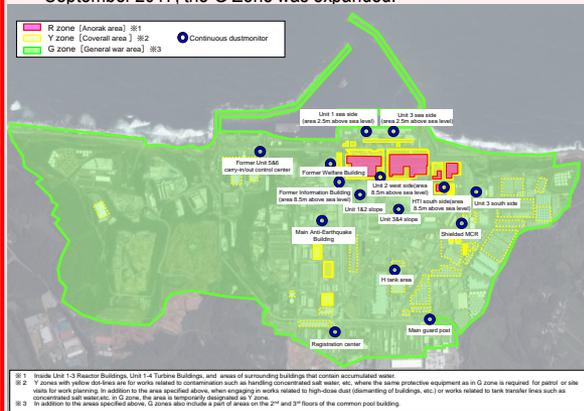
Based on the progress of measures to reduce environmental dosage on site, the site is categorized into two zones: highly contaminated area around Unit 1-4 buildings, etc. and other areas to optimize protective equipment according to each category aiming at improving safety and productivity by reducing load during work.

From March 2016, limited operation started. From March and September 2017, the G Zone was expanded.

※1 Inside Unit 1-3 Reactor Buildings, Unit 1-4 Turbine Buildings, and areas of surrounding buildings that contain accumulated water.
 ※2 Y zones with yellow dot areas are for works related to contamination such as handling concentrated salt water, etc. when the same protective equipment as in G zone is required for patrol or site visits for work planning. In addition to the area specified above, when engaging in works related to high-dose dust (disassembling of buildings, etc.) or works related to tank transfer lines such as concentrated salt water tanks in G zone, the area is temporarily designated as Y zone.
 ※3 In addition to the areas specified above, G zones also include a part of areas on the 2nd and 3rd floors of the common pool building.

R zone (Anorak area)	Y zone (Coverall area)	G zone (General wear)
Full-face mask 	Full-face or half-face masks 	Disposable disposable mask
Anorak on coverall Or double coveralls 	Coverall 	General*3 Dedicated on-site wear
