## Main decommissioning works and steps

All fuel had been removed from Unit 4 SFP by December 22, 2014. Work continues toward fuel removal and debris (Note 1) retrieval from Unit 1-3.

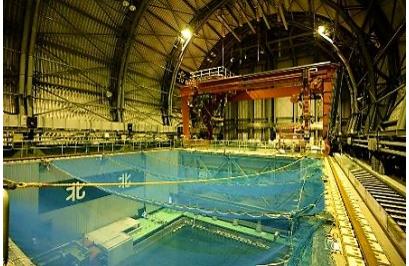
Status inside the cover for fuel removal (March 15, 2018)

As measures to reduce the dose on the Reactor Building operating floor, the decontamination and installation of shields were completed in June and December 2016 respectively. Installation of a fuel removal cover started from January 2017 and installation of all dome roofs was completed in February 2018.

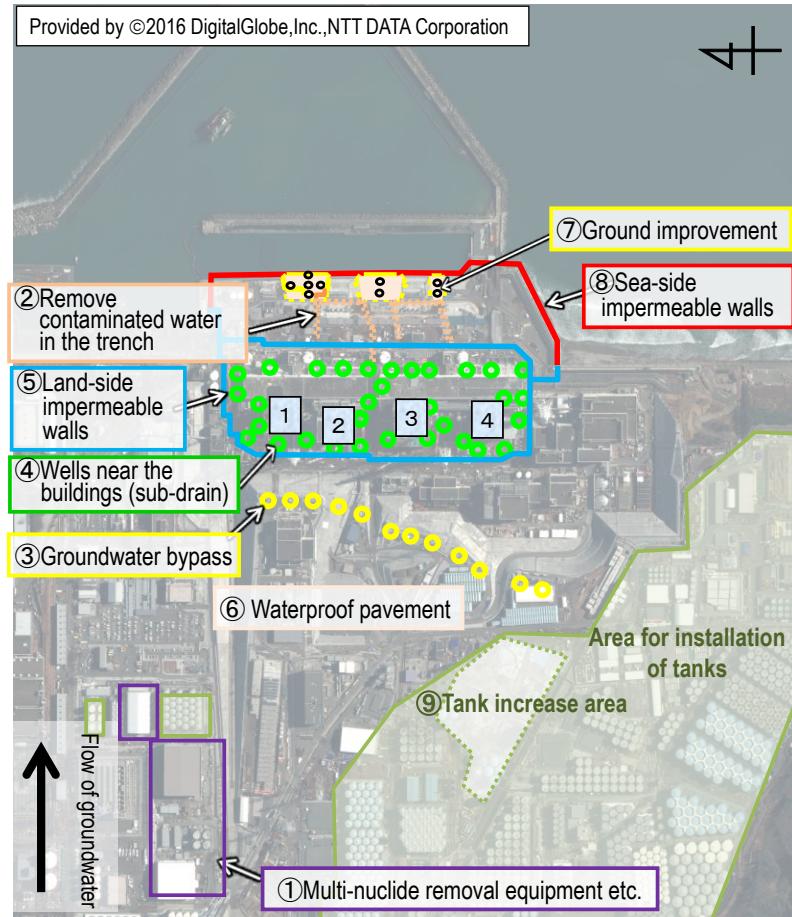
Countermeasures for contaminated water are implemented in accordance with the following three principles:

### 1. Eliminate contamination sources

- ① Multi-nuclide removal equipment, etc.
- ② Remove contaminated water from the trench (Note 3)  
(Note 3) Underground tunnel containing pipes.

### 2. Isolate water from contamination

- ③ Pump up groundwater for bypassing
- ④ Pump up groundwater near buildings
- ⑤ Land-side impermeable walls
- ⑥ Waterproof pavement

### 3. Prevent leakage of contaminated water

- ⑦ Enhance soil by adding sodium silicate
- ⑧ Sea-side impermeable walls
- ⑨ Increase the number of (welded-joint) tanks

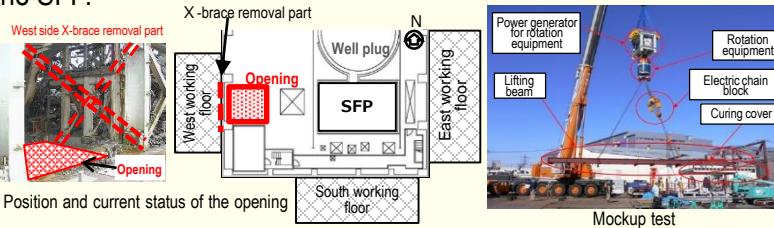
Toward work to protect the spent fuel pool (SFP), etc., the opening will be covered to create an access route from the west working floor and prevent small rubble from falling from the operating floor while removing rubble at the center and on the south side.

Mockup tests regarding the installation of the opening cover were conducted in November and December 2018 and onsite work started from January 2019. After completing the installation by around March 2019, work will shift to removing small rubble around the SFP.

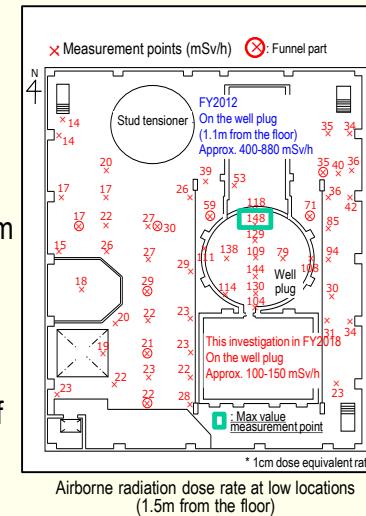
### Confirmation of reduced airborne radiation dose rate on the Unit 2 operating floor

Toward spent fuel removal, as one of the investigations to understand the contamination condition across the operating floor, the airborne radiation dose rate at low locations of the operating floor was measured in November and December 2018.

The results confirmed a significant reduction from the previous investigative findings, which was considered attributable to natural reduction, the effect of rainwater flowing into buildings and containment of remaining objects inside the operating floor.

Based on the results obtained, the distribution of dust density required to formulate future work plans will be evaluated, including dust scattering and shielding design.

- Before this investigation, work to move and contain the remaining objects was completed on November 6, 2018.
  - Toward spent fuel removal, as one of the investigations to understand the contamination condition across the operating floor, the airborne radiation dose rate at low locations of the operating floor was measured in November and December 2018.

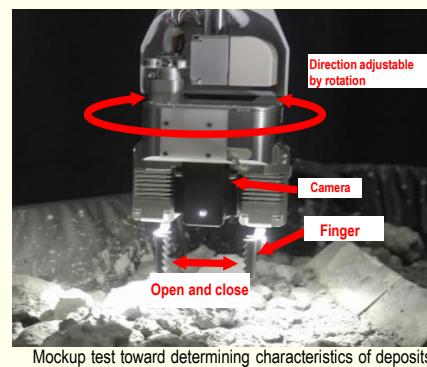
In this investigation, therefore, a finger will be operated according to the characteristics of the deposits to determine the adhesion and the existence of any contact trace on the deposit surface. Videos, dose and temperature data close to the deposits will also be collected.

Information obtained from this investigation will be utilized in the internal investigation in late FY2019.

- The purpose of the scheduled investigation inside the Primary Containment Vessel (PCV) from mid- to late-February 2019 is to determine the characteristics (hardness and fragility) of deposits detected on the bottom of the pedestal.
- In this investigation, therefore, a finger will be operated according to the characteristics of the deposits to determine the adhesion condition and the existence of any contact trace on the deposit surface. Videos, dose and temperature data close to the deposits will also be collected.
- Information obtained from this investigation will be utilized in the internal investigation in the 2nd half of FY2019.

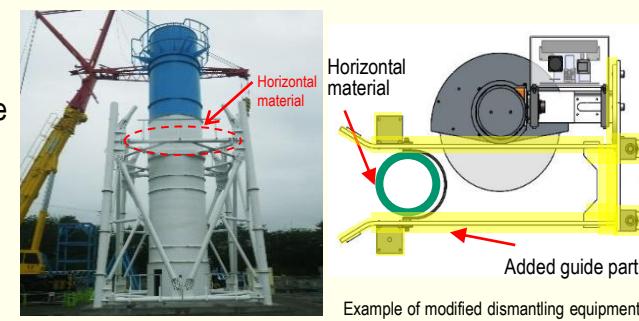
Example of modified dismantling equipment

Specifically, a guide part was added to prevent blade nick of the cutting machine due to the horizontal sway occurring when the equipment is shaken by strong wind during work to cut horizontal materials of the iron tower.

For these additional measures, the demonstration test will be extended until March 2019. After completing the test, the dismantling equipment will be transferred to the site and assembled to start dismantling of the exhaust stack from May.

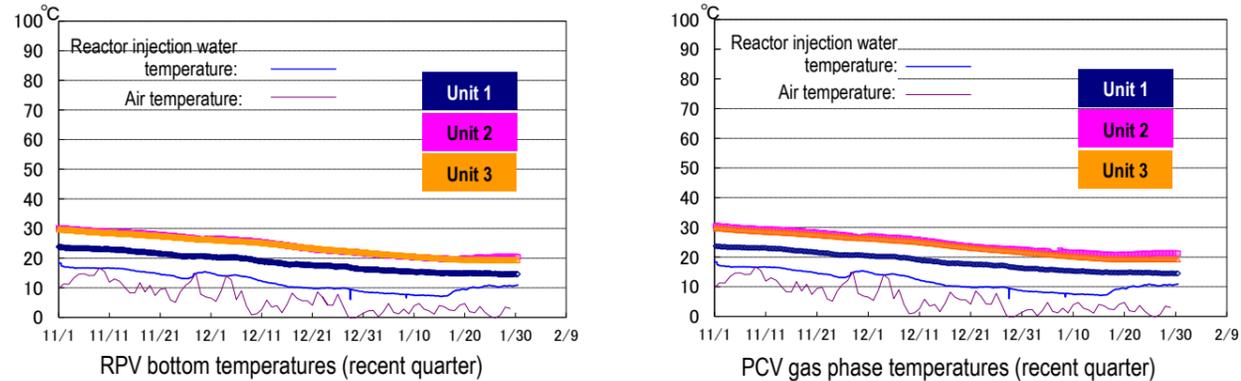
Through continuous reactor cooling by water injection, the temperatures of the Reactor Pressure Vessel (RPV) bottom and the Primary Containment Vessel (PCV) gas phase were maintained within the range of approx. 15 to 25°C for the past month, though it varied depending on the unit and location of the thermometer.

\* The trend graphs show part of the temperature data measured at multiple points.

◆ The temperatures of the Reactor Pressure Vessel (RPV) and Primary Containment Vessel (PCV) of Units 1-3 have been maintained within the range of approx. 15-25°C<sup>\*1</sup> over the past month. There was no significant change in the density of radioactive materials newly released from Reactor Buildings in the air<sup>\*2</sup>. It was evaluated that the comprehensive cold shutdown condition had been maintained.

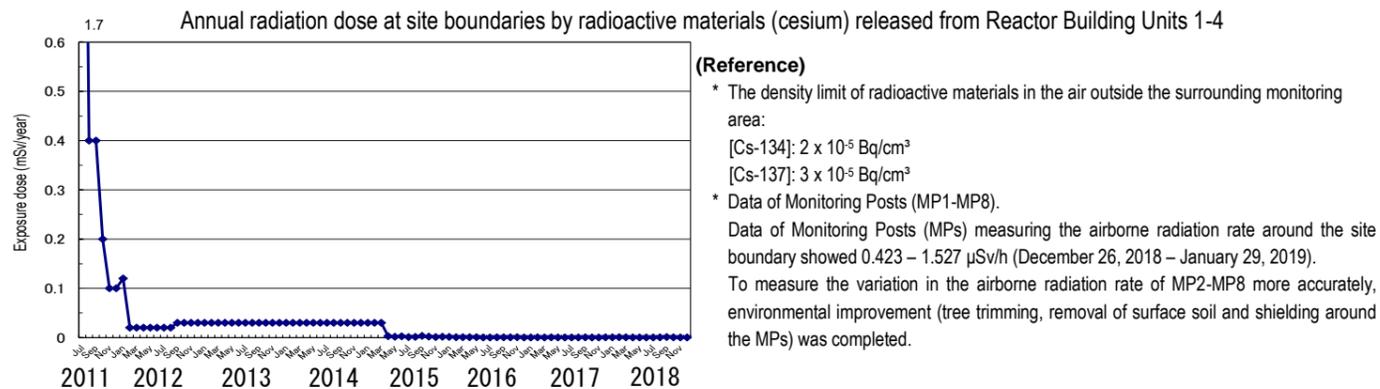
As of December 2018, the density of radioactive materials newly released from Reactor Building Units 1-4 in the air and measured at the site boundary was evaluated at approx.  $2.8 \times 10^{-12}$  Bq/cm<sup>3</sup> for Cs-134 and  $1.2 \times 10^{-11}$  Bq/cm<sup>3</sup> for Cs-137, while the radiation exposure dose due to the release of radioactive materials there was less than 0.00029 mSv/year.

Note: Different formulas and coefficients were used to evaluate the radiation dose in the facility operation plan and monthly report. The evaluation methods were integrated in September 2012. As the fuel removal from the spent fuel pool (SFP) commenced for Unit 4, the radiation exposure dose from Unit 4 was added to the items subject to evaluation since November 2013. The evaluation has been changed to a method considering the values of continuous dust monitors since FY2015, with data to be evaluated monthly and announced the following month.

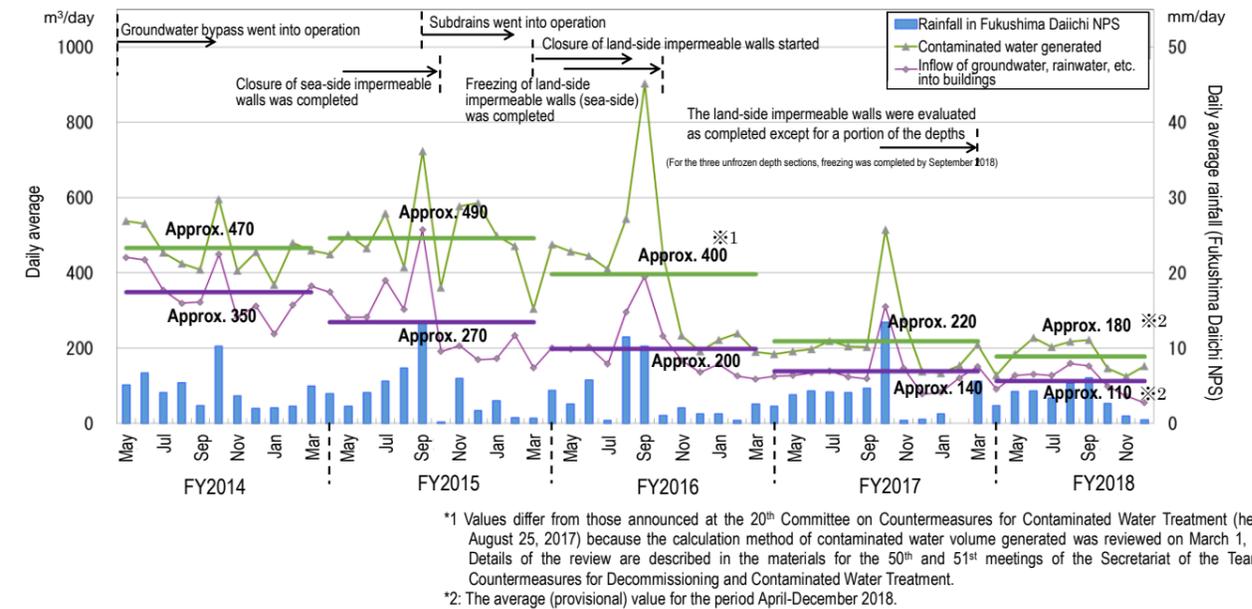
- Multi-layered measures, including pumping up by subdrains and land-side impermeable walls, which were implemented to control the continued generation of contaminated water, reduced the groundwater inflow into buildings.

- Following the steady implementation of “isolation” measures (groundwater bypass subdrains, frozen walls, etc.), the inflow reduced from approx. 470 m<sup>3</sup>/day (the FY2014 average) when the measures were first launched to approx. 220 m<sup>3</sup>/day (the FY2017 average), though the figure varied depending on rainfall, etc.
- Measures will continue to further reduce the volume of contaminated water generated.

Figure 1: Changes in contaminated water generated and inflow of groundwater, rainwater, etc. into buildings

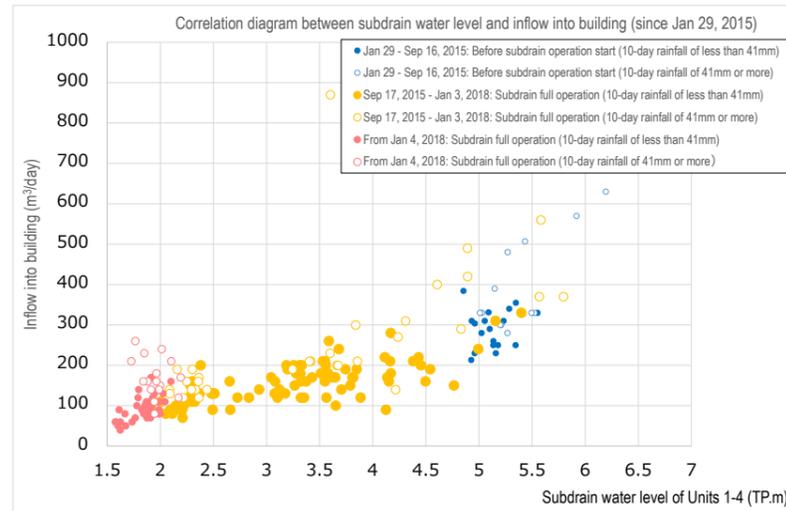
- To eliminate the need to suspend water pumping while cleaning the subdrain transfer pipe, the pipe will be duplicated. Installation of the pipe and ancillary facilities was completed.
- Since the subdrains went into operation, the inflow into buildings tended to decline to under 150 m<sup>3</sup>/day when the subdrain water level declined below T.P. 3.0 m but increased during rainfall.

Figure 2: Correlation between inflow such as groundwater and rainwater into buildings and the water level of Unit 1-4 subdrains

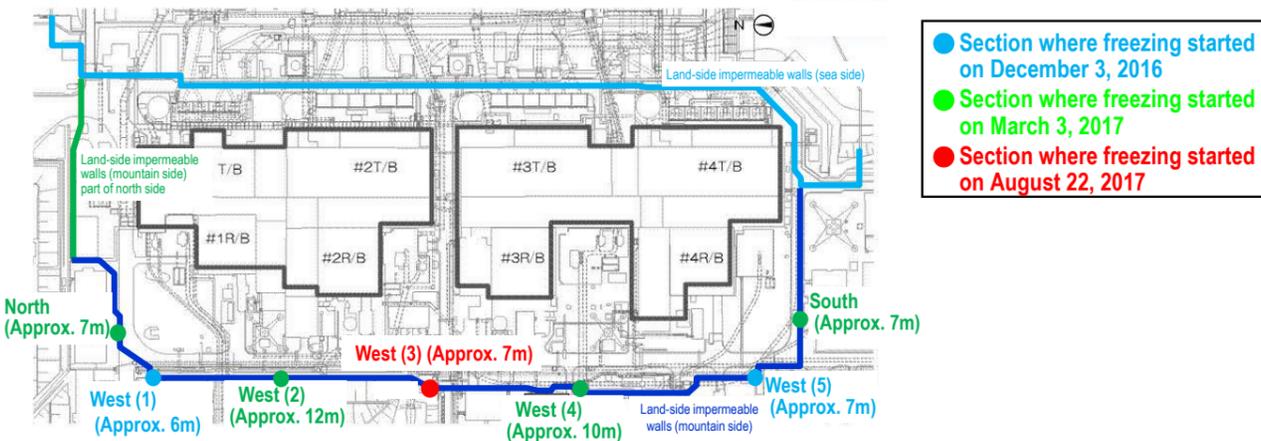
- A maintenance operation for the land-side impermeable walls to prevent frozen soil from thickening further continued from May 2017 on the north and south sides and started from November 2017 on the east side, where frozen soil of sufficient thickness was identified. The scope of the maintenance operation was expanded in March 2018.

- In March 2018, the land-side impermeable walls were considered completed except for a portion of the depths; based on a monitoring result showing that the underground temperature had declined below 0°C in almost all areas, while on the mountain side, the difference between the inside and outside increased to approx. 4-5 m. Multi-layered contaminated water management measures, including subdrains and facing, have kept the groundwater level stable. Consequently, a water-level management system to isolate the buildings from groundwater was considered to have been established. The Committee on Countermeasures for Contaminated Water Treatment, held on March 7, clearly recognized the effect of the land-side impermeable walls in shielding the groundwater and evaluated that the land-side impermeable walls had allowed a significant reduction in the amount of contaminated water generated.

Figure 3: Closure of part of the land-side impermeable walls (on the mountain side)

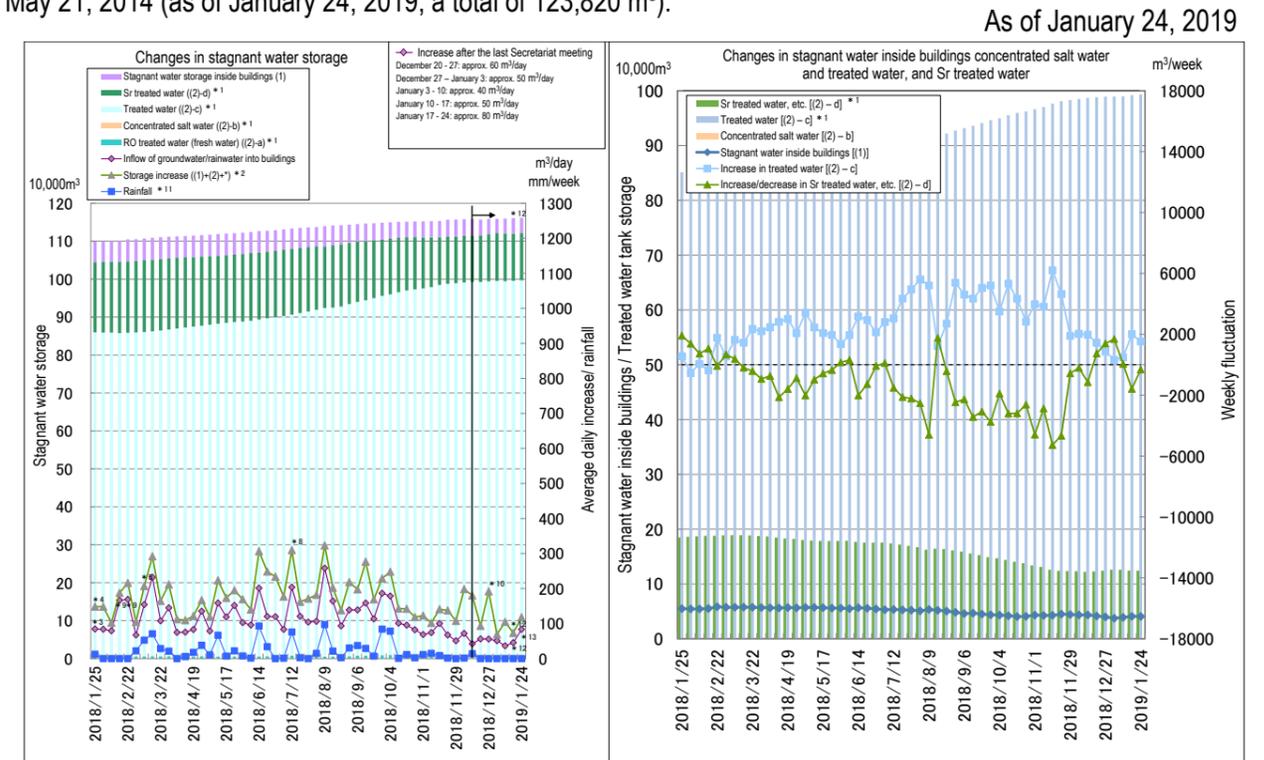
- \*1: Water amount for which the water-level gauge indicates 0% or more
- \*2: To detect storage increases more accurately, the calculation method was reviewed as follows from February 9, 2017: (The revised method was applied from March 1, 2018) [(Inflow of groundwater/rainwater into buildings) + (other transfer) + (chemical injection into ALPS)]

- \*3: Reevaluated by adding groundwater and rainwater inflow into the residual water areas (January 18 and 25, 2018).
- \*4: Reviewed because SARRY reverse cleaning water was added to "Storage increase." (January 25, 2018)

- \*9: Inflow into buildings increased due to the effect of repair work on the K drainage channel.
- \*10: The storage amount increased due to transfer to buildings in association with the decommissioning work. (The transferred amount comprised ①an ALPS chemical injection amount of approx. 14 m<sup>3</sup>/day, ②transfer from wells and groundwater drains: approx. 11m<sup>3</sup>/day, ③transfer from On-site Bunker: approx. 85m<sup>3</sup>/day, etc.)

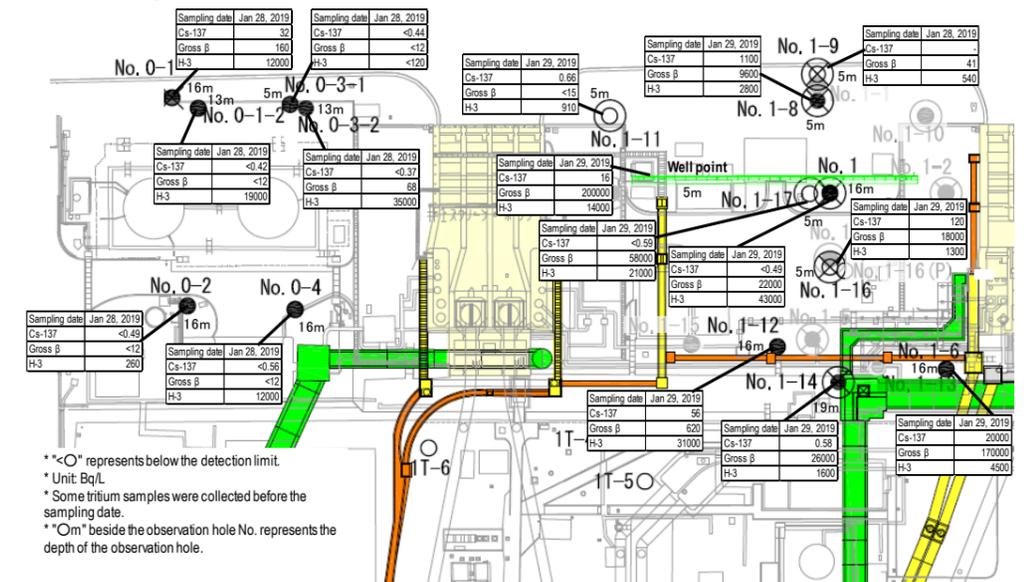
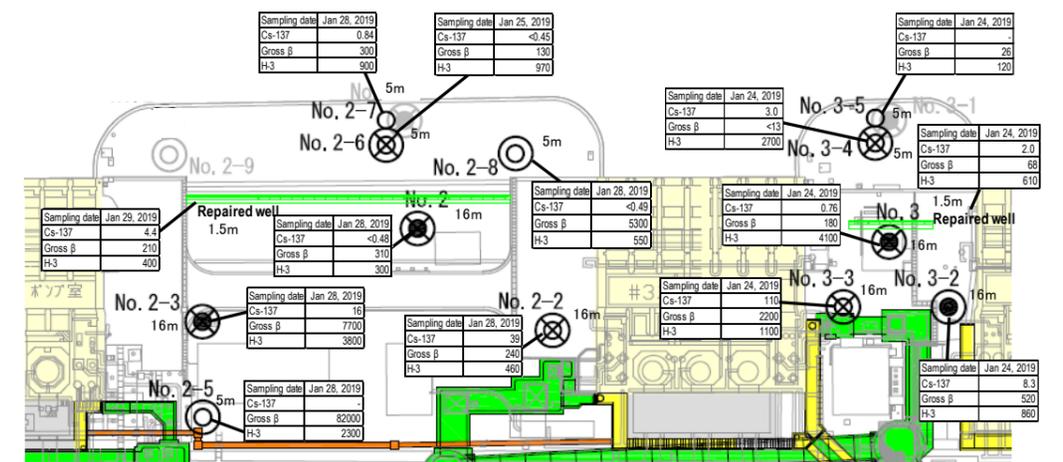
Figure 5: Groundwater density on the Turbine Building east side

<Unit 1 intake north side, between Unit 1 and 2 intakes>

<Between Unit 2 and 3 intakes, between Unit 3 and 4 intakes>

- The H-3 density at No. 1-14 remained constant at around 3,000 Bq/L, then declined since September 2018 and currently stands at around 1,600 Bq/L. Since August 15, 2013, pumping of groundwater continued (at the well point between the Unit 1 and 2 intakes: August 15, 2013 – October 13, 2015 and from October 24; at the repaired well: October 14 - 23, 2015).

pumping of groundwater continued (at the well point between the Unit 2 and 3 intakes: December 18, 2013 - October 13, 2015; at the repaired well: from October 14, 2015).

- The H-3 density at No. 3-4 had been declining from around 2,000 Bq/L since January 2018 to around 900 Bq/L, then increasing and currently stands at around 2,700 Bq/L. Since April 1, 2015, pumping of groundwater continued (at the well point between the Unit 3 and 4 intakes: April 1 – September 16, 2015; at the repaired well: from September 17, 2015).

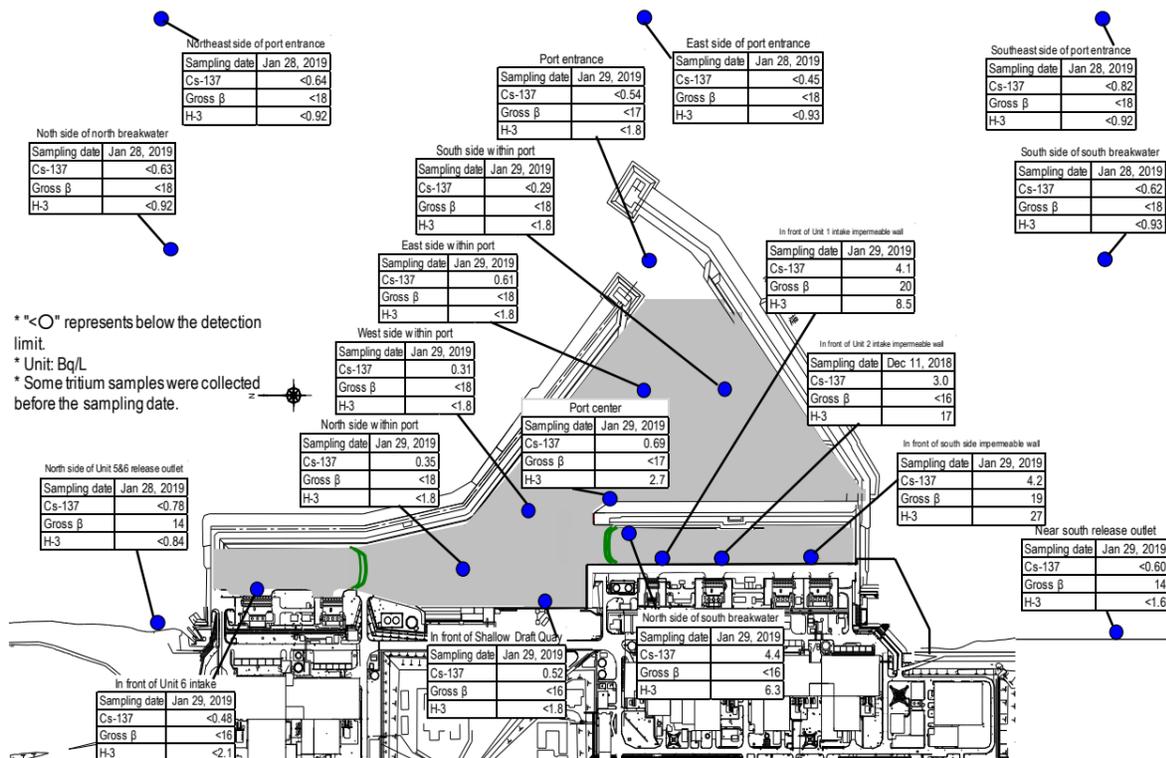
Figure 6: Seawater density around the port

- Regarding the radioactive materials in seawater in the area within the port, densities have remained below the legal discharge limit except for the increase in Cs-137 and Sr-90 during rain. They have been below the level of those in the Unit 1-4 intake open channel area and have been declining following the completed installation and the connection of steel pipe sheet piles for the sea-side impermeable walls.

- Regarding the radioactive materials in seawater in the area outside the port, densities of Cs-137 and Sr-90 have been declining, but remained unchanged following the completed installation and the connection of steel pipe sheet piles for the sea-side impermeable walls.

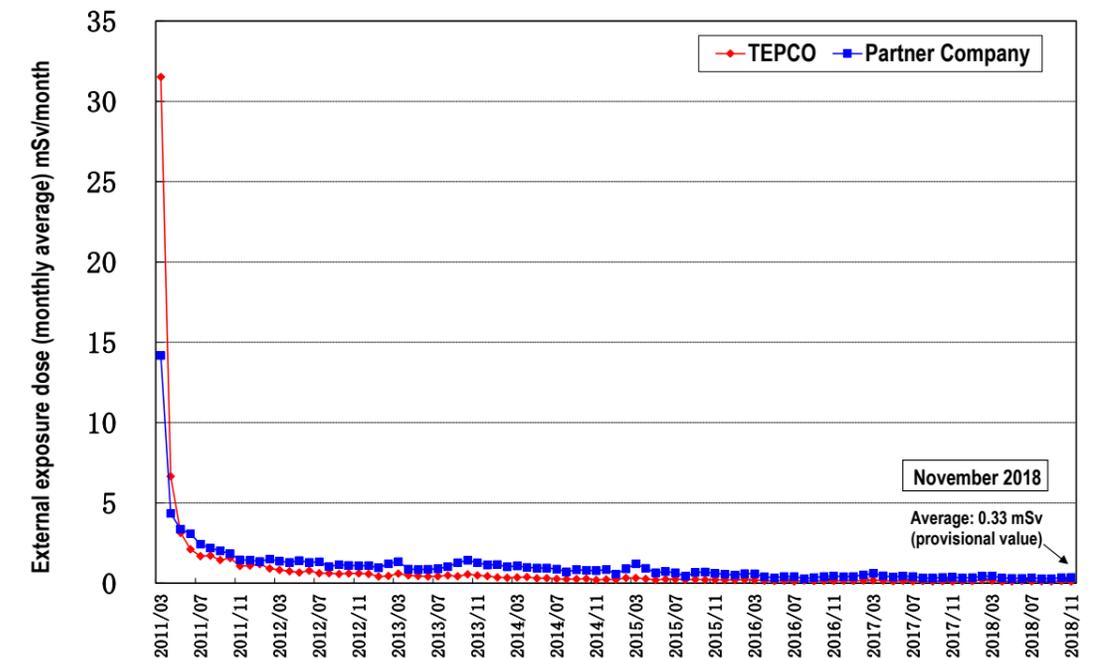
- The monthly average exposure dose of workers remained at approx. 0.59 mSv/month during FY2015, approx. 0.39 mSv/month during FY2016 and approx. 0.36 mSv/month during FY2017. (Reference: Annual average exposure dose 20 mSv/year  $\doteq$  1.7 mSv/month)

Figure 8: Changes in monthly individual worker exposure dose (monthly average exposure dose since March 2011)

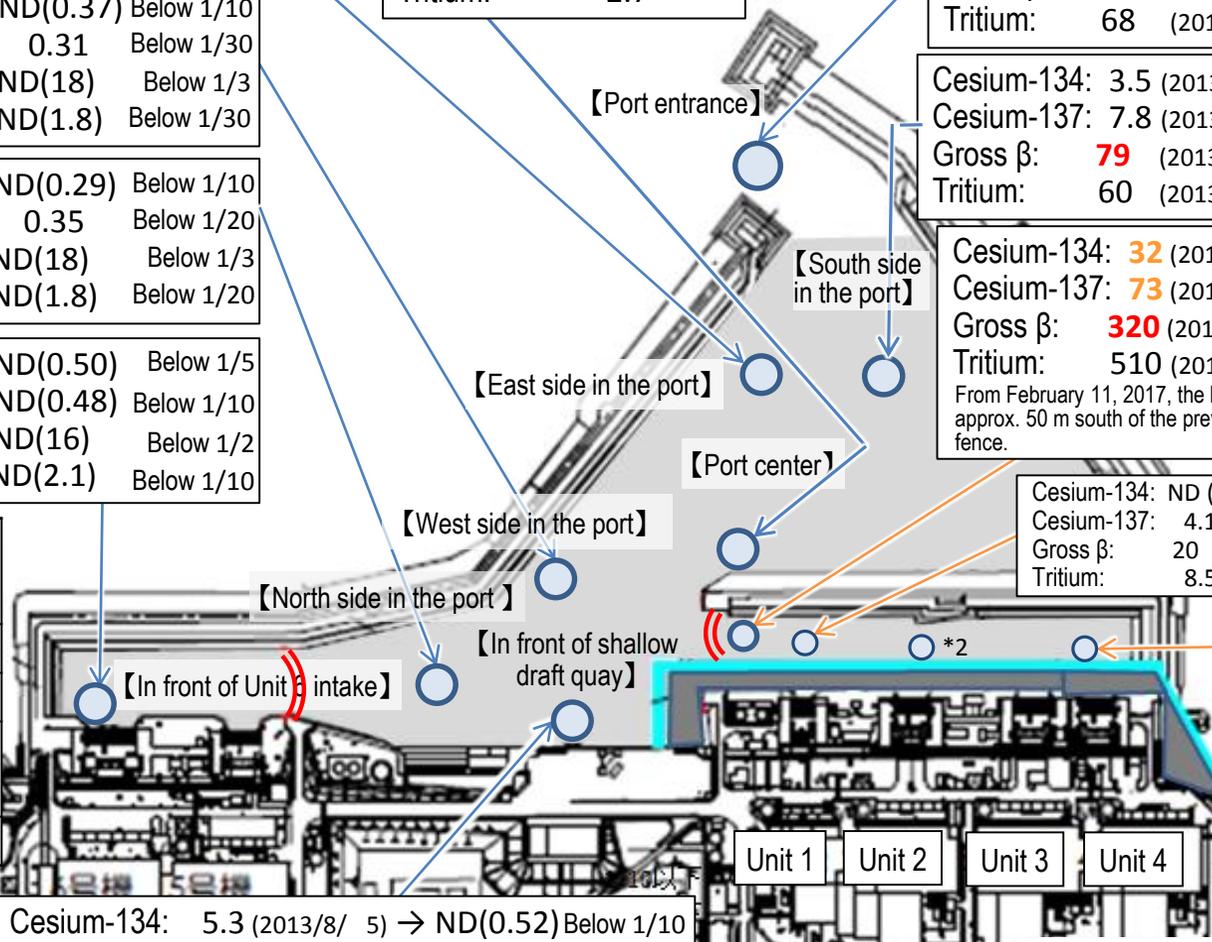
Summary of TEPCO data as of January 30, 2019

Cesium-134: 5.3 (2013/8/ 5) → ND(0.52) Below 1/10  
Cesium-137: 8.6 (2013/8/ 5) → 0.52 Below 1/10  
Gross β: **40** (2013/7/ 3) → ND(16) Below 1/2  
Tritium: 340 (2013/6/26) → ND(1.8) Below 1/100

Legal discharge limit	WHO Guidelines for Drinking Water Quality
Cesium-134	60	10
Cesium-137	90	10
Strontium-90 (strongly correlate with Gross β)	30	10
Tritium	60,000	10,000

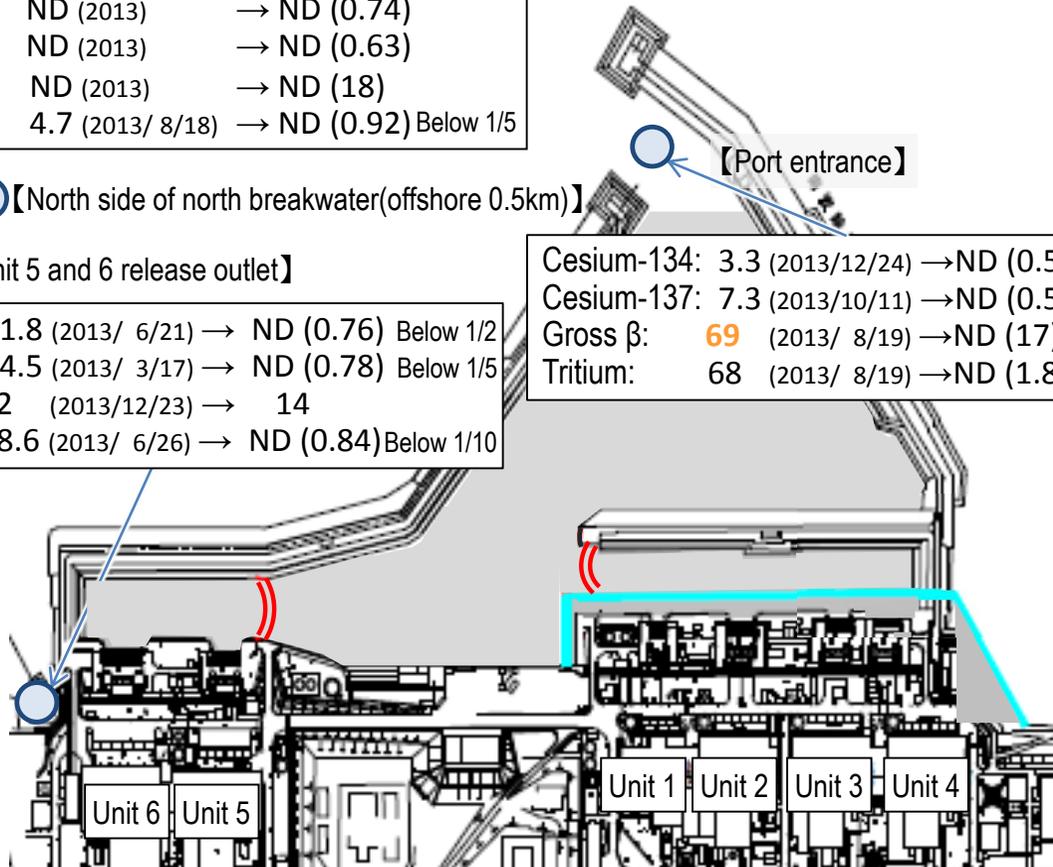
Summary of TEPCO data as of January 30, 2019

# Status of seawater monitoring around outside of the port (comparison between the highest values in 2013 and the latest values)

Note: Because safety of the sampling points was unassured due to the influence of Typhoon No. 10 in 2016, samples were taken from approx. 330 m south of the Unit 1-4 release outlet. Samples were also taken from a point approx. 280m south from the same release outlet from January 27, 2017 and approx. 320m from March 23, 2018

Note: The gross β measurement values include natural potassium 40 (approx. 12 Bq/L). They also include the contribution of yttrium 90, which radioactively balance strontium 90.

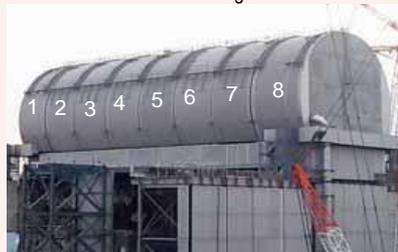
Prior to the installation of a cover for fuel removal, removal of large rubble from the spent fuel pool was completed in November 2015. To ensure safe and steady fuel removal, training of remote control was conducted at the factory using the actual fuel-handling machine which will be installed on site (February – December 2015). Measures to reduce dose on the Reactor Building top floor (decontamination, shields) were completed in December 2016. Installation of a cover for fuel removal and a fuel-handling machine is underway from January 2017. Installation of the fuel removal cover was completed on February 23, 2018. Regarding fuel removal, after confirming the cause of the defects in the FHM and crane and implementing measures for similar parts, works will continue toward removal starting from the end of March 2019 putting safety first.

Installation of dome roof (February 21)

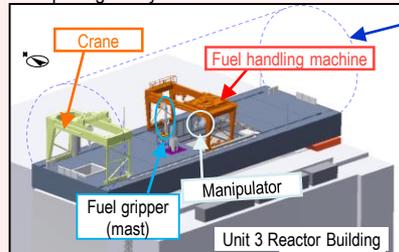
Image of entire fuel handling facility inside the cover

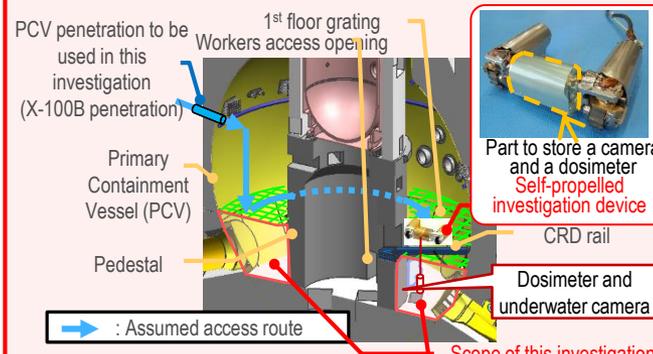
- In April 2015, a device, which entered the inside of the PCV through a narrow access opening (bore:  $\phi$  100 mm), collected information such as images and airborne dose inside the PCV 1st floor.
- In March 2017, the investigation using a self-propelled investigation device, conducted to inspect the spreading of debris to the basement floor outside the pedestal, took images of the PCV bottom status for the first time. The status inside the PCV will continue to be examined based on the collected image and dose data.

<Image of investigation inside the PCV>

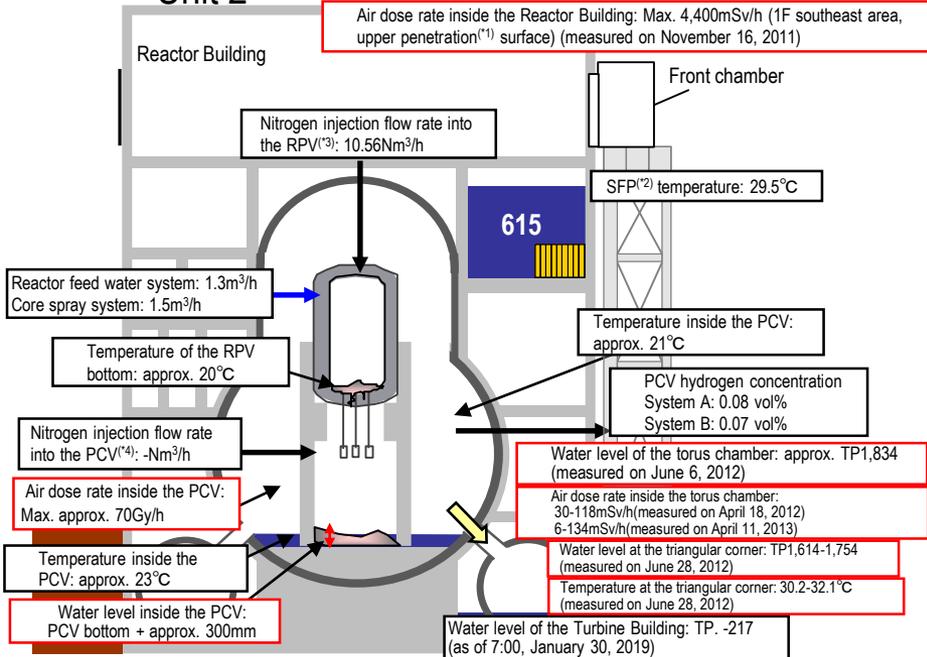
\* Indices related to plant are values as of 11:00, January 30, 2019

Investigations inside PCV	1st (Jan 2012)	- Acquiring images - Measuring air temperature
	2nd (Mar 2012)	- Confirming water surface - Measuring water temperature - Measuring dose rate
	3rd (Feb 2013 – Jun 2014)	- Acquiring images - Sampling stagnant water - Measuring water level - Installing permanent monitoring instrumentation
	4th (Jan – Feb 2017)	- Acquiring images - Measuring dose rate - Measuring air temperature
Leakage points from PCV	- No leakage from torus chamber rooftop - No leakage from all inside/outside surfaces of S/C

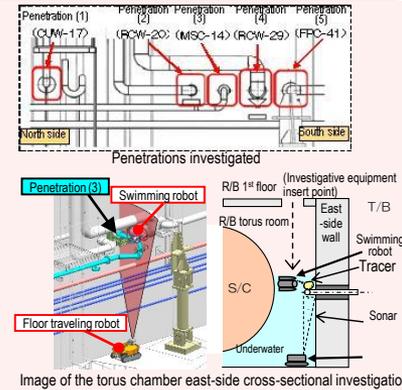
**Investigative results on torus chamber walls**

- The torus chamber walls were investigated (on the north side of the east-side walls) using equipment specially developed for that purpose (a swimming robot and a floor traveling robot).
- At the east-side wall pipe penetrations (five points), “the status” and “existence of flow” were checked.
- A demonstration using the above two types of underwater wall investigative equipment showed how the equipment could check the status of penetration.
- Regarding Penetrations 1 - 5, the results of checking the sprayed tracer<sup>(5)</sup> by camera showed no flow around the penetrations. (investigation by the swimming robot)
- Regarding Penetration 3, a sonar check showed no flow around the penetrations. (investigation by the floor traveling robot)

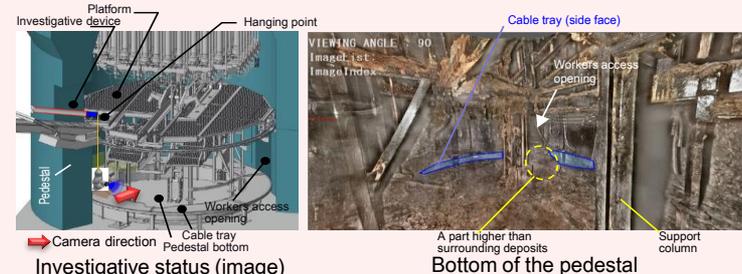
- On January 26 and 30, 2017, a camera was inserted from the PCV penetration to inspect the status of the CRD replacement rail on which the robot will travel. On February 9, deposit on the access route of the self-propelled investigative device was removed and on February 16, the inside of the PCV was investigated using the device.

- The results of this series of investigations confirmed fallen and deformed gratings and a quantity of deposit inside the pedestal.
- On January 19, 2018, the status below the platform inside the pedestal was investigated using an investigative device with a hanging mechanism. From the analytical results of images obtained in the investigation, deposits probably including fuel debris were found at the bottom of the pedestal. In addition, multiple parts higher than the surrounding deposits were also detected. We presumed that there were multiple routes of fuel debris falling.

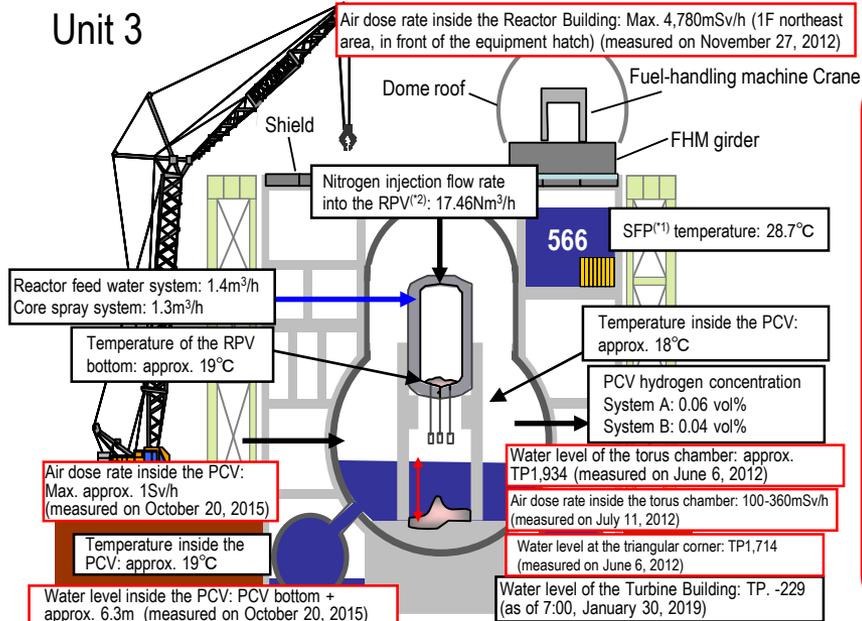
\* Indices related to plant are values as of 11:00, January 30, 2019

Investigations inside PCV	1st (Oct – Dec 2015)	- Acquiring images - Measuring air temperature and dose rate - Measuring water level and temperature - Sampling stagnant water - Installing permanent monitoring instrumentation (December 2015)
	2nd (Jul 2017)	- Acquiring images - Installing permanent monitoring instrumentation (August 2017)
Leakage points from PCV	- Main steam pipe bellows (identified in May 2014)

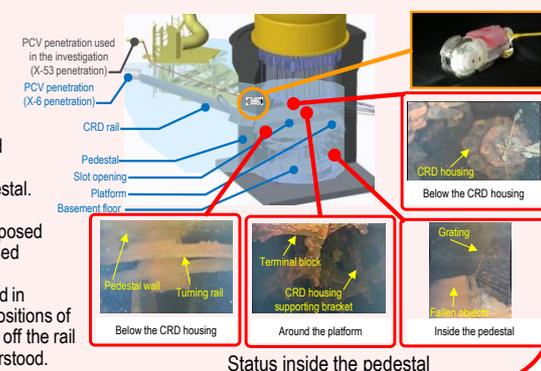
- Analysis of image data obtained in the investigation identified damage to multiple structures and the supposed core internals. Consideration about fuel removal based on the obtained information will continue.

- Videos obtained in the investigation were reproduced in 3D. Based on the reproduced images, the relative positions of the structures, such as the rotating platform slipping off the rail with a portion buried in deposits, were visually understood.

Status inside the pedestal

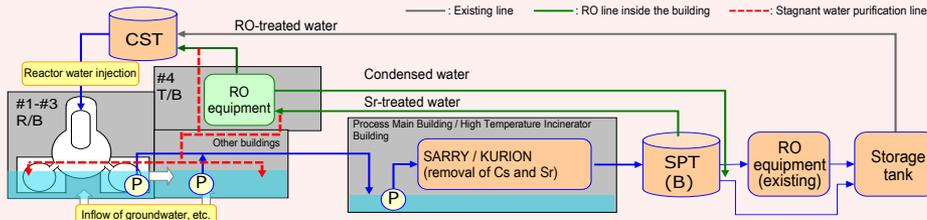
- To reduce the risk of contaminated-water leakage, the circulation loop was shortened by installing a reverse osmosis (RO) device in the Unit 4 Turbine Building within the circulation loop, comprising the transfer of contaminated water, water treatment and injection into the reactors. Operation of the installed RO device started from October 7 and 24-hour operation started from October 20. Installation of the new RO device inside the building shortened the circulation loop from approx. 3 to 0.8 km.

\* The entire length of contaminated water transfer pipes is approx. 2.1km, including the transfer line of surplus water to the upper heights (approx. 1.3km).

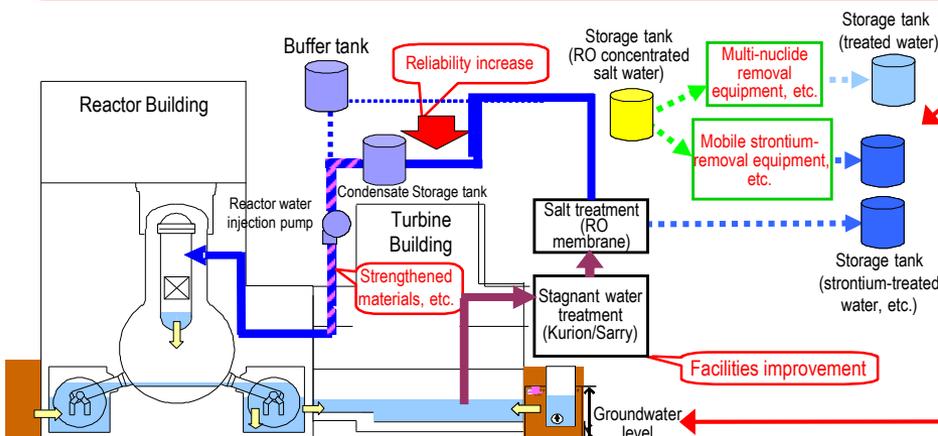
Contaminated water (RO concentrated salt water) is being treated using seven types of equipment including the multi-nuclide removal equipment (ALPS). Treatment of the RO concentrated salt water was completed on May 27, 2015, with the exception of the remaining water at the tank bottom. The remaining water will be treated sequentially toward dismantling the tanks.

The strontium-treated water from other facilities than the multi-nuclide removal equipment will be re-purified in the multi-nuclide removal equipment to further reduce risks.

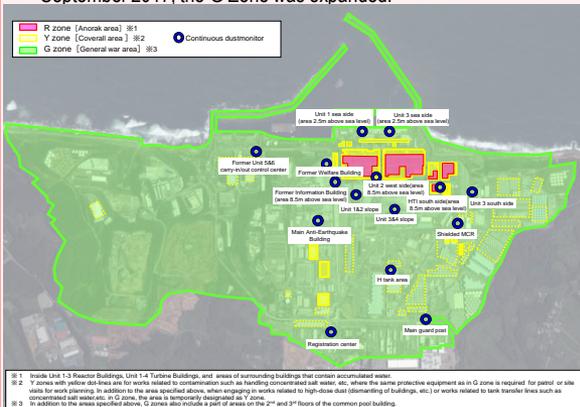
Based on the progress of measures to reduce environmental dosage on site, the site is categorized into two zones: highly contaminated area around Unit 1-4 buildings, etc. and other areas to optimize protective equipment according to each category aiming at improving safety and productivity by reducing load during work.

R zone (Anorak area)	Y zone (Coverall area)	G zone (General wear)
Full-face mask 	Full-face or half-face masks 	Disposable disposable mask 
Anorak on coverall Or double coveralls 	Coverall 	General*3 Dedicated on-site wear
