## Main decommissioning work and steps

# Progress status

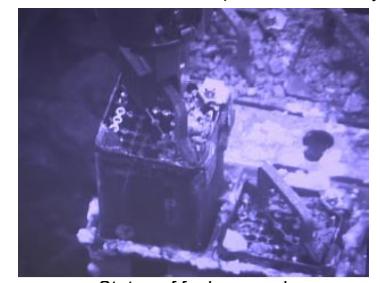
Status of fuel removal (April 15, 2019)

Toward fuel removal from the Unit 3 SFP, the rubble removal training, which was scheduled in conjunction with fuel removal training, started from March 15, 2019 and fuel removal started from April 15.

As measures to reduce the dose on the Reactor Building operating floor, decontamination and installation of shields were completed in June and December 2016, respectively. Installation of a fuel removal cover started in January 2017 and installation of all dome roofs was completed in February 2018.

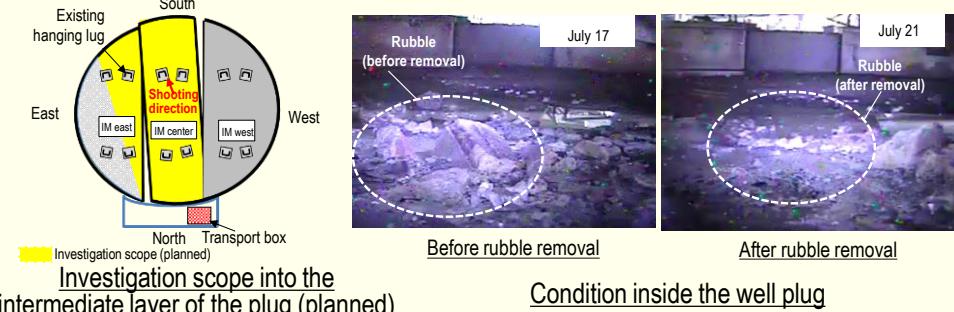
Toward fuel removal from the spent fuel pool, an investigation started from July 17 to examine how to handle the well plug, which was considered as having been misaligned due to the influence of the hydrogen explosion at the time of the accident.

In this investigation, two robots (for investigation and monitoring) will be used to measure 3D-images, air dose rate, etc.

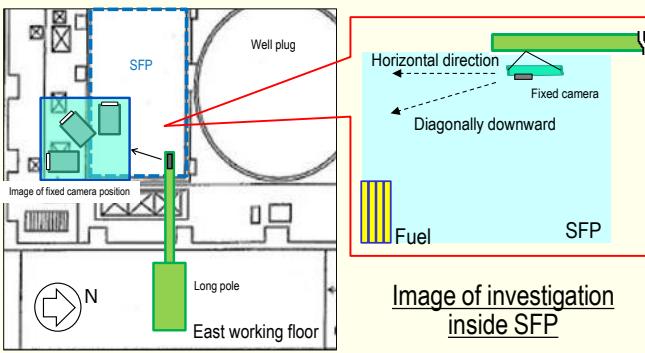
Toward fuel removal from the spent fuel pool (SFP), the fallen roof over the SFP will be removed. To prevent the anticipated risk of small rubble, and other objects falling during removal and any influence on the soundness of fuel, the SFP will be covered before the work.

As preparation, the condition inside the pool will be investigated using a underwater camera in August.

- The fallen roof over the SFP will be removed. To prevent the anticipated risk of small rubble, and other objects falling during the removal and any influence on the soundness of fuel, the SFP will be covered before the work. As preparation, the condition inside the pool will be investigated using an underwater camera in August 2019.

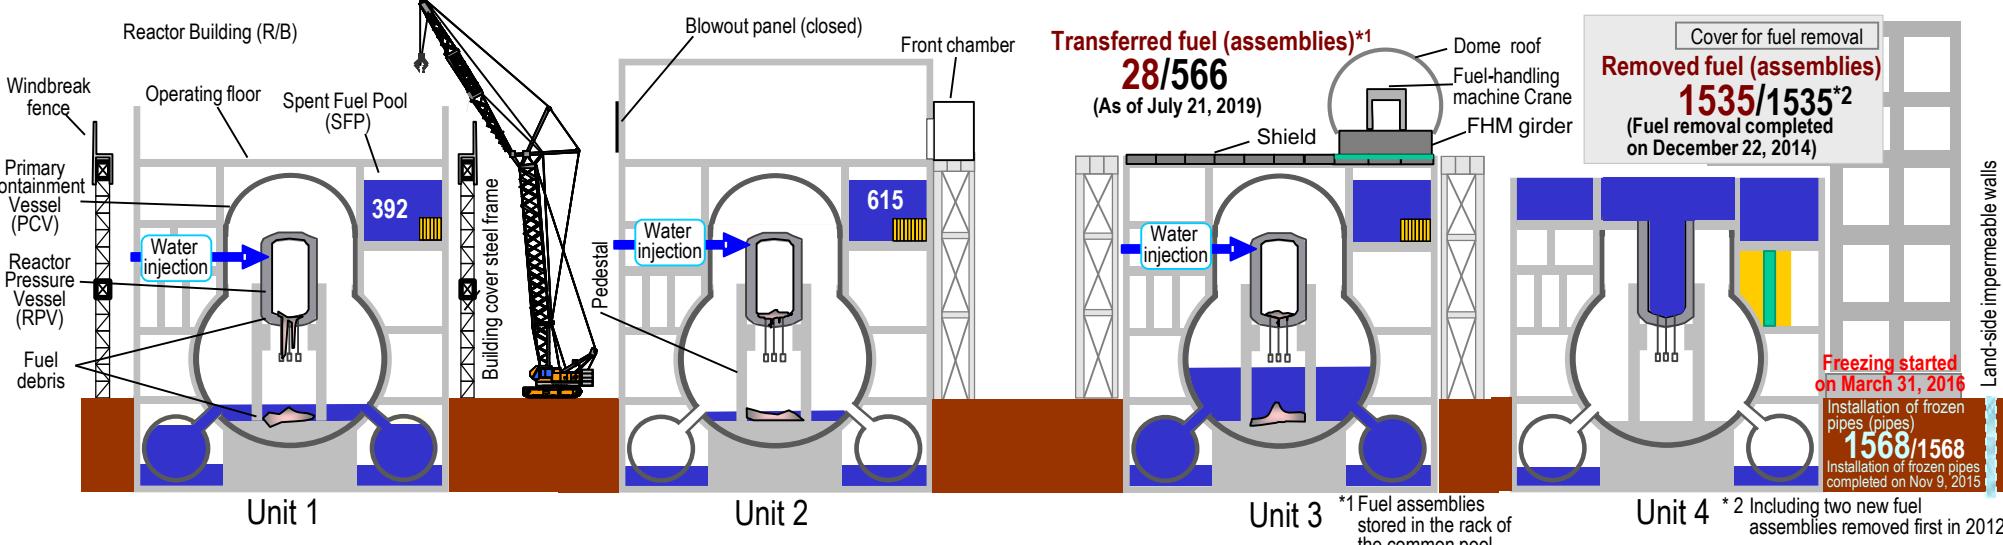
Fuel removal was resumed from July 4 and removal of 21 non-irradiated fuel assemblies was completed within July as planned. Up until July 21, 28 of all 566 fuel assemblies had been removed.

On July 17 and 21, leakage from the joint of a hose for working fluid of the fuel-handling facility carrying working fluid was detected. The cause will be investigated, measures implemented and similar parts checked, and other works in the facility inspection, which started from July 24, to resume fuel and rubble removal from early September.

- On July 17 and 21, 2019, leakage from the joint of a hose for working fluid of the fuel-handling facility carrying working fluid was detected. The cause will be investigated, measures implemented and similar parts checked, and other works in the facility inspection, which started from July 24, to resume fuel and rubble removal from early September 2019.

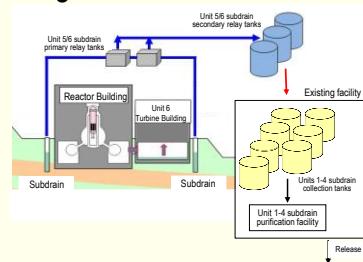
The groundwater level around the Unit 5/6 buildings remained high. There is a risk of important facilities being flooded by groundwater inflow due to aging building penetrations and other factors.

To eliminate this risk, examination toward recovering the Unit 5/6 subdrain from FY2021 started. Pumped up subdrain water will be transferred to Unit 1-4 subdrain purification facilities for treatment. Scope to utilize the capacity born in the Unit 5/6 building contaminated-water treatment equipment will also be examined for treatment of accumulated water onsite.

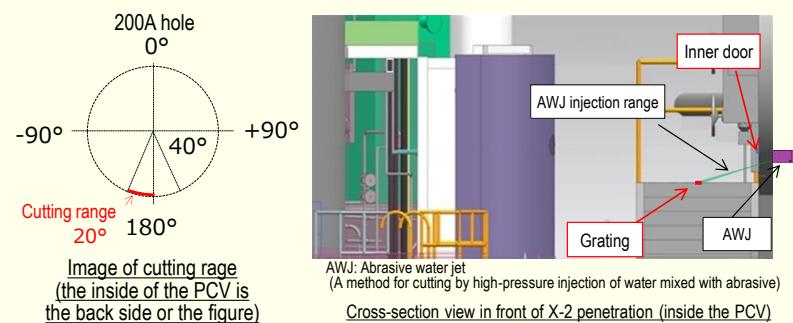
Prior to investigating the inside of the Primary Containment Vessel (PCV), an access route was being constructed. On June 4, 2019, during drilling of the inner door of the X-2 penetration, monitoring data showed that the dust density of the temporarily-installed monitor had exceeded the criteria value set for work management.

This was considered attributable to the influence of high-pressure water during the drilling, which was poured on the grating inside the PCV and scattered dust. For future drilling and other works, the cutting scope will be changed within a range with less influence to understand the tendency of dust density during drilling.

The work will resume in around late July 2019. After obtaining sufficient knowledge about dust scattering, the inner door will be drilled and obstacles inside the PCV will be cut sequentially from late August onwards.

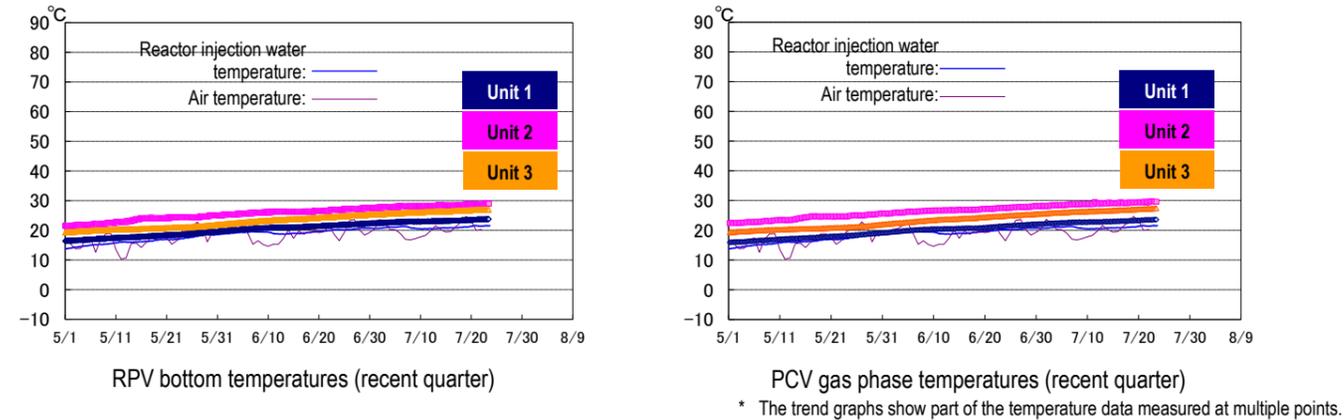
Through continuous reactor cooling by water injection, the temperatures of the Reactor Pressure Vessel (RPV) bottom and the Primary Containment Vessel (PCV) gas phase were maintained within the range of approx. 20 to 30°C for the past month, though they varied depending on the unit and location of the thermometer.

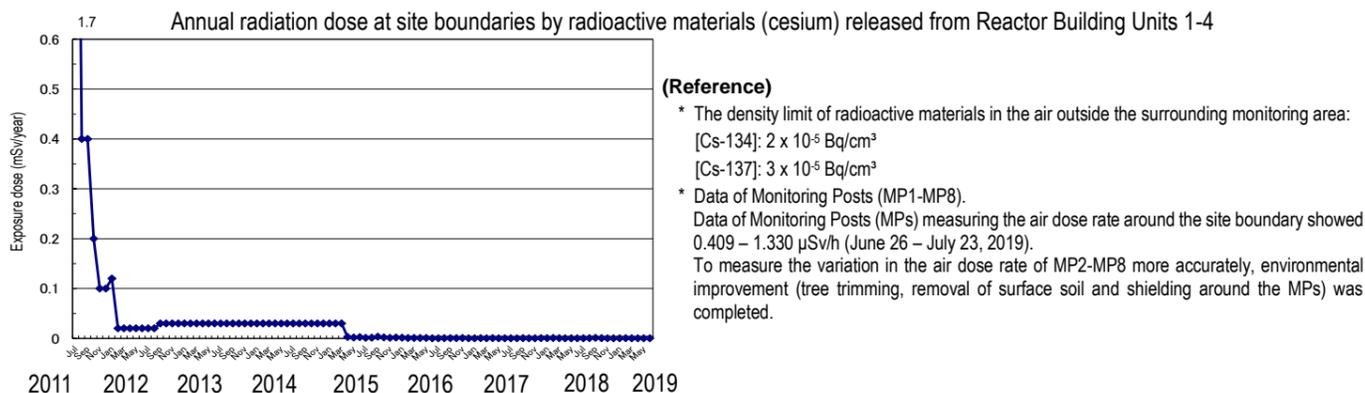
As of June 2019, the density of radioactive materials newly released from Reactor Building Units 1-4 into the air and measured at the site boundary was evaluated at approx.  $2.9 \times 10^{-12}$  and  $5.6 \times 10^{-12}$  Bq/cm<sup>3</sup> for Cs-134 and -137 respectively, while the radiation exposure dose due to the release of radioactive materials there was less than 0.00025 mSv/year.

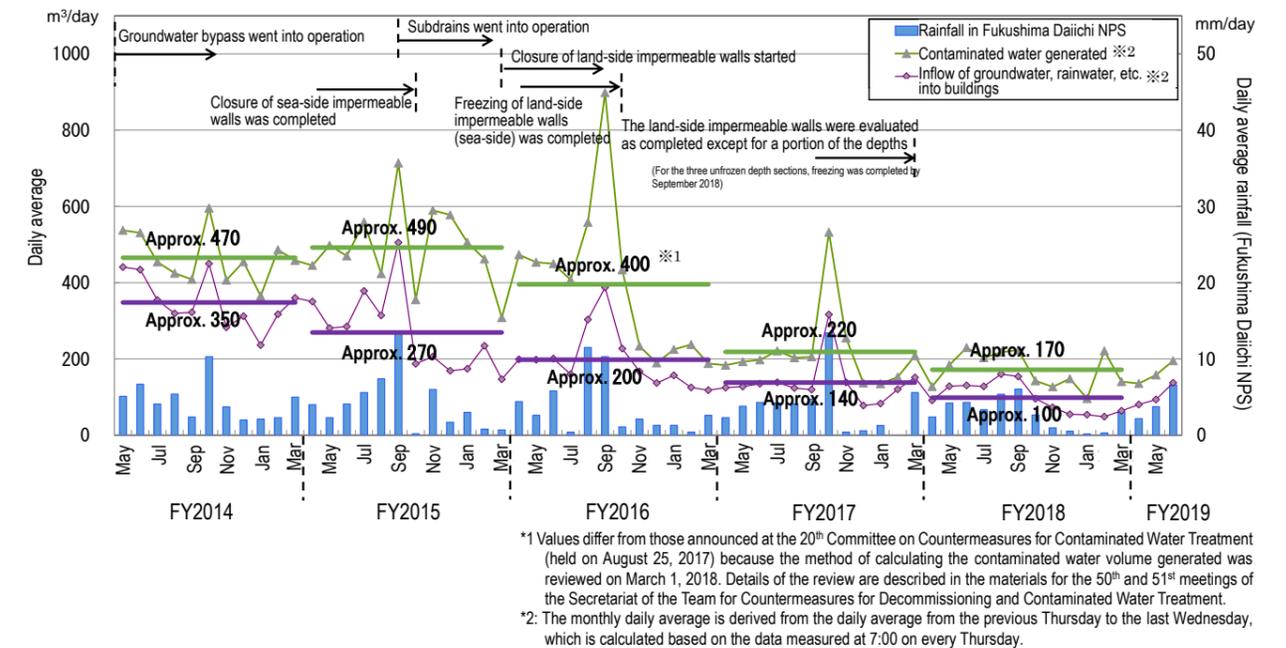
- Following the steady implementation of "redirecting" measures (groundwater bypass, subdrains, land-side impermeable walls, etc.), the generation amount reduced from approx. 470 m<sup>3</sup>/day (the FY2014 average) when the measures were first launched to approx. 170 m<sup>3</sup>/day (the FY2018 average), though it varied depending on rainfall, etc.
- Measures will continue to further reduce the volume of contaminated water generated.

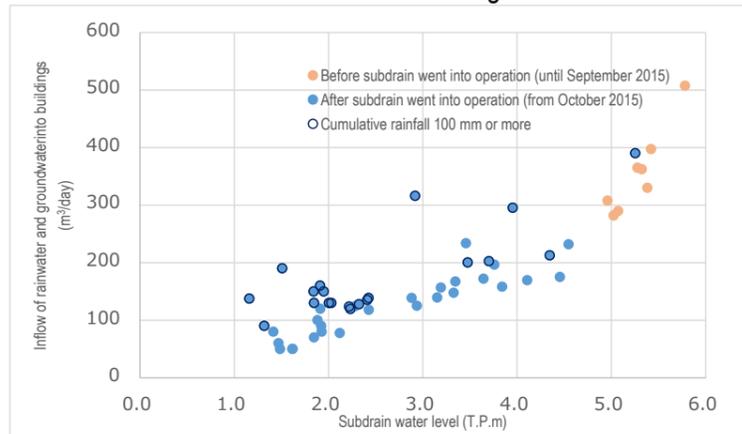
Figure 2: Correlation between inflow such as groundwater and rainwater into buildings and the water level of Unit 1-4 subdrains

- To eliminate the need to suspend water pumping while cleaning the subdrain transfer pipe, the pipe will be duplicated. Installation of the pipe and ancillary facilities was completed.
- Since the subdrains went into operation, the inflow into buildings tended to decline to under 150 m<sup>3</sup>/day when the subdrain water level declined below T.P. 3.0 m but increased during rainfall.

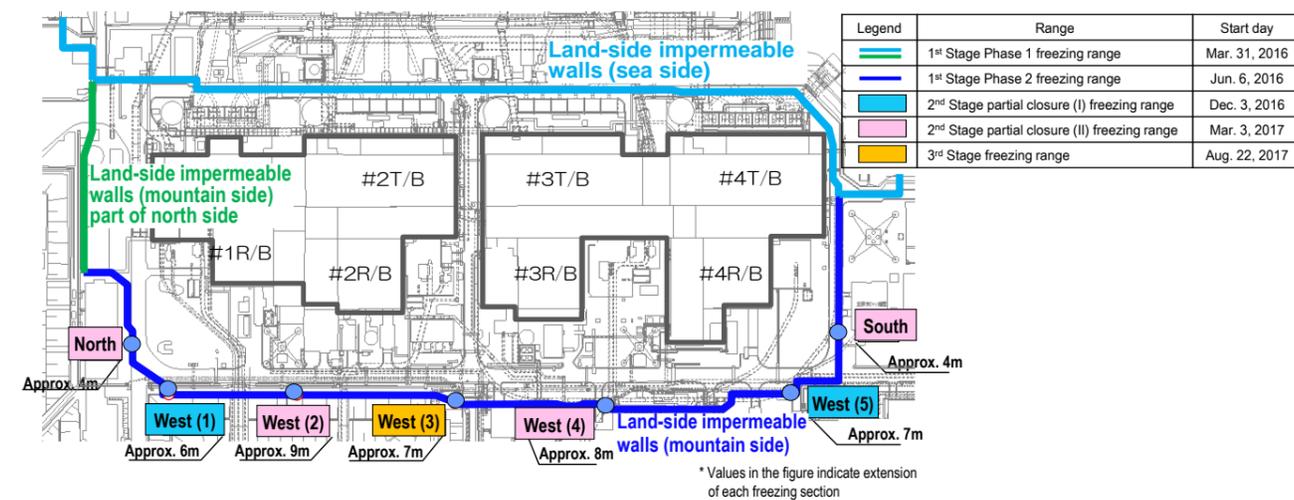
Figure 3: Closure of part of the land-side impermeable walls (on the mountain side)

- A supplementary method was implemented for the unfrozen depth and it was confirmed that the temperature of this portion had declined below 0°C by September 2018. From February 2019, maintenance operation started at all sections.

- The groundwater level in the area inside the land-side impermeable walls has been declining every year. On the mountain side, the difference between the inside and outside increased to approx. 4-5 m. The water level in the bank area has remained low (T.P. 1.6-1.7 m) compared to the ground surface (T.P. 2.5 m).

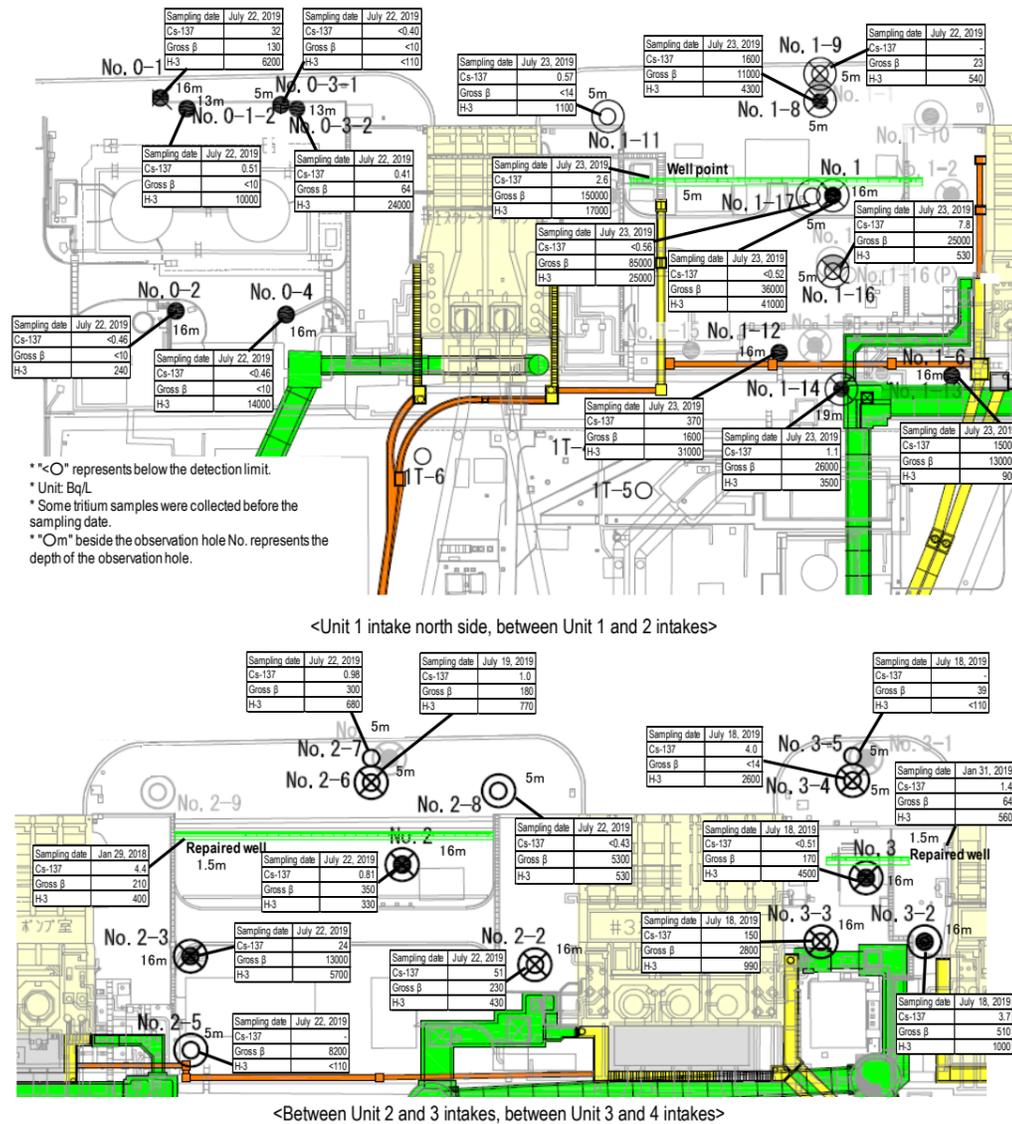
Figure 5: Groundwater density on the Turbine Building east side

- At No. 1-12, the density of gross β radioactive materials had been increasing from around 200 Bq/L since December 2018 and currently stands at around 1,600 Bq/L. Since August 15, 2013, pumping of groundwater continued (at the well point between the Unit 1 and 2 intakes: August 15, 2013 – October 13, 2015 and from October 24; at the repaired well: October 14 - 23, 2015).

around 120 Bq/L. The density of gross  $\beta$  radioactive materials at the same point had been decreasing from around 80,000 Bq/L since June 2019 and currently stands at around 8,200 Bq/L. Since December 18, 2013, pumping of groundwater continued (at the well point between the Unit 2 and 3 intakes: December 18, 2013 - October 13, 2015; at the repaired well: from October 14, 2015).

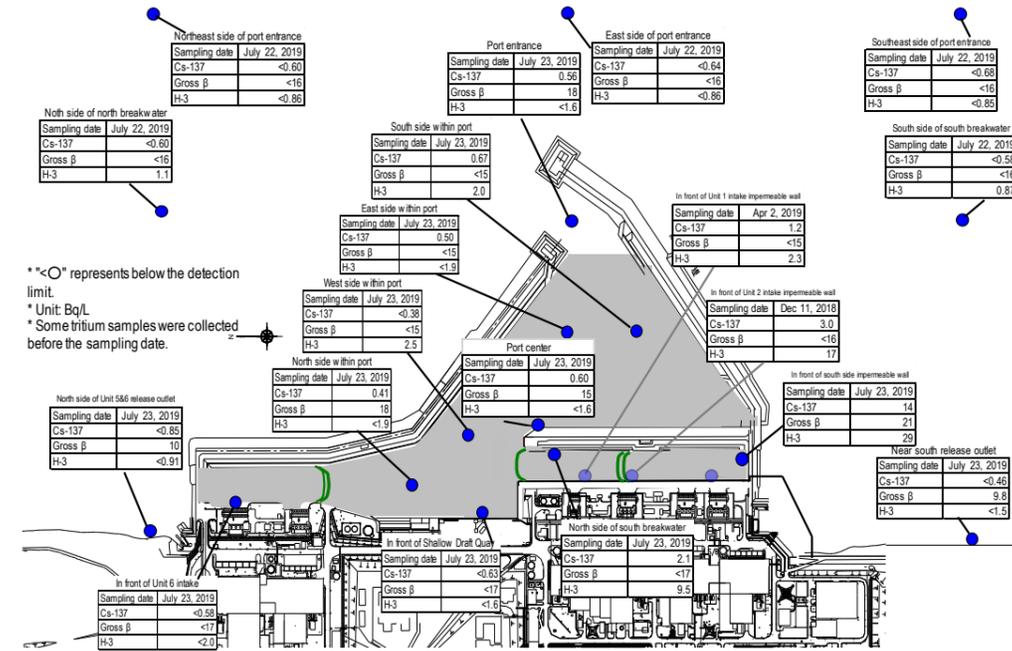
Figure 6: Seawater density around the port

- In the area within the port, densities of radioactive materials in seawater have remained below the legal discharge limit, while increasing in Cs-137 and Sr-90 below the legal discharge limit during rain. They have remained below the level of those in the Unit 1-4 intake open channel area and been declining following the completed installation and connection of steel pipe sheet piles for the sea-side impermeable walls.

- In the area outside the port, regarding the densities of radioactive materials in seawater, those of Cs-137 and Sr-90 declined and remained low after the installation and connection of steel pipe sheet piles for the sea-side impermeable walls were completed.

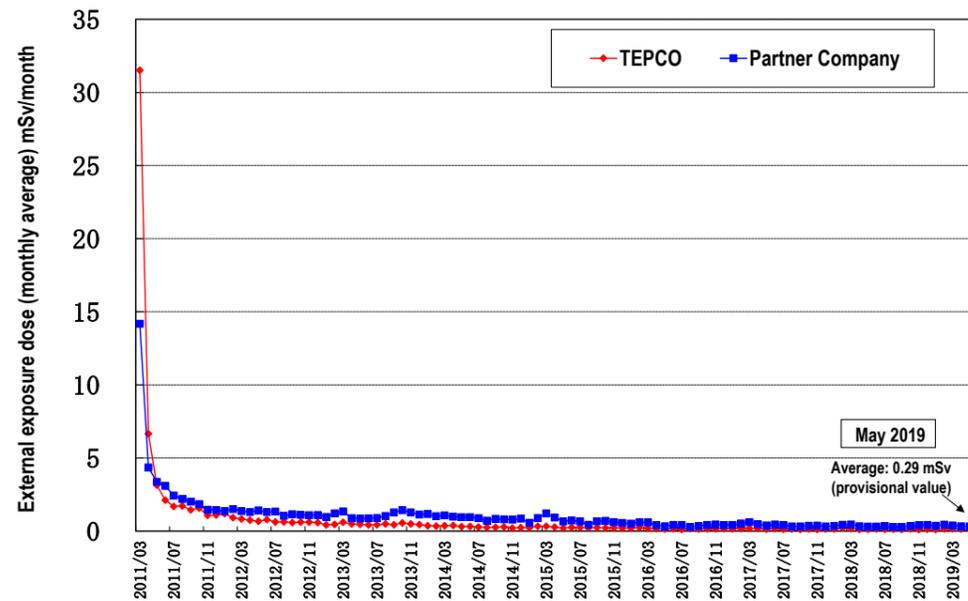
Figure 8: Changes in monthly individual worker exposure dose (monthly average exposure dose since March 2011)

- The monthly average exposure dose of workers remained at approx. approx. 0.39 mSv/month during FY2016, approx. 0.36 mSv/month during FY2017 and approx. approx. 0.32 mSv/month during FY2018. (Reference: Annual average exposure dose 20 mSv/year  $\div$  1.7 mSv/month)

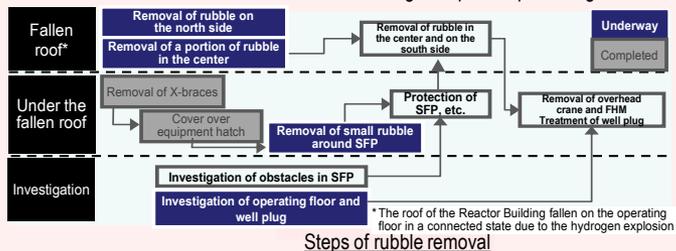
&lt;Status of the operating floor&gt;

Toward fuel removal from the spent fuel pool, there is a plan to install a dedicated cover for fuel removal over the top floor of the Reactor Building (operating floor). On November 10, 2016, removal of all roof panels and wall panels of the building cover was completed. On May 11, 2017, removal of pillars and beams of the building cover was completed. On December 19, 2017, modification of the pillars and beams of the building cover and installation windbreak fences were completed. From March 18, 2019, removal of small rubble in the east-side area around the SFP started as an initial step using pliers and suction equipment. From July 9, 2019, small rubble removal on the south side of the SFP started. Rubble removal and investigation prior to protecting the SFP, etc. are currently underway.

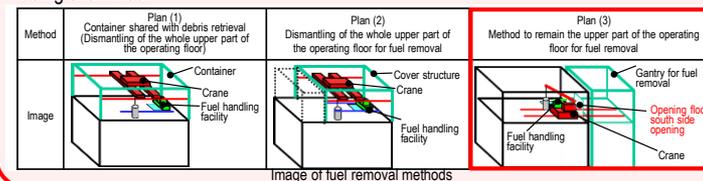
In addition to Plan (1) in which the whole upper part of the operating floor is dismantled and the container of poor fuel is shared with debris retrieval and Plan (2) in which a cover for pool fuel retrieval is separately installed, a method which minimizes the range of dismantling the upper part of the operating floor and accesses from the south side is being examined.

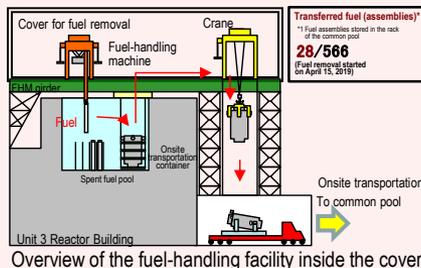
Toward fuel removal, the rubble retrieval training inside the pool, which was scheduled in conjunction with fuel removal training, started from March 15, 2019, and started fuel removal from April 15, 2019.

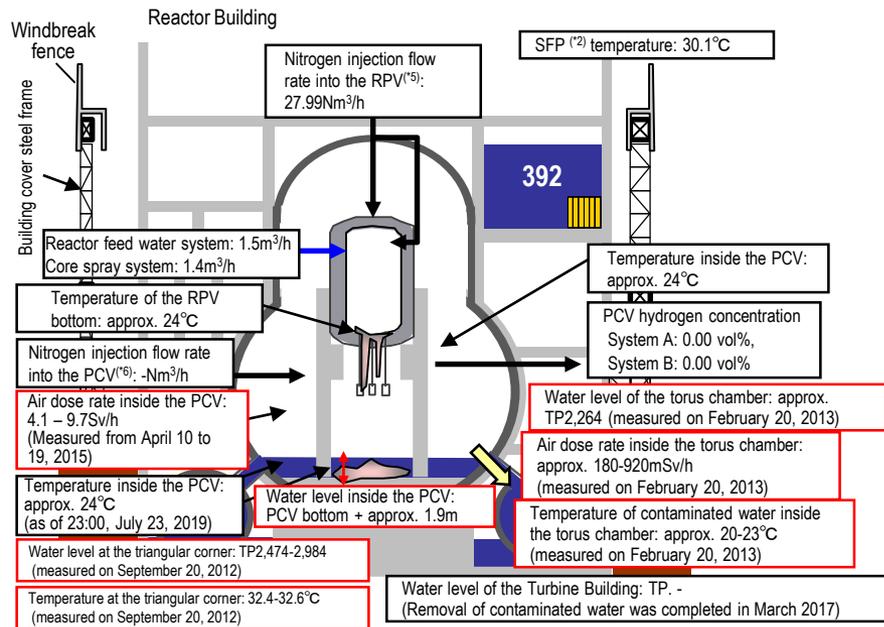
Air dose rate inside the Reactor Building:  
Max. 5,150mSv/h (1F southeast area) (measured on July 4, 2012)

\* Indices related to the plant are values as of 11:00, July 24, 2019

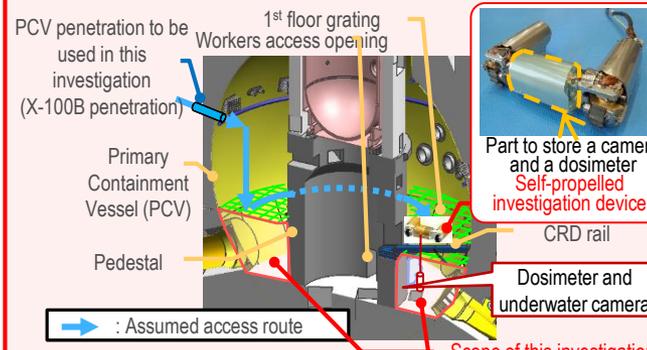
Image of hanging of dosimeter and camera

- In April 2015, a device, which entered the inside of the PCV through a narrow access opening (bore:  $\phi$  100 mm), collected information such as images and airborne dose inside the PCV 1st floor.
- In March 2017, the investigation using a self-propelled investigation device, conducted to inspect the spreading of debris to the basement floor outside the pedestal, took images of the PCV bottom status for the first time. The status inside the PCV will continue to be examined based on the collected image and dose data.

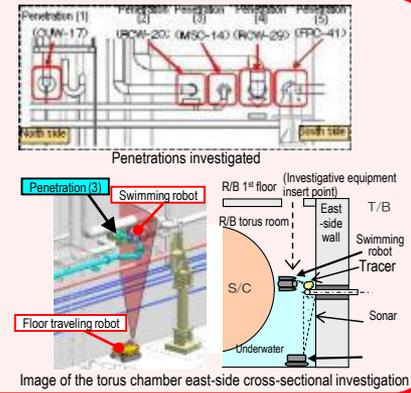
- The torus chamber walls were investigated (on the north side of the east-side walls) using equipment specially developed for that purpose (a swimming robot and a floor traveling robot).
- At the east-side wall pipe penetrations (five points), "the status" and "existence of flow" were checked.
- A demonstration using the above two types of underwater wall investigative equipment showed how the equipment could check the status of penetration.
- Regarding Penetrations 1 - 5, the results of checking the sprayed tracer (\*) by camera showed no flow around the penetrations. (investigation by the swimming robot)
- Regarding Penetration 3, a sonar check showed no flow around the penetrations. (investigation by the floor traveling robot)

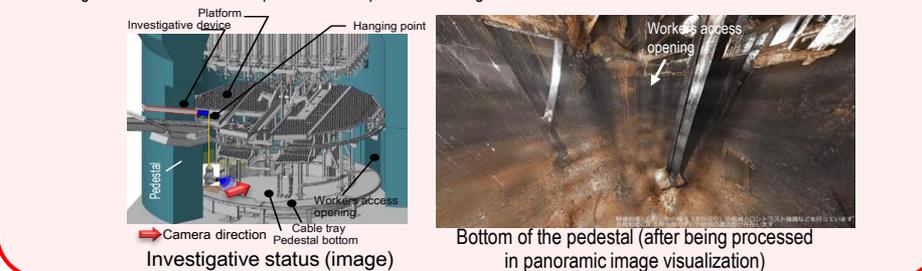
- The results of this series of investigations confirmed fallen and deformed gratings and a quantity of deposit inside the pedestal.
  - On January 19, 2018, the status below the platform inside the pedestal was investigated using an investigative device with a hanging mechanism. From the analytical results of images obtained in the investigation, deposits probably including fuel debris were found at the bottom of the pedestal. In addition, multiple parts higher than the surrounding deposits were also detected. We presumed that there were multiple routes of fuel debris falling. Obtained data were processed in panoramic image visualization to acquire clearer images.

- On February 13, 2019, an investigation touching the deposits at the bottom of the pedestal and on the platform was conducted and confirmed that the pebble-shaped deposits, etc. could be moved and that hard rock-like deposits that could not be gripped may exist.

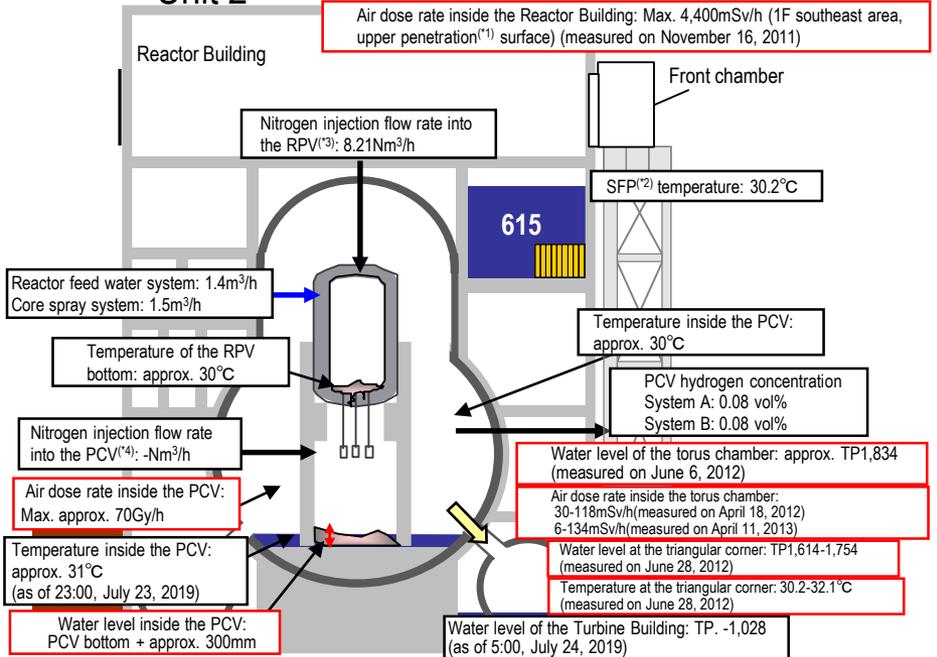
\* Indices related to plant are values as of 11:00, July 24, 2019

Investigations inside PCV	1st (Jan 2012)	2nd (Mar 2012)	3rd (Feb 2013 - Jun 2014)	4th (Jan - Feb 2017)
	- Acquiring images - Measuring air temperature	- Confirming water surface - Measuring water temperature - Measuring dose rate	- Acquiring images - Sampling contaminated water - Measuring water level - Installing permanent monitoring instrumentation	- Acquiring images - Measuring dose rate - Measuring air temperature
Leakage points from PCV	- No leakage from torus chamber rooftop - No leakage from all inside/outside surfaces of S/C

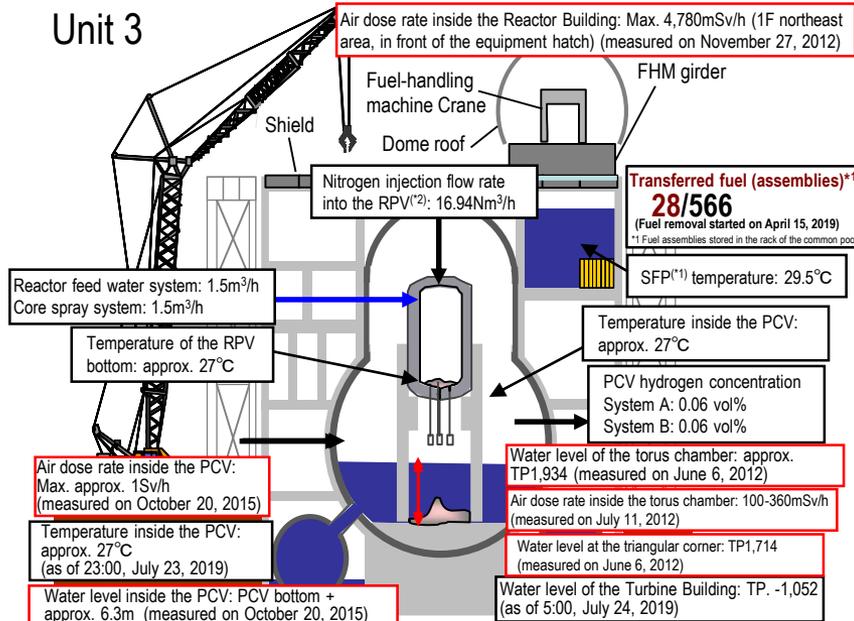
\* Indices related to plant are values as of 11:00, July 24, 2019

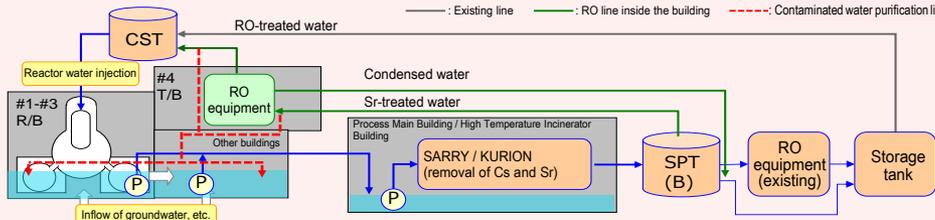
- To reduce the risk of contaminated-water leakage, the circulation loop was shortened by installing a reverse osmosis (RO) device in the Unit 4 Turbine Building within the circulation loop, comprising the transfer of contaminated water, water treatment and injection into the reactors. Operation of the installed RO device started from October 7 and 24-hour operation started from October 20. Installation of the new RO device inside the building shortened the circulation loop from approx. 3 to 0.8 km.

\* The entire length of contaminated water transfer pipes is approx. 2.1km, including the transfer line of surplus water to the upper heights (approx. 1.3km).

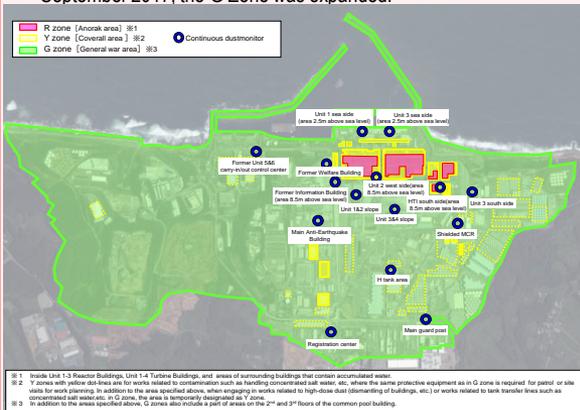
Based on the progress of measures to reduce environmental dosage on site, the site is categorized into two zones: highly contaminated area around Unit 1-4 buildings, etc. and other areas to optimize protective equipment according to each category aiming at improving safety and productivity by reducing load during work.

※1 Inside Unit 1-3 Reactor Buildings, Unit 1-4 Turbine Buildings, and areas of surrounding buildings that contain accumulated water.  
 ※2 Y zones with yellow dot areas are for works related to contamination such as handling concentrated salt water, etc. when the same protective equipment as in G zone is required for patrol or site visits for work planning. In addition to the area specified above, when engaging in works related to high-dose dust (disassembling of buildings, etc.) or works related to tank transfer lines such as concentrated salt water tanks in G zone, the area is temporarily designated as Y zone.  
 ※3 In addition to the areas specified above, G zones also include a part of areas on the 2nd and 3rd floors of the common pool building.
