## Main decommissioning work and steps

Fuel removal from the Unit 4 SFP was completed on December 22, 2014 and removal from the Unit 3 SFP has been underway since April 15, 2019. Dust density in the surrounding environment is being monitored and work is being implemented with safety first. Work continues sequentially toward the start of fuel removal from Units 1 and 2 and debris (Note 1) retrieval from Units 1-3.

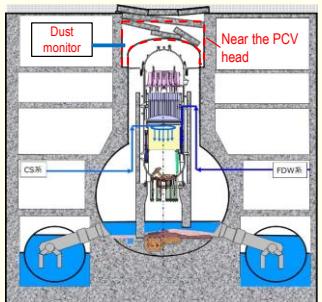
Image of additional installation of dust density monitor

Specifically, we are considering adding a dust monitor using piping installed near the PCV head.

After investigating the closure of piping from the beginning of October, a dust monitor will be installed, and the access route construction work will be resumed from the beginning of November at the earliest.

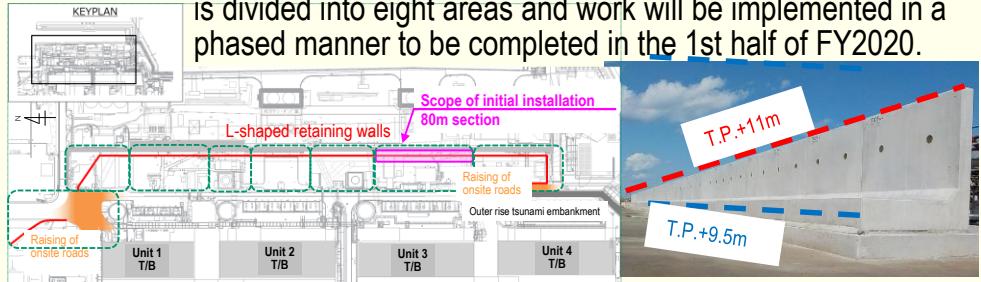
Scope and status of tide embankment installation

In preparation for the potentially urgent hazard of the Chishima trench tsunami, a tide embankment is being installed.

Following preparatory work, including removal and transfer of the existing facilities and site preparation and raising, installation of L-shaped retaining walls started from September 23. The tide embankment (approx. 600m long) is divided into eight areas and work will be implemented in a phased manner to be completed in the 1st half of FY2020.

- In preparation for the potentially urgent hazard of the Chishima trench tsunami, a tide embankment is being installed.
- Following preparatory work, including removal and transfer of the existing facilities and site preparation and raising, installation of L-shaped retaining walls started from September 23, 2019. The tide embankment (approx. 600m long) is divided into eight areas and work will be implemented in a phased manner to be completed in the 1st half of FY2020.

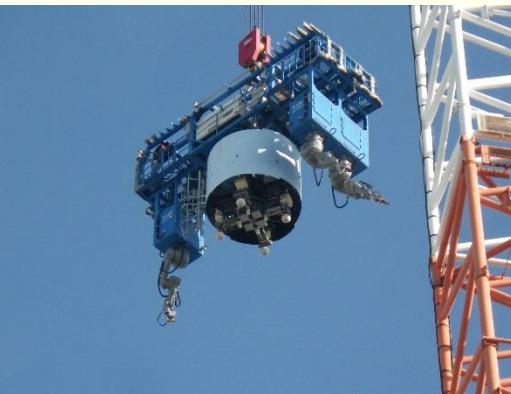
Hanging down of the top block

After the review of the proceeding step, dismantling work of the 2nd block started on September 12 and was completed on September 26, although there were some malfunction in the communication facility during the preparation and a suspension due to the typhoon.

Based on the insights obtained in dismantling of the 2nd block, we proceed with the goal of completing the dismantle of the 3rd and the 4th blocks in late October.

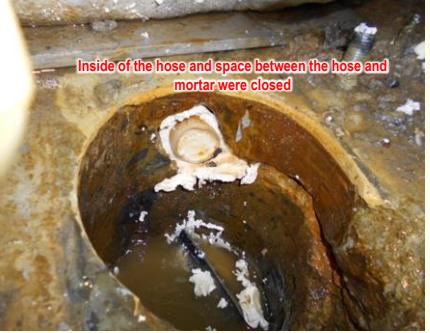
Status of water shutoff measures

After the closure, inflow from the closed part stopped and the inflow rate to the Onsite Bunker Building declined from approx. 40 m<sup>3</sup>/day to almost none (approx. 0.2 m<sup>3</sup>/day).

Ongoing monitoring of the water level continues.

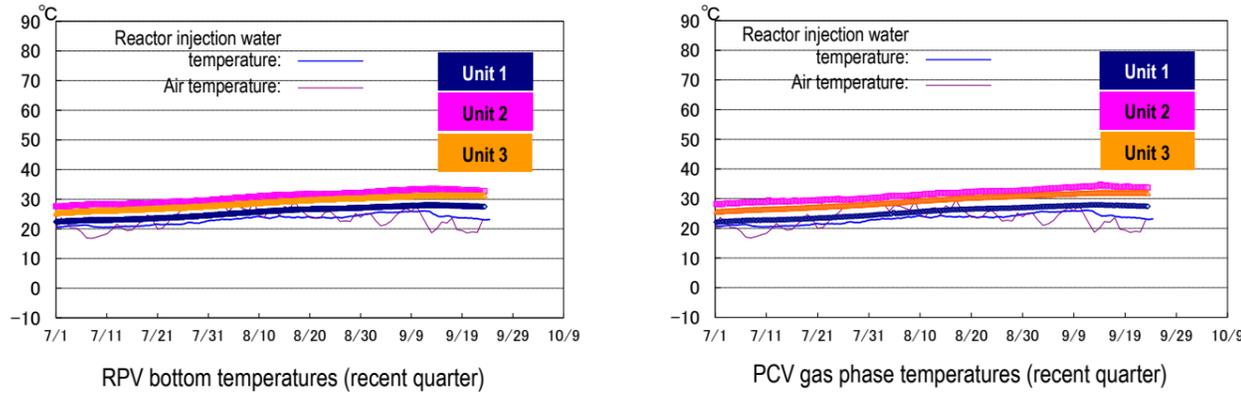
Through continuous reactor cooling by water injection, the temperatures of the Reactor Pressure Vessel (RPV) bottom and the Primary Containment Vessel (PCV) gas phase were maintained within the range of approx. 25 to 35°C for the past month, though they varied depending on the unit and location of the thermometer.

\* The trend graphs show part of the temperature data measured at multiple points.

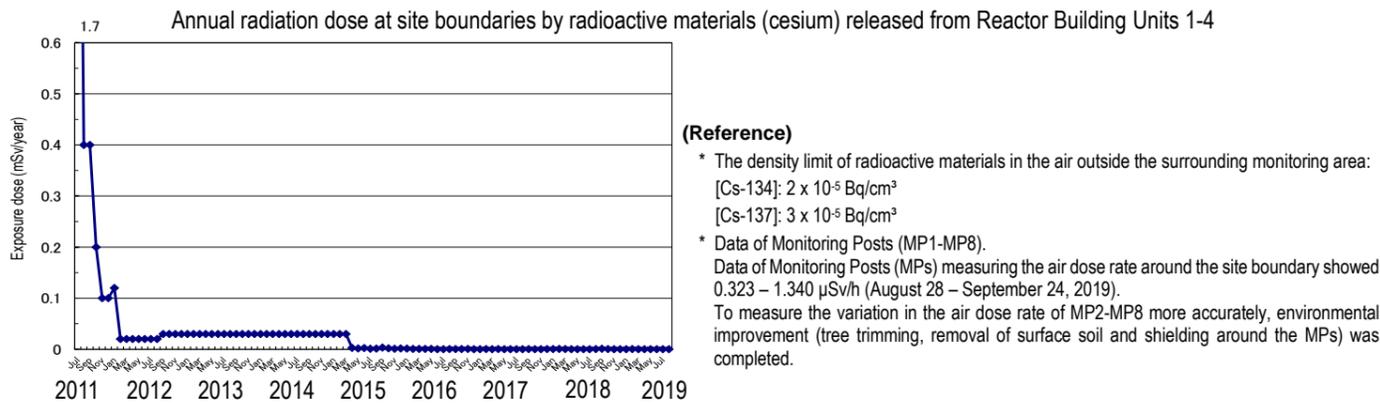
As of August 2019, the density of radioactive materials newly released from Reactor Building Units 1-4 into the air and measured at the site boundary was evaluated at approx.  $2.9 \times 10^{-12}$  Bq/cm<sup>3</sup> and  $9.6 \times 10^{-12}$  Bq/cm<sup>3</sup> for Cs-134 and Cs-137 respectively, while the radiation exposure dose due to the release of radioactive materials there was less than 0.00027 mSv/year.

Note: Different formulas and coefficients were used to evaluate the radiation dose in the facility operation plan and monthly report. The evaluation methods were integrated in September 2012. As the fuel removal from the spent fuel pool (SFP) commenced for Unit 4, the radiation exposure dose from Unit 4 was added to the items subject to evaluation since November 2013. The evaluation has been changed to a method considering the values of continuous dust monitors since FY2015, with data to be evaluated monthly and announced the following month.

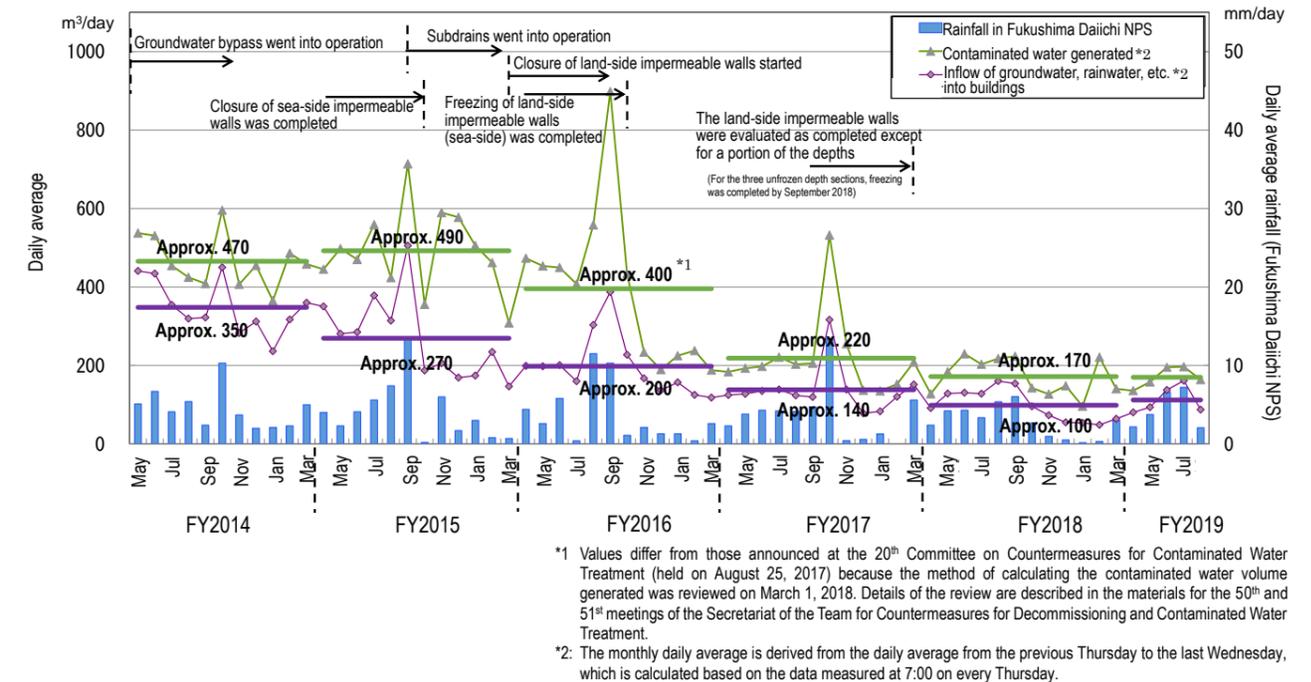
Figure 1: Changes in contaminated water generated and inflow of groundwater, rainwater, into buildings

- Following the steady implementation of "redirecting" measures (groundwater bypass, subdrains, land-side impermeable walls and other measures), the generation amount reduced from approx. 470 m<sup>3</sup>/day (the FY2014 average) when the measures were first launched to approx. 170 m<sup>3</sup>/day (the FY2018 average).
- Measures will continue to further reduce the volume of contaminated water generated.

- Through these measures, the generation of contaminated water was reduced from approx. 470 m<sup>3</sup>/day (in FY2014) to approx. 170 m<sup>3</sup>/day (in FY2018).

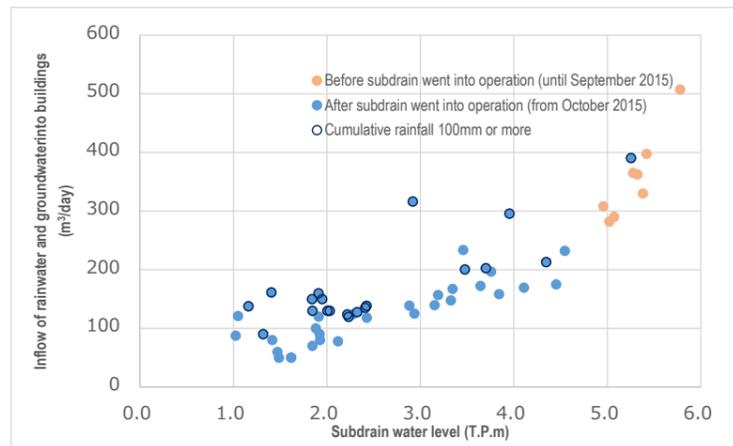
Figure 2: Correlation between inflow such as groundwater and rainwater into buildings and the water level of Unit 1-4 subdrains

- To eliminate the need to suspend water pumping while cleaning the subdrain transfer pipe, the pipe will be duplicated. Installation of the pipe and ancillary facilities was completed.
- Since the subdrains went into operation, the inflow into buildings tended to decline to under 150 m<sup>3</sup>/day when the subdrain water level declined below T.P. 3.0 m but increased during rainfall.

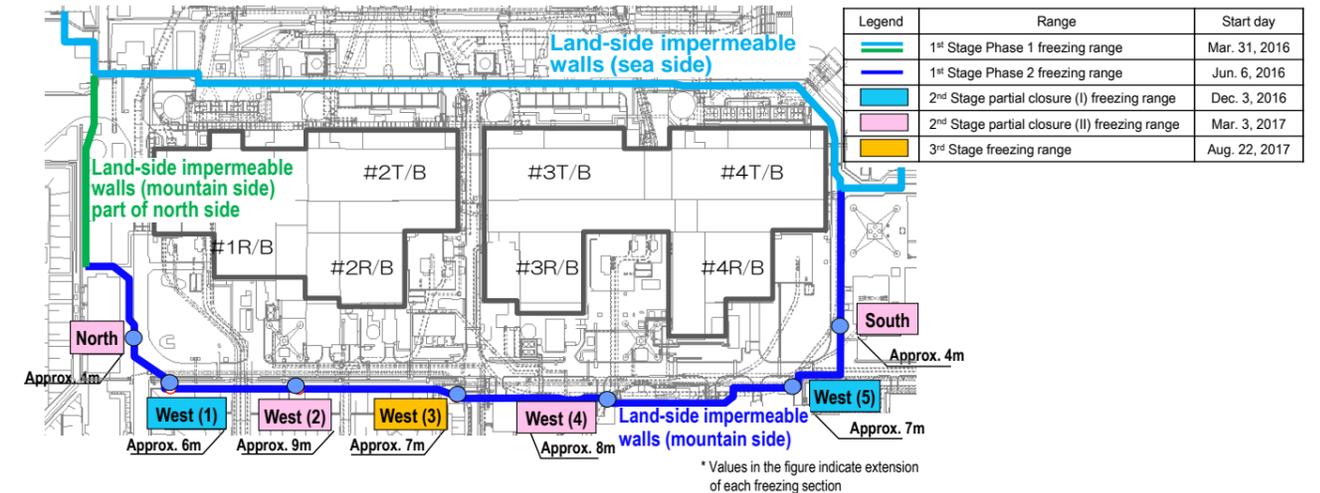
Figure 3: Closure parts of the land-side impermeable walls (on the mountain side)

- A supplementary method was implemented for the unfrozen depth and it was confirmed that the temperature of this portion had declined below 0°C by September 2018. From February 2019, a maintenance operation started throughout all sections.

- The groundwater level in the area inside the land-side impermeable walls has been declining every year. On the mountain side, the difference between the inside and outside increased to approx. 4-5 m. The water level in the bank area has remained low (T.P. 1.6-1.7 m) compared to the ground surface (T.P. 2.5 m).

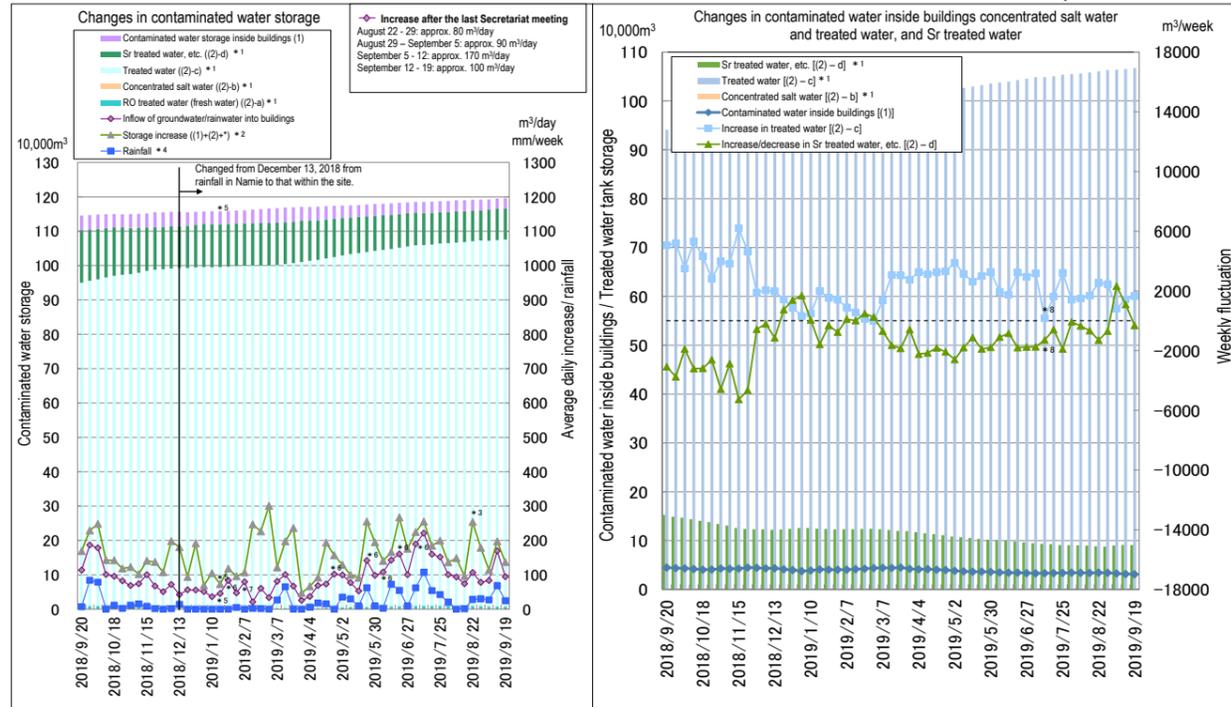
\*1: Water amount for which the water-level gauge indicates 0% or more  
 \*2: To detect storage increases more accurately, the calculation method was reviewed as follows from February 9, 2017: (The revised method was applied from March 1, 2018) [(Inflow of groundwater/rainwater into buildings) + (other transfer) + (chemical injection into ALPS)]  
 \*3: The storage amount increased due to transfer to buildings in association with the decommissioning work. (The transferred amount comprised ①Transfer from On-site Bunker Building to Process Main Building: approx. 110 m³/day, ②ALPS waste chemical: 13 m³/day, ③Transfer from wells and groundwater drains: approx. 13 m³/day, others)  
 \*4: Changed from December 13, 2018 from rainfall in Namie to that within the site.  
 \*5: Since January 17, 2019, Unit 3 C/B contaminated water has been managed in addition to contaminated water storage in buildings. For the inflow of groundwater, rainwater, and others to buildings and increase in storage have been reflected since January 24, 2019.

\*6: Considered attributable to the increased inflow of groundwater, rainwater, and others to buildings due to the decline in the level of contaminated water in buildings. (January 17, April 22, May 16 and 30, June 13 and 27, 2019)  
 \*7: Water-level gauges were replaced (February 7 – March 7, 2019)  
 \*8: Calculation methods for water volume and the capacity of tanks, which had varied in each tank area, were unified in all areas. By this unification, the calculated increase in treated water and variation in Sr-treated water, and others changed. However, the actual treated volumes were approx. 2200 m³/week for treated water and approx. 1100 m³/week for Sr-treated water, and others (July 11, 2019).

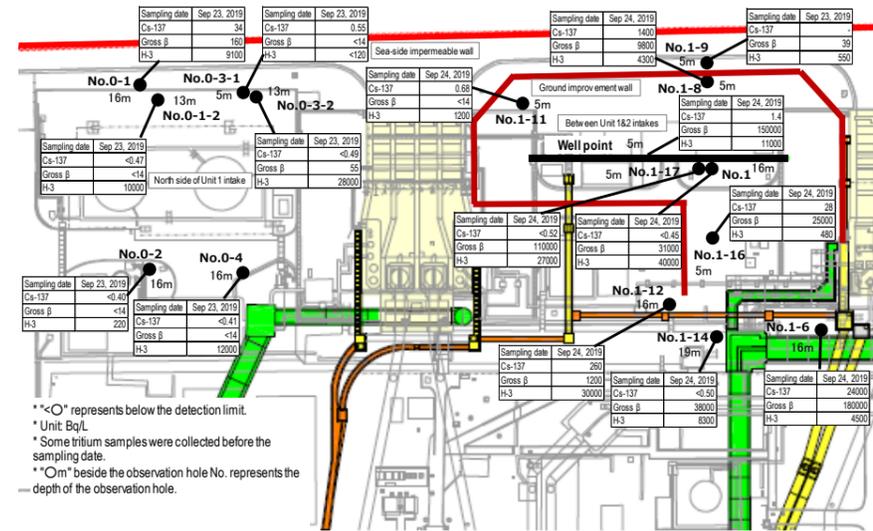
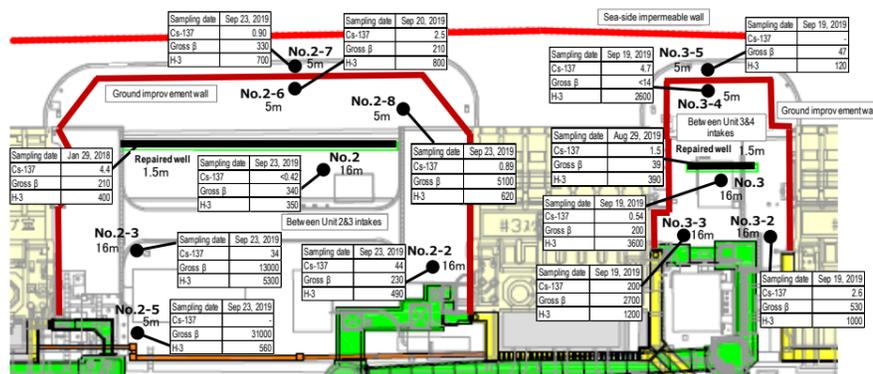
Figure 5: Groundwater density on the Turbine Building east side

<Unit 1 intake north side, between Unit 1 and 2 intakes>

<Between Unit 2 and 3 intakes, between Unit 3 and 4 intakes>

- At No. 1-12, the density of gross β radioactive materials had been increasing from around 200 Bq/L since December 2018 and currently stands at around 1,200 Bq/L. Since August 15, 2013, pumping of groundwater continued (at the well point between the Unit 1 and 2 intakes: August 15, 2013 – October 13, 2015 and from October 24; at the repaired well: October 14-23, 2015).

- At No. 2-6, the density of gross β radioactive materials had been increasing from around 100 Bq/L since May 2019 and currently stands at around 210 Bq/L. Since December 18, 2013, pumping of groundwater continued (at the well point between the Unit 2 and 3 intakes: December 18, 2013 - October 13, 2015; at the repaired well: from October 14, 2015).

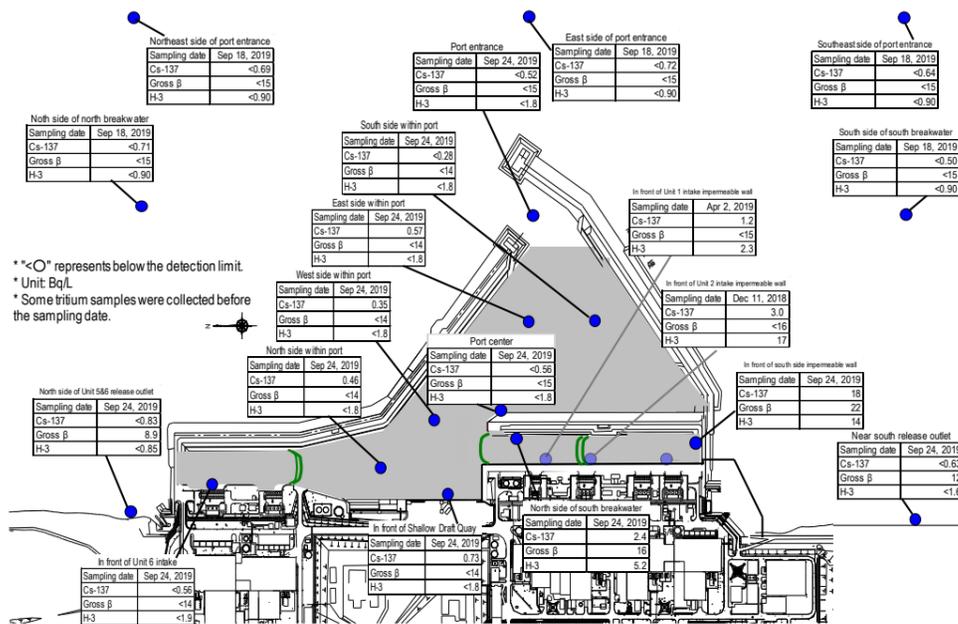
Figure 6: Seawater density around the port

level of those in the Unit 1-4 intake open channel area and been declining following the completed installation and connection of steel pipe sheet piles for the sea-side impermeable walls.

- In the area outside the port, regarding the densities of radioactive materials in seawater, those of Cs-137 and Sr-90 declined and remained low after steel pipe sheet piles for the sea-side impermeable walls were installed and connected.

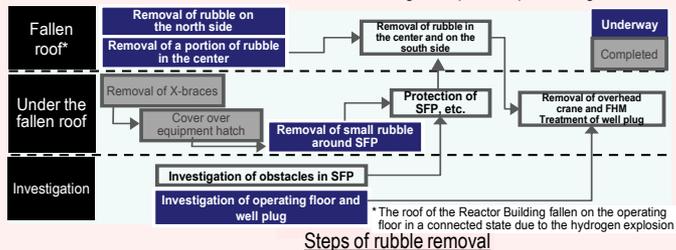
&lt;Status of the operating floor&gt;

Toward fuel removal from the spent fuel pool, there is a plan to install a dedicated cover for fuel removal over the top floor of the Reactor Building (operating floor). On November 10, 2016, removal of all roof panels and wall panels of the building cover was completed. On May 11, 2017, removal of pillars and beams of the building cover was completed. On December 19, 2017, modification of the pillars and beams of the building cover and installation windbreak fences were completed. From March 18, 2019, removal of small rubble in the east-side area around the SFP started as an initial step using pliers and suction equipment. From July 9, 2019, small rubble removal on the south side of the SFP started. Rubble removal and investigation prior to protecting the SFP, etc. are currently underway.

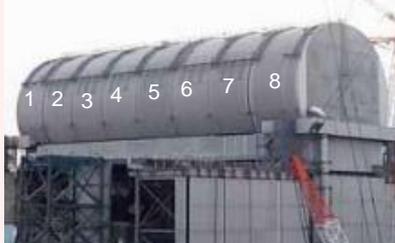
Installation of dome roof (February 21, 2019)

Prior to the installation of a cover for fuel removal, removal of large rubble from the spent fuel pool was completed in November 2015. To ensure safe and steady fuel removal, training of remote control was conducted at the factory using the actual fuel-handling machine which will be installed on site (February – December 2015). Measures to reduce dose on the Reactor Building top floor (decontamination, shields) were completed in December 2016. Installation of a cover for fuel removal and a fuel-handling machine is underway from January 2017. Installation of the fuel removal cover was completed on February 23, 2018.

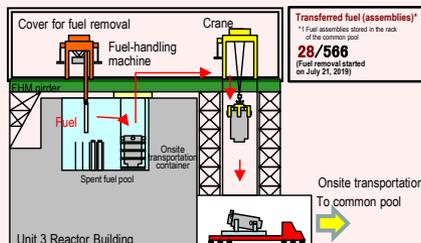
Fuel removal status (April 15, 2019)

Toward fuel removal, the rubble retrieval training inside the pool, which was scheduled in conjunction with fuel removal training, started from March 15, 2019, and started fuel removal from April 15, 2019.

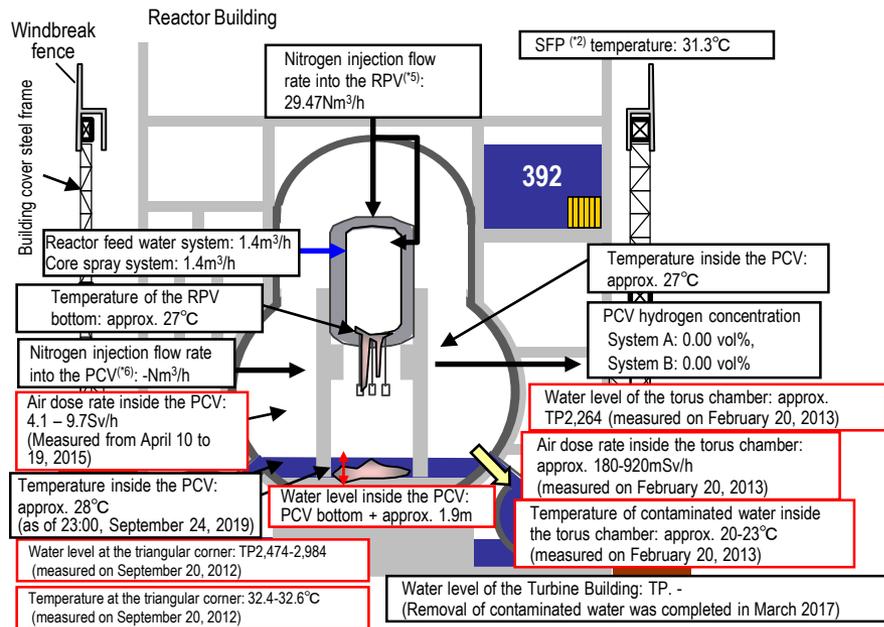
## Unit 1

Air dose rate inside the Reactor Building:  
 Max. 5,150mSv/h (1F southeast area) (measured on July 4, 2012)

\* Indices related to the plant are values as of 11:00, September 25, 2019

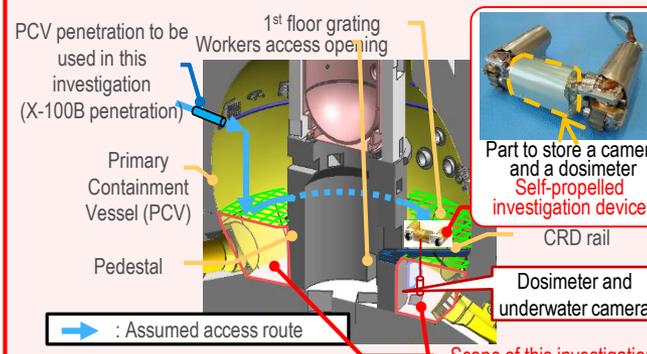
<Image of investigation inside the PCV>

- In April 2015, a device, which entered the inside of the PCV through a narrow access opening (bore:  $\phi$  100 mm), collected information such as images and airborne dose inside the PCV 1st floor.
- In March 2017, the investigation using a self-propelled investigation device, conducted to inspect the spreading of debris to the basement floor outside the pedestal, took images of the PCV bottom status for the first time. The status inside the PCV will continue to be examined based on the collected image and dose data.

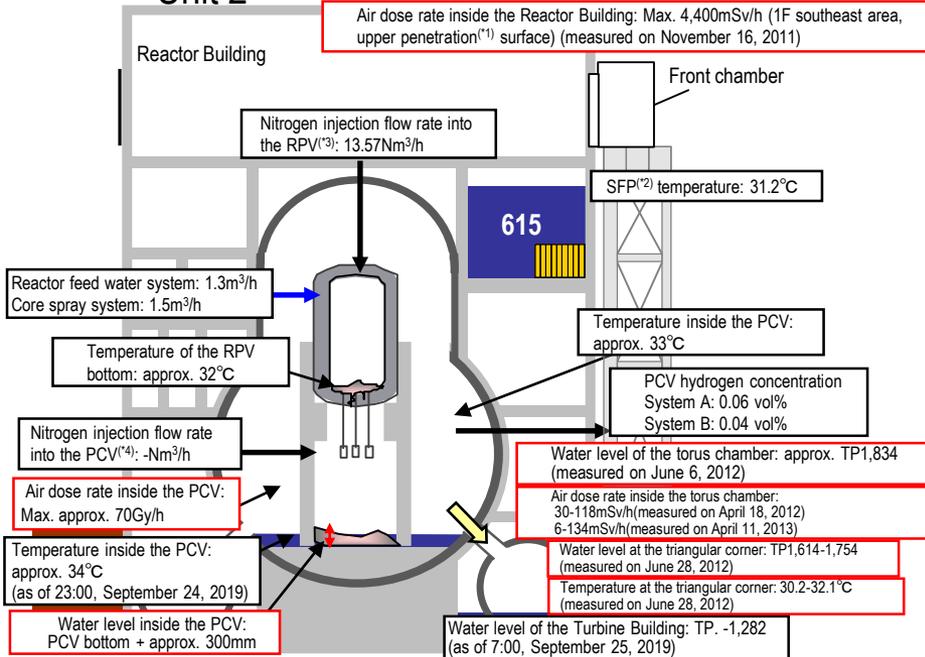
## Unit 2

\* Indices related to plant are values as of 11:00, September 25, 2019

Investigations inside PCV	1st (Jan 2012)	- Acquiring images - Measuring air temperature
	2nd (Mar 2012)	- Confirming water surface - Measuring water temperature - Measuring dose rate
	3rd (Feb 2013 – Jun 2014)	- Acquiring images - Sampling contaminated water - Measuring water level - Installing permanent monitoring instrumentation
	4th (Jan – Feb 2017)	- Acquiring images - Measuring dose rate - Measuring air temperature
Leakage points from PCV	- No leakage from torus chamber rooftop - No leakage from all inside/outside surfaces of S/C

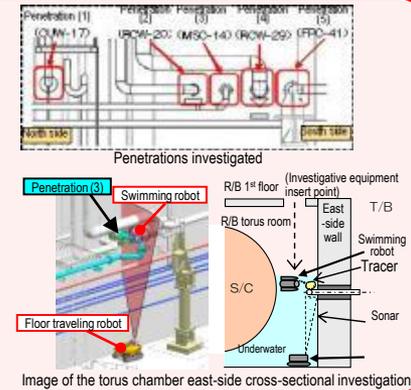
## Investigative results on torus chamber walls

- The torus chamber walls were investigated (on the north side of the east-side walls) using equipment specially developed for that purpose (a swimming robot and a floor traveling robot).
- At the east-side wall pipe penetrations (five points), "the status" and "existence of flow" were checked.
- A demonstration using the above two types of underwater wall investigative equipment showed how the equipment could check the status of penetration.
- Regarding Penetrations 1 - 5, the results of checking the sprayed tracer (\*) by camera showed no flow around the penetrations. (investigation by the swimming robot)
- Regarding Penetration 3, a sonar check showed no flow around the penetrations. (investigation by the floor traveling robot)

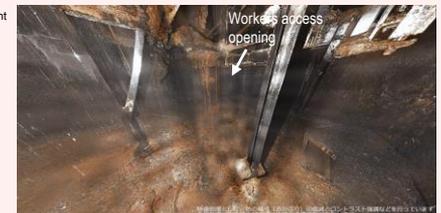
- The results of this series of investigations confirmed fallen and deformed gratings and a quantity of deposit inside the pedestal.
- On January 19, 2018, the status below the platform inside the pedestal was investigated using an investigative device with a hanging mechanism. From the analytical results of images obtained in the investigation, deposits probably including fuel debris were found at the bottom of the pedestal. In addition, multiple parts higher than the surrounding deposits were also detected. We presumed that there were multiple routes of fuel debris falling. Obtained data were processed in panoramic image visualization to acquire clearer images.

- On February 13, 2019, an investigation touching the deposits at the bottom of the pedestal and on the platform was conducted and confirmed that the pebble-shaped deposits, etc. could be moved and that hard rock-like deposits that could not be gripped may exist.

Bottom of the pedestal (after being processed in panoramic image visualization)

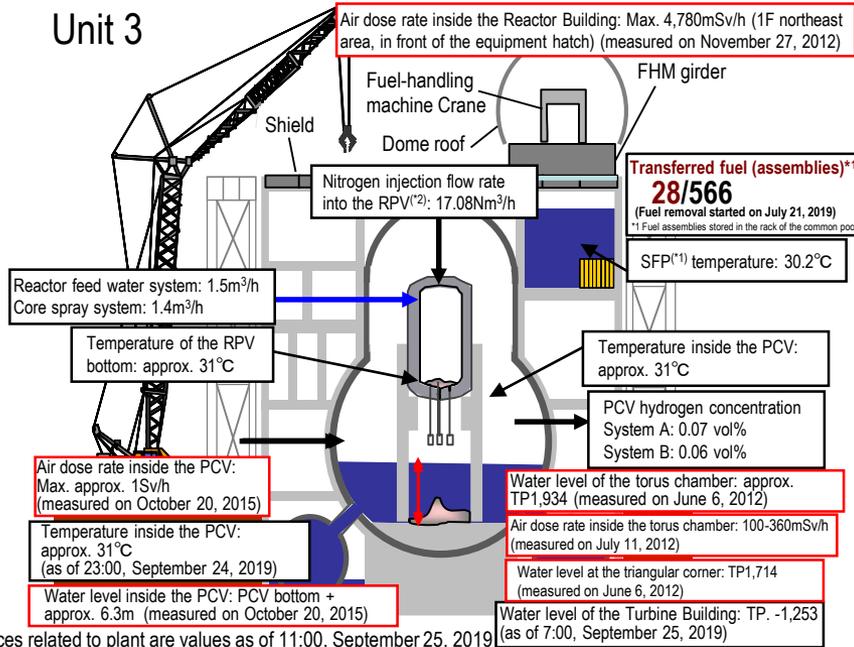
### Unit 3

From April 23, 2014, image data has been acquired by camera and the radiation dose measured via pipes for measurement instrumentation, which connect the air-conditioning room on the Reactor Building 2nd floor with the Main Steam Isolation Valve Room on the 1st floor. On May 15, 2014, water flow from the expansion joint of one Main Steam Line was detected.

This is the first leak from PCV detected in the Unit 3. Based on the images collected in this investigation, the leak volume will be estimated and the need for additional investigations will be examined. The investigative results will also be utilized to examine water stoppage and PCV repair methods.

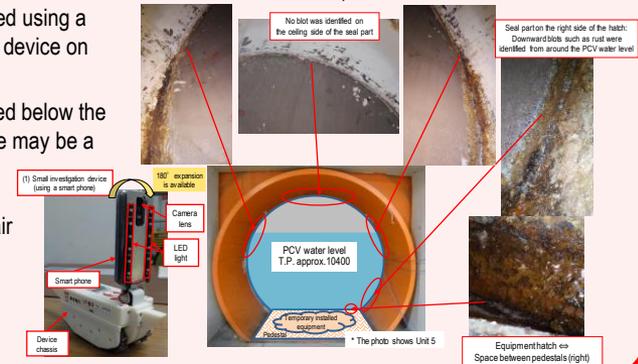
### Investigative results into the Unit 3 PCV equipment hatch using a small investigation device

- As part of the investigation into the PCV to facilitate fuel debris retrieval, the status around the Unit 3 PCV equipment hatch was investigated using a small self-traveling investigation device on November 26, 2015.

- Given blots such as rust identified below the water level inside the PCV, there may be a leakage from the seal to the extent of bleeding.

Methods to investigate and repair the parts, including other PCV penetrations with a similar structure, will be considered.

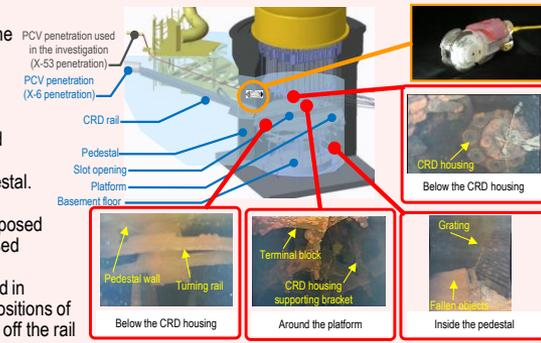
- Analysis of image data obtained in the investigation identified damage to multiple structures and the supposed core internals. Consideration about fuel removal based on the obtained information will continue.

- Videos obtained in the investigation were reproduced in 3D. Based on the reproduced images, the relative positions of the structures, such as the rotating platform slipping off the rail with a portion buried in deposits, were visually understood.

Status inside the pedestal

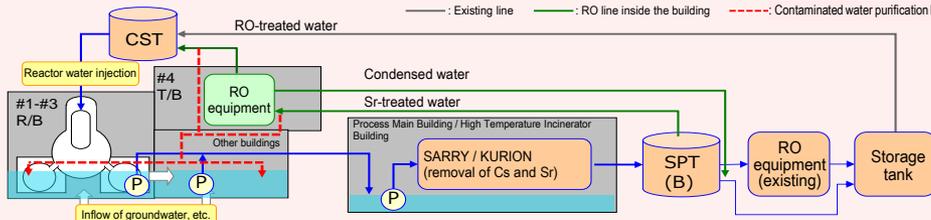
- To reduce the risk of contaminated-water leakage, the circulation loop was shortened by installing a reverse osmosis (RO) device in the Unit 4 Turbine Building within the circulation loop, comprising the transfer of contaminated water, water treatment and injection into the reactors. Operation of the installed RO device started from October 7 and 24-hour operation started from October 20. Installation of the new RO device inside the building shortened the circulation loop from approx. 3 to 0.8 km.

\* The entire length of contaminated water transfer pipes is approx. 2.1km, including the transfer line of surplus water to the upper heights (approx. 1.3km).

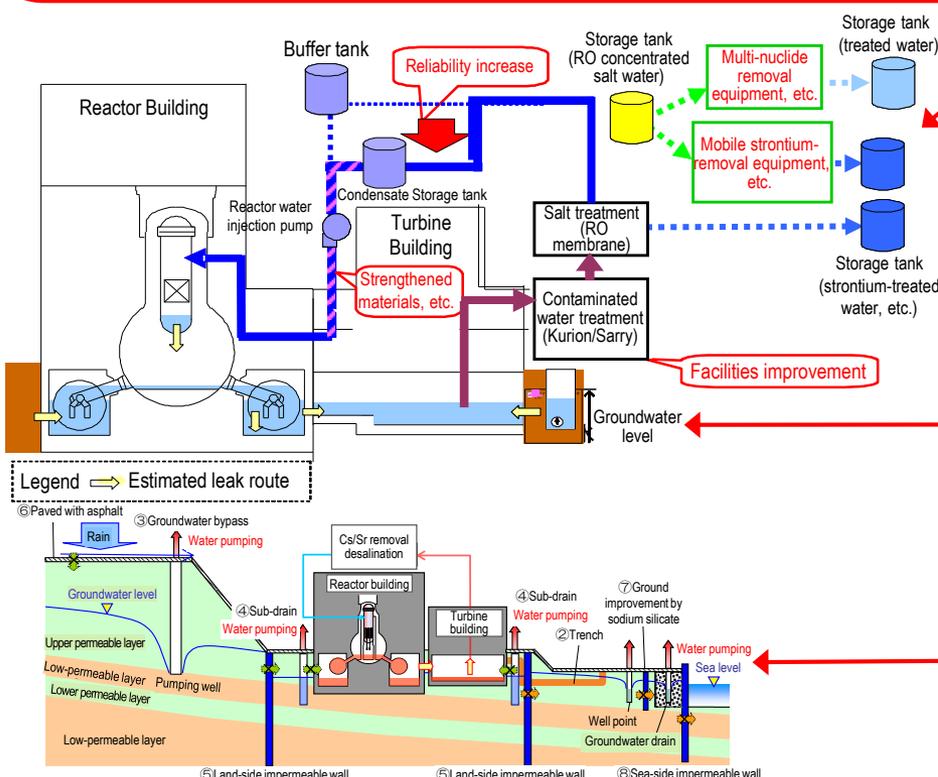
Contaminated water (RO concentrated salt water) is being treated using seven types of equipment including the multi-nuclide removal equipment (ALPS). Treatment of the RO concentrated salt water was completed on May 27, 2015, with the exception of the remaining water at the tank bottom. The remaining water will be treated sequentially toward dismantling the tanks.

The strontium-treated water from other facilities than the multi-nuclide removal equipment will be re-purified in the multi-nuclide removal equipment to further reduce risks.

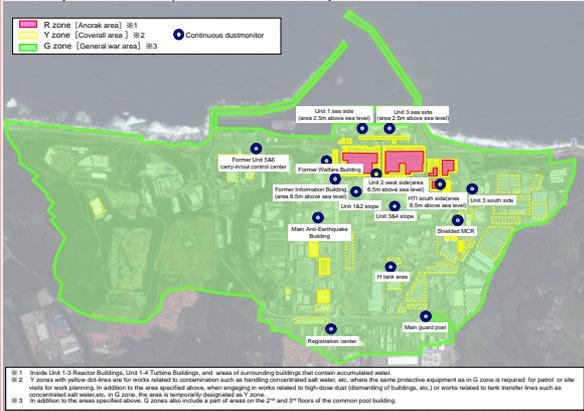
Based on the progress of measures to reduce environmental dosage on site, the site is categorized into two zones: highly contaminated area around Unit 1-4 buildings, etc. and other areas to optimize protective equipment according to each category aiming at improving safety and productivity by reducing load during work.

R zone (Anorak area)	Y zone (Coverall area)	G zone (General wear)
Full-face mask 	Full-face or half-face masks 	Disposable disposable mask 
Anorak on coverall Or double coveralls 	Coverall 	General*3 Dedicated on-site wear

\*1 For works in buildings including water-treatment facilities (multi-nuclide removal equipment, etc.) (excluding site visits), wear a full-face mask.  
 \*2 For works in tank areas containing concentrated salt water or Sr-treated water (excluding works not handling concentrated salt water, etc., patrol, on-site investigation for work planning, and site visits) and works related to tank transfer lines, wear a full-face mask.  
 \*3 Specified light works (patrol, monitoring, delivery of goods brought from outside, etc.)
