## 2. Roadmap towards Restoration from the Accident

(Step 2 Completed on December 16, 2011)

Progress status of "Roadmap towards Restoration from the Accident at Fukushima Daiichi Nuclear Power Station" on December 16

# Current Status of “Roadmap towards Restoration from the Accident at Fukushima Daiichi Nuclear Power Station, TEPCO” (Step 2 completion)

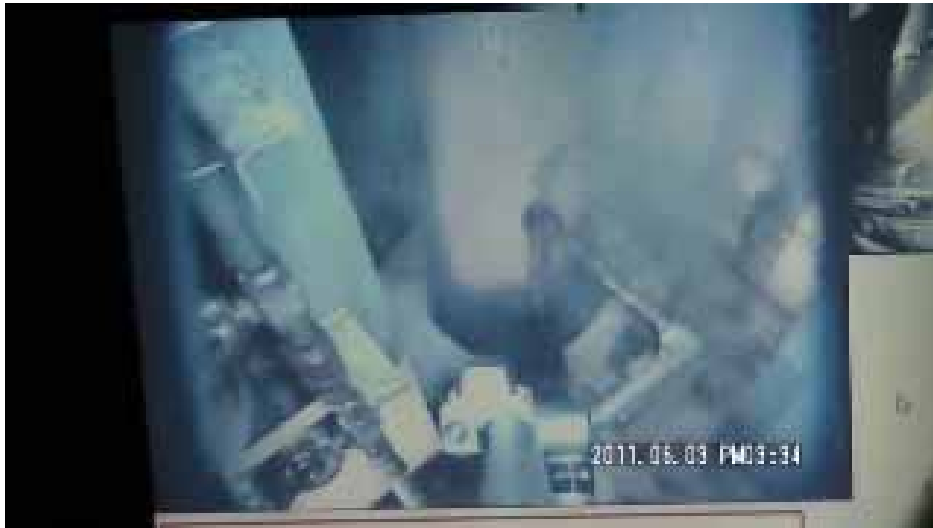
Steam release from the penetration on 1<sup>st</sup> floor  
(photo as at Jun. 3, 2011)

Steam release from the penetration point on the 1<sup>st</sup> floor was observed on Jun. 3, however no longer confirmed on Oct. 13.

Steam generation has been stopped or so little as to be condensed before leaking into the building, if any. (Therefore inside the PCV should have been cooled.)

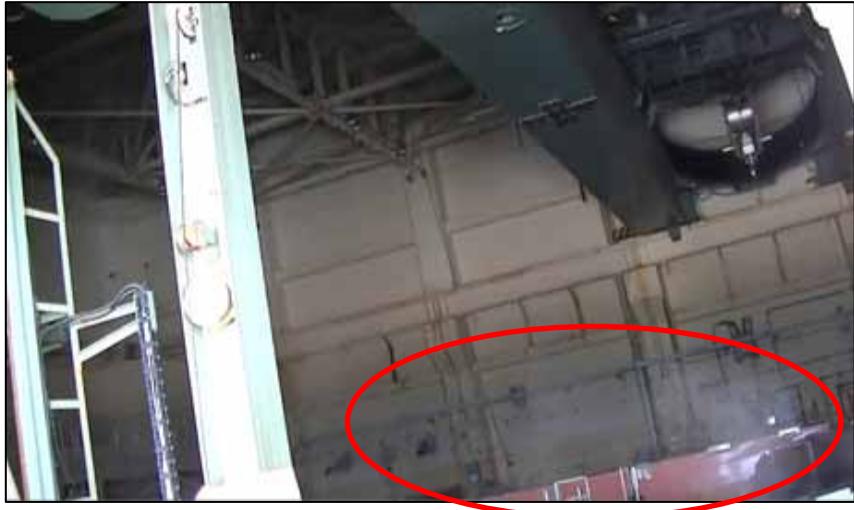
Steam release from right above the reactor on 5<sup>th</sup> floor (photo as of Sep. 17, 2011)

- Steam release was observed on Sep. 17, however no longer confirmed on Oct. 20.
- In addition, the paints of the overhead crane were being stripped off on Oct. 20, which shows that the air is dry (the adhesion of the paints had been weakened via humidity and then the paints were stripped when the air was dried.)

Steam generation has been stopped or so little as to be condensed before leaking into the building, if any.  
(Therefore inside the PCV should have been cooled.)

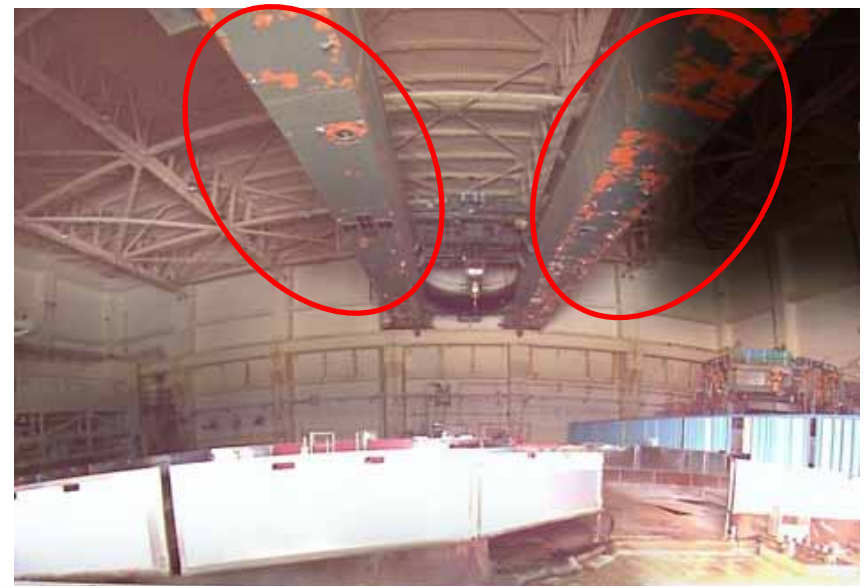
Situation of 5<sup>th</sup> floor of reactor building with no steam release (photo as of Oct. 20, 2011)

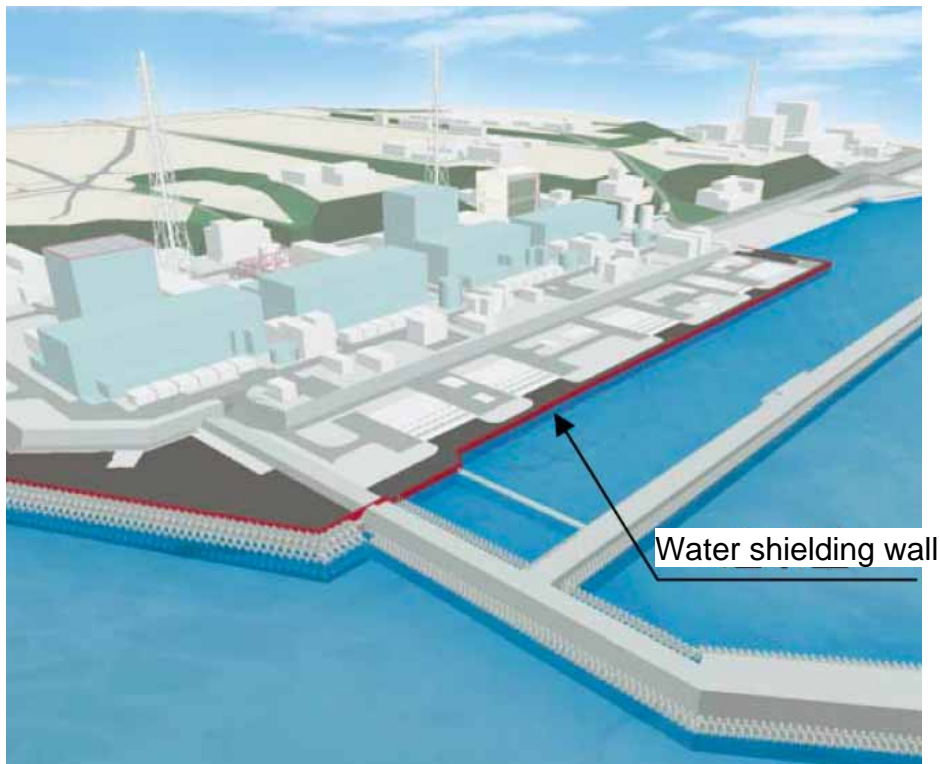
Overview

- By controlling accumulated water flows into underground water, we implement/start preventative measures to mitigate underground water contamination as well as to halt the spread of contamination into the ocean.
  - ✓ Mitigate the leaking of accumulated water in the building by ensuring that the level of accumulated water is lower than the sub drain water level (confirm via a radioactive materials density analysis of the sub drain).
  - ✓ Start the placement of the water shielding walls in front of the existing seawall of Units 1-4 (this will prevent the spread of contaminated underground water from flowing into the ocean)

Image of water shielding wall

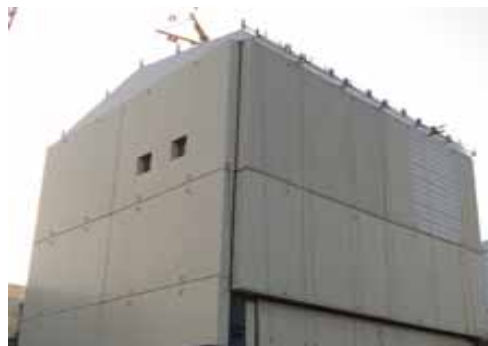
Unit 1 reactor building cover installation

- Spraying dust inhibitor agents to mitigate spreading of powder dust containing radioactive materials.
- Completed Unit 1 reactor building cover installation (Oct. 28, 2011).
- Radiation dose at the site is being held down due to rubble removal.
  - ✓ The removed rubble and waste resulting from restoration work such as cut down trees due to site clearing were transported after we classified them by type and radiation emitting amount at storage area.
  - ✓ The rubble were placed in containers and stored indoors in accordance with their radiation emitting amount.
- Completed PCV gas control system.
  - ✓ Started operation of PCV gas control system in Unit 1 (Dec.15, 2011), Unit 2 (Oct.28, 2011) and Unit 3 (Mar. 14, 2012).

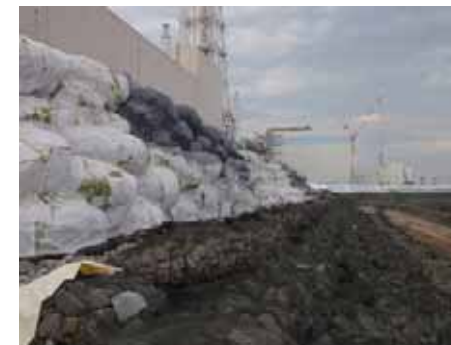
Installation of temporary tide barrier

- A temporary tide barrier was installed as a countermeasure against tsunamis caused by earthquakes. (May 18 ~ Jun. 30, 2011)
- Several kinds of countermeasures for radiation shielding were implemented.
