#### **Groundwater Observation Hole at Fukushima Daiichi Nuclear Power Station**

Tokyo Electric Power Company

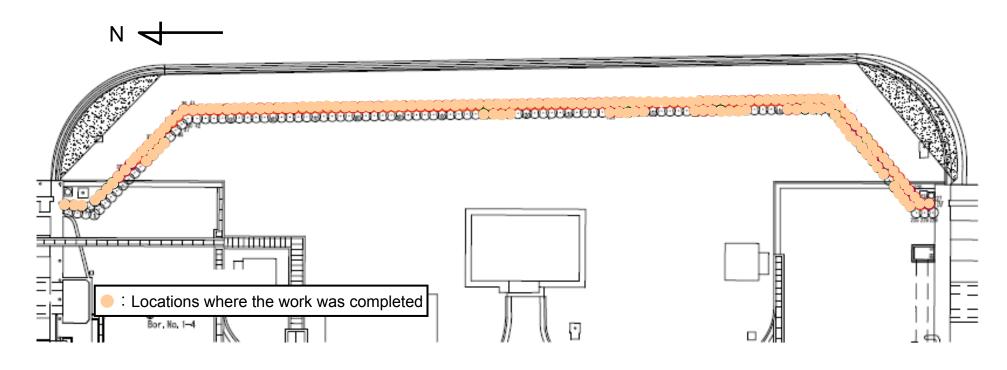
# ■ Progress Status of Bank Protection Foundation Improvement Work between Water Intakes of Units 1 and 2

- The foundation improvement was started on July 8, and is currently underway by use of ten foundation improvement machines. (The work starts at 7:00 PM each day and ends at 7:00 AM next day.)
- By the morning of July 31, the work was completed in total of 154 locations (113 on the sea side line and 41 on the mountain side line). (The work is planed to cover a total of 228 locations (114 on the sea side line and 114 on the mountain side line))

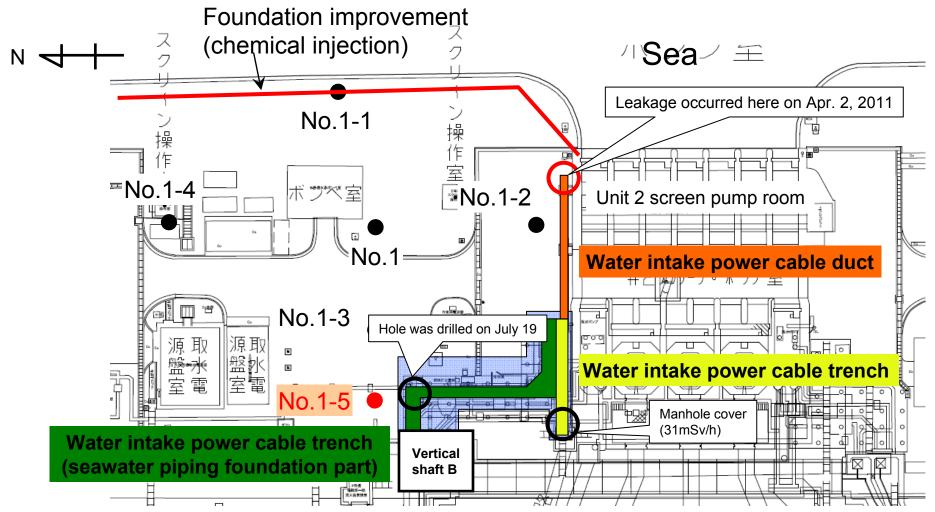
### ■Position of the groundwater observation hole No.1-5

■This observation hole locates at approx. 15m from the observation hole No.1-3 to the mountain side (near the vertical shaft B at the seawater piping trench).

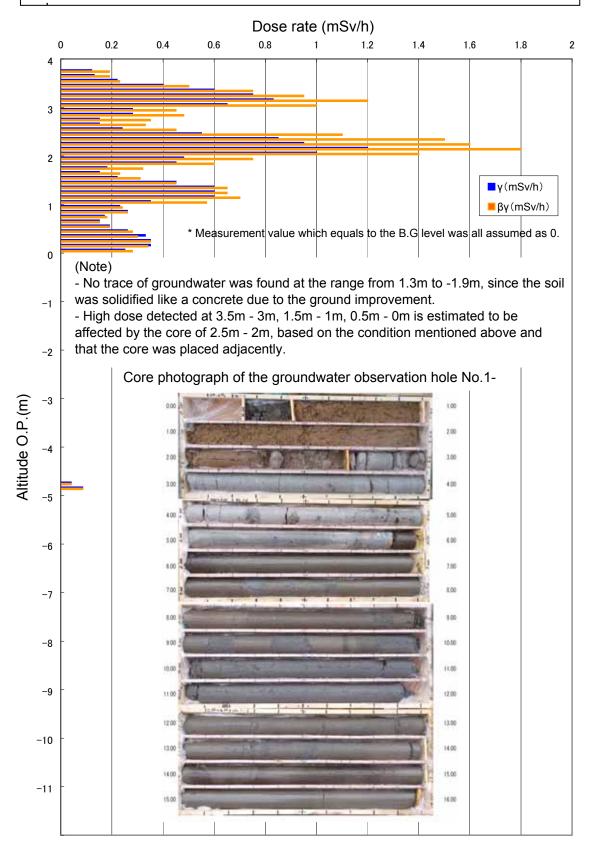
## ■ Dose Rate Transition of Boring Core of the Grounwater Observation Hole No.1-5 (Provitional Value)

- Dose rate measurement of boring core (soil) was performed at the groundwater observation hole No.1-5 (near the power cable trench of the groundwater observation hole No.1-3). It is considered that each core is affected by the adjacent core of high dose rate (please refer the note below), so we will remeasure them with a space between
