Mistaken Transport of Accumulated Water to the Incineration Workshop Building at <Reference> the Central Radioactive Waste Treatment Facility of the Fukushima Daiichi Nuclear **Power Station**

April 14, 2014 **TEPCO**

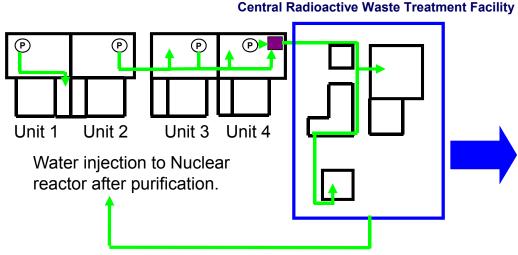
Accumulated water of the Processing main building was mistakenly transferred to the Incinerator work building, which resulted in flowing out to the first basement.

Transfer line used for accumulated water transportation on a regular basis.

Transfer line with pump turned on, which is not in use for accumulated water transportation on a regular basis.

- There are no points which pass through to outside the building on the layout.
- There is no significant change shown in the analysis result of subdrain water around the Incinerator work building
- The water level of subdrain water is high enough against the water level of the Incinerator work building.
- There is no change in the water levels of either the incinerator building or the work building.
- ⇒ By which, it is estimated that there is no leakage occurred outside the Incinerator work building.
