Estimation of accident progression based on the data measured for Unit-1 and the analyses available to date

\* This document is generated based on the proposal and evaluation by TEPCO Systems Corporation [1] concerning the changes of water level indicator readings (Unit-1/Issue-3) in Attachment 2 “List of issues”.

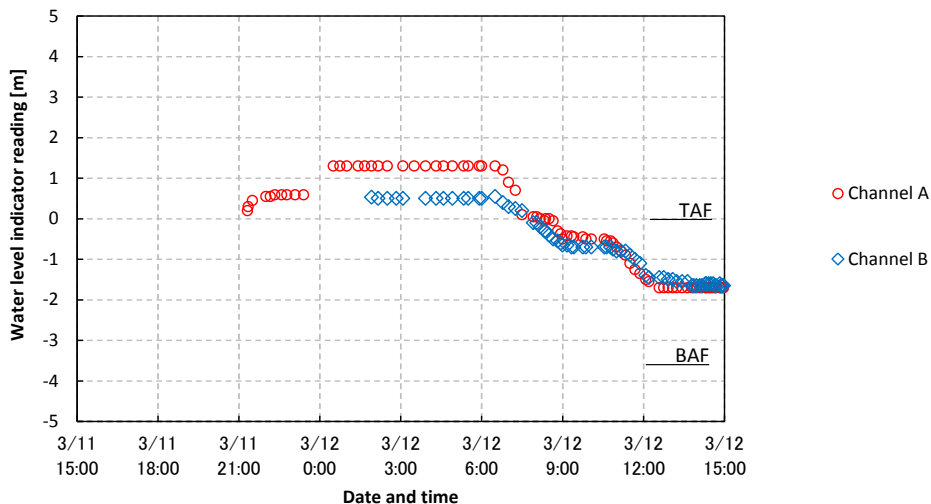
Figure 1 Fuel range water level indicator readings

Figure 1 shows the fuel range water level indicator readings from the station blackout till about 24 hours later. The water level indicator (Channel A) gave its reading of TAF+0.2m at 21:19 on March 11<sup>th</sup>, but by that time no water was being injected into the reactor which means the actual water level in the reactor was considered to have dropped below BAF by then. That is, the reading overstated the actual water level. Further, it should be noted that the readings were increasing at that time. But the only possible reason for increasing readings with no water injection into the reactor would be a decrease of the water level in the piping on the reference water chamber side (reference leg). From these deliberations the water level in the reference leg was considered to have largely dropped by this time and that it was further decreasing.

At around 21:30 the increase in the readings became slower and eventually stopped at 22:20 and stayed constant at TAF+0.59m till 23:24. In other words, changes in conditions to cause the water level decrease in the reference leg probably ceased by around 21:00 to 22:20 (a ground for Event E6 in Table 1). Thereafter at 00:30 on March 12<sup>th</sup>, the reading rose to TAF+1.3m and stayed there till around 06:00. The water level indicator readings at this time coincided roughly with the value for the situation in which the water level in the reference leg drops to the elevation of the PCV penetration, while the piping on the reactor side (variable leg) is almost completely filled and the reactor water level is below the connection part of the variable leg. Thereafter, the readings were gradually lowered to TAF-1.7m by around 12:00 and stayed there. The reading at this time coincided roughly with the value for the situation in which the water in the variable leg is completely lost by evaporation. Meanwhile, the PCV temperature measured on March 21<sup>st</sup> was about 400 deg C [2]. At this temperature the water in the water level indicators was likely to have completely evaporated. In addition, the water level indicator readings were almost constant by that time. Putting these together, it would mean that no water was left in the water level indicator piping by around 12:00 on March 12<sup>th</sup>. On the other hand, the water level indicator (Channel B) had been working since 02:30 on March 12<sup>th</sup> and its reading stayed roughly constant at about TAF+0.5m till around 06:00. Its reading was about 0.8m lower than that of Channel A. This might mean that the Channel B reference leg still had water to about an 80cm height at this time. Further it could be considered that, after 06:00 on March 12<sup>th</sup> the water in the variable leg evaporated as in Channel A and that by around 12:00 water in the variable leg as well as in the reference leg was completely lost.

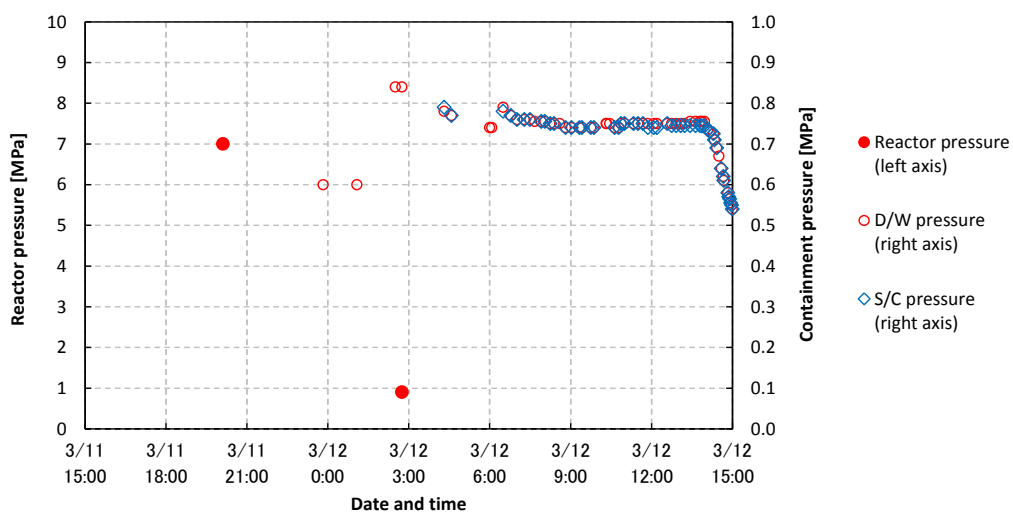
Figure 2 Measured reactor and PCV pressures

Figure 2 shows the reactor pressures and PCV pressures from the station blackout till

about 24 hours later. The measured reactor pressures were 7MPa[abs] at 20:07 on March 11<sup>th</sup> and 0.9MPa[abs] at 02:45 on March 12<sup>th</sup>. After the station blackout, the safety function of the safety relief valves (SRV) worked. The working pressure was about 7.7MPa[abs] [9]. The reactor pressure as of 20:07 on March 11<sup>th</sup> was likely to be slightly below the minimum value of the SRV working pressures. This might indicate the possibility that at this time the RPV was already leaking (Event E3 in Table 1). As possible leakage causes, in-core instrumentation line damage or line melting and main steam line damage have been suggested [3][4][5][6].

The measured PCV pressures were 0.6MPa[abs] at 23:50 on March 11<sup>th</sup> and 01:05 on March 12<sup>th</sup>. Such pressures cannot be reached without leakage from the RPV to the D/W, as explained below in Section 2.2, i.e., leakage from the RPV to the D/W seems likely to have occurred by 23:50 on March 11<sup>th</sup>. Later at 02:30 on March 12<sup>th</sup> the measured PCV pressure was 0.84MPa[abs], which roughly balanced with the RPV pressure of 0.9MPa[abs] at 02:45 on March 12<sup>th</sup>. Thereafter, the PCV pressure gradually decreased and then to increase at around 06:00 on March 12<sup>th</sup>. In the current estimation, the RPV lower head failure was considered to have occurred at around 06:00 on March 12<sup>th</sup>, and therefore the PCV pressure increase at this time was considered to be caused by the relocation of molten debris to the PCV in the wake of RPV damage. In other words, the pressure increase prior to this time point was estimated to be caused by some other reasons, and the pressure increase at this particular period from 01:05 to 02:30 on March 12<sup>th</sup> was estimated to be caused by the large amount of molten debris relocation to the lower plenum (Event E8 in Table 1).

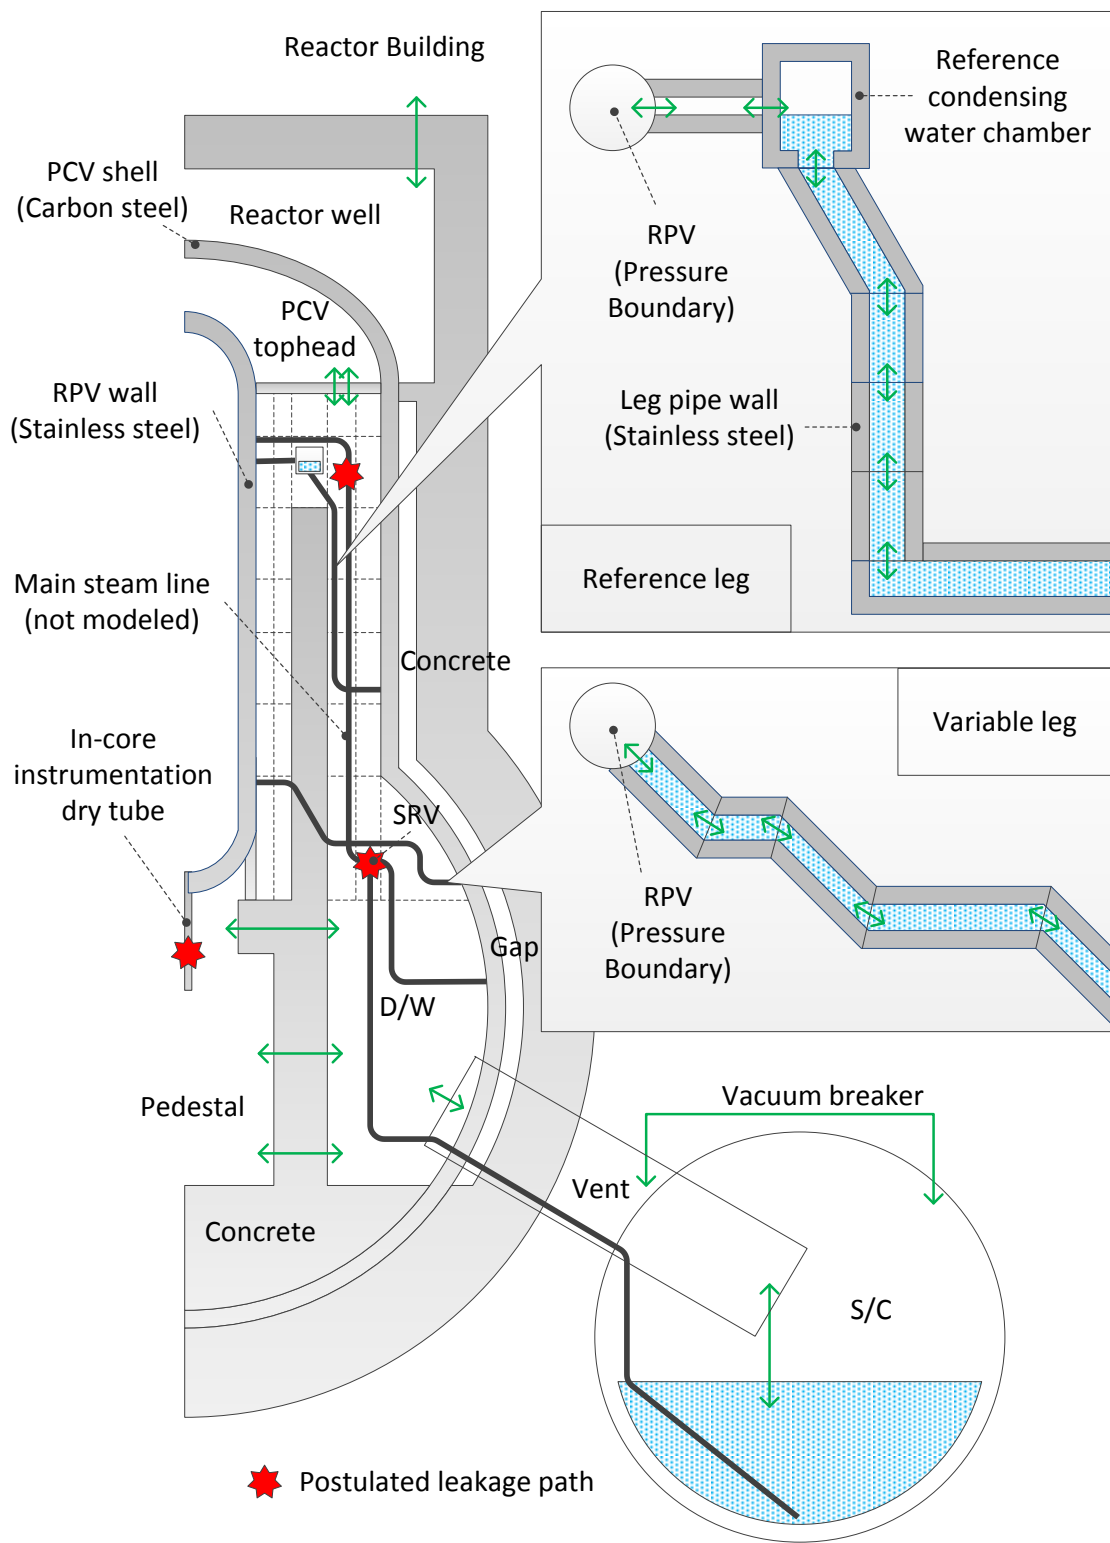
Figure 3 Geometry for analysis

Figure 3 shows the geometry for analysis<sup>1</sup>. The water level indicator line and PCV were modeled in several regions, flow paths (arrows) and heat structures (colored). Each heat structure exchanges heat with the adjacent region. The core internals in the RPV were not modeled. The temperature boundaries were the RPV inner wall and the space in the reactor building.

The water level indicator line was modeled in the PCV space as several regions and heat structures in the geometry, so that the water level changes therein due to evaporation could be simulated. The configuration was defined based on the design data. The PCV space was further divided as illustrated within the dashed lines in the figure in order to simulate temperature distribution and natural convection around the water level indicator line. This enabled simulation of the PCV temperatures as a function of elevation, etc. Although not illustrated in the figure, the regions were divided also along the circumferential direction (the direction into the page), and thus reference legs of Channel A and Channel B were separately modeled in different regions along the circumferential direction. This enabled simulation of the behavior difference in Channel A and Channel B water level indicator lines. Variable legs were modeled to the same for both channels, for simplicity.

The star marks in the figure represent the leak locations assumed in the current estimation. The leak location from the instrumentation line to pedestal corresponded to the leak in a limited amount from RPV in Table 1 (Event E3). As the location of the main leak

from the RPV, the upper side of the main steam line was assumed in the base case below in the current estimation. For comparison, the leak was assumed at the SRV position as well. It should be noted that the main steam line was not modeled in the analysis, but it is illustrated in the figure in order to help visualize positional relations in the simulation.

<sup>1</sup> The "Reference leg" in Figure 3 means the piping on the reference water level side, while "Variable leg" means the piping on the reactor water level side.

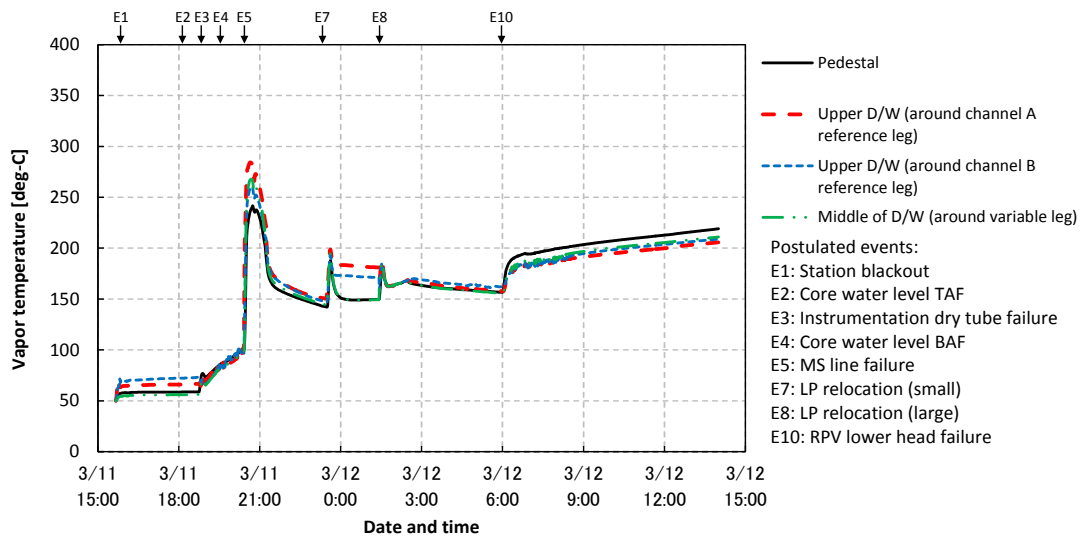
Figure 4 Temperature changes in the D/W (base case)

Figure 4 presents the analysis results of temperature changes in the atmosphere surrounding the pedestal, the upper part of the D/W (near the reference legs of Channel A and Channel B), and the central part of the D/W (near the variable legs)<sup>2</sup>. The temperature increase is relatively gradual until 18:50 on March 11<sup>th</sup>, when a leak through the in-core instrumentation line was assumed. Further, even after the leak to the pedestal started, the temperature increase in the PCV atmosphere is at most about 100 deg C, not significantly high enough to evaporate water in the water level indicator line. This is because it is hard to increase the atmosphere temperature due to the low heat radiation from the RPV, the limited gaseous leaks to the pedestal, and the large heat capacity of heat structures in the PCV. Thereafter, upon initiation of large quantity, high temperature steam leaks from the main steam line at 20:30, all the PCV temperatures increase quickly. As the leaked amount decreases with time, the atmosphere temperature decreases because heat is absorbed by heat structures therein. Similar temperature changes of a spike-shape increase followed by a decrease are also noticed at 23:30 (March 11<sup>th</sup>) at the time of debris relocation in a limited amount and 01:30 on March 12<sup>th</sup> at the time of debris relocation in a big amount. Thereafter at 06:00 on March 12<sup>th</sup>, when the molten debris relocated because the RPV lower head had failed, heat from the molten debris is directly transferred to the atmosphere and it continues to increase the PCV temperatures.

Upon occurrence of leaks from the main steam line, the peak temperature of Channel A reaches a higher value than that of Channel B. The actual value of their difference is subject to the leak position. The position assumed in the current estimation was the upper side of the main steam line and it was close to the condensing water chamber of Channel B. In other words, in the analysis the leak above the Channel B piping raises the Channel A piping

temperature. This is because the high temperature leaked gas causes upward and horizontal flows of gas above Channel B piping and these gas flows raise the temperature around Channel A piping. Figure 5 shows the temperature distribution in the gas phase in the D/W at 20:35 on March 11<sup>th</sup>, when the temperatures in the gas phase in the D/W peaked. The area around the variable leg is located at a fairly lower elevation than the leak position and therefore its peak temperature becomes lower than that around the reference leg, because the high temperature leaked gas loses some heat due to the surrounding structures before flowing down to the area around the variable leg.

<sup>2</sup> The "LP relocation" in Figure 4 illustrates the debris relocation to the lower plenum.

period remained roughly constant (see Figure 4). This comes from the balanced heat supplied from the leaked steam generated by decay heat and heat loss absorbed by surrounding structures in the PCV. The pressure increases sharply at 01:30 on March 12<sup>th</sup>, when the debris relocation in a large amount was assumed, but it does not reach 0.84MPa[abs] measured at 02:30. In the current analysis, no hydrogen generation was assumed upon the debris relocation to the lower plenum. This may have led to underestimation of the containment pressures. In another existing analysis, hydrogen was newly generated upon debris relocation [5].

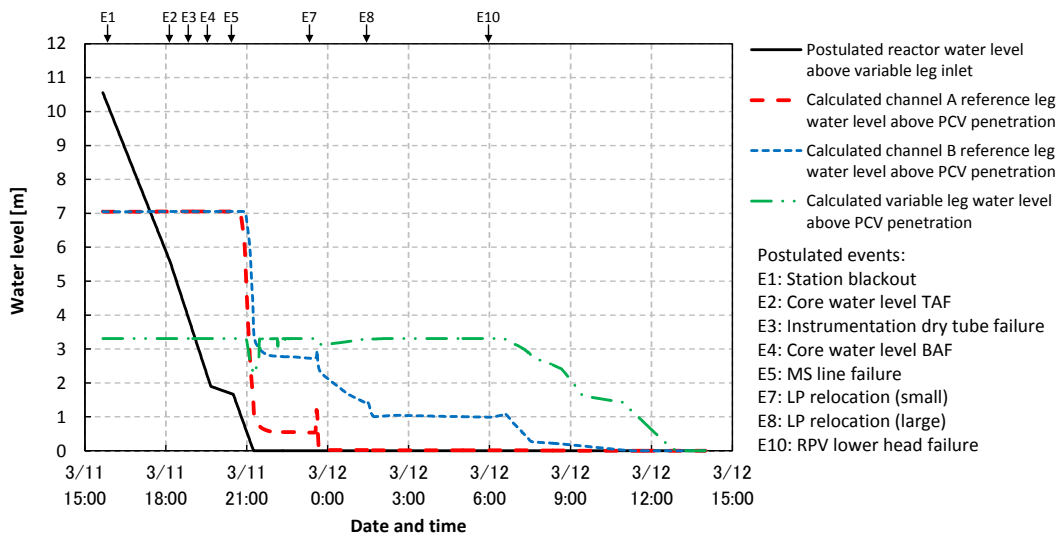
Figure 6 Water levels in the core and water level indicator piping (base case)

Figure 6 presents the postulated reactor water levels and the analyzed water level changes in the piping of reference and variable legs. The reactor water level is assumed based on the estimated accident progression. The reactor water level is assumed to reach approximately the elevation of the variable leg inlet at the timing when the RPV depressurization ended and it maintains this level until 23:30 on March 11<sup>th</sup> when the debris relocation took place in a limited amount. The reactor water level changes estimated now are used to evaluate the water level indicator readings.

The PCV atmosphere temperature increase raises the water temperature in the water level indicator lines. When this water temperature exceeds the saturation temperature, which was lowered by reactor depressurization, the water in the reference leg starts to evaporate. The temperature of the whole reference leg rises, and water levels decrease drastically by about 22:00 due to evaporation at its various parts. The water level further decreases thereafter due to the debris relocation to the lower plenum two times. Calculated water level decrease of Channel B is less than that of Channel A, because the ambient

temperature around Channel B is relatively lower than that of Channel A (Figure 5). At some of the timings, the water level shows a spike-shaped increase. This is because the volume fraction of gaseous phase in the horizontal portion of the piping increases due to evaporation of water therein and this raises the water level in the upper portion of the piping temporarily.

On the other hand, the variable leg remains almost completely filled with water until about 06:00 on March 12<sup>th</sup> when the RPV lower head failure was assumed and then the variable leg water level gradually decreases until all its water is lost at around 12:00. The water level drops a few times after 21:00 on March 11<sup>th</sup>. This is due to a temporary temperature increase because of the gaseous leak from the main steam line. The water level in the variable leg recovers thereafter. This is because the temperature increase due to leaked gas is limited in time, as seen in Figure 4, the ambient temperature around the variable leg piping falls and this condenses the steam coming from the pressure boundary.

The water level changes in Figure 6 are converted to the water level indicator readings in Figure 7 and compared with the measured values. It should be noted that the fuel range water level indicators are calibrated to the correct water level at room temperature and atmospheric pressure, and therefore its reading is different from the real water level even if the water level indicator line is filled with water. The results obtained from the analysis, based on boundary conditions set from the accident progression assumed in Table 1, can reproduce approximately the general trend of measurement results including the

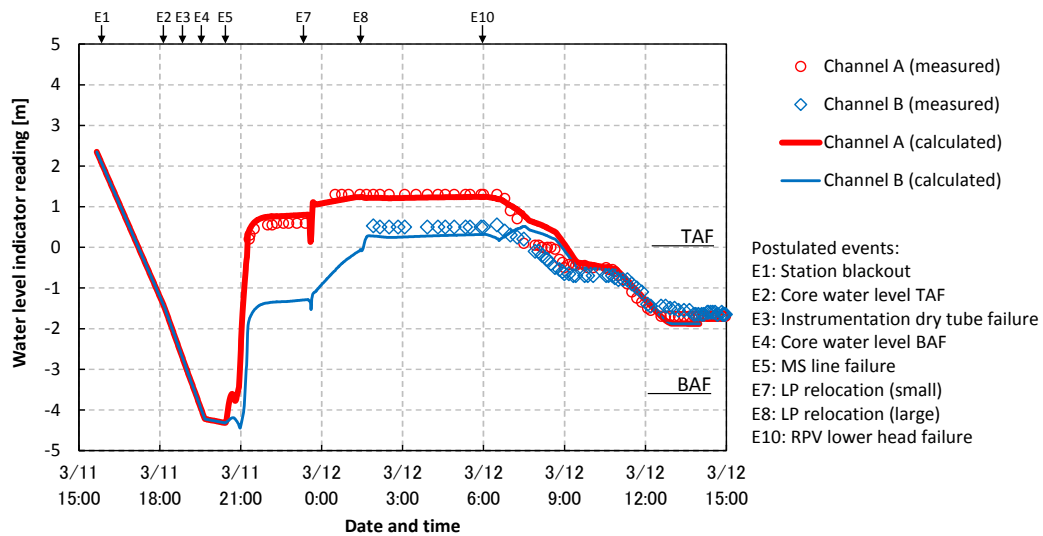
Figure 7 Comparison between water level indicator readings and water levels measured (base case)

difference in readings between Channel A and Channel B. The decreasing trend of readings becomes gradual at around 09:00 to 11:00 on March 12<sup>th</sup>. This time period corresponds to the timing when the water level in the variable leg was at the level of the variable leg horizontal portion. In the analysis, by modeling this horizontal portion of the water level indicator line, this gradual transition of water level indicator readings can be reproduced.

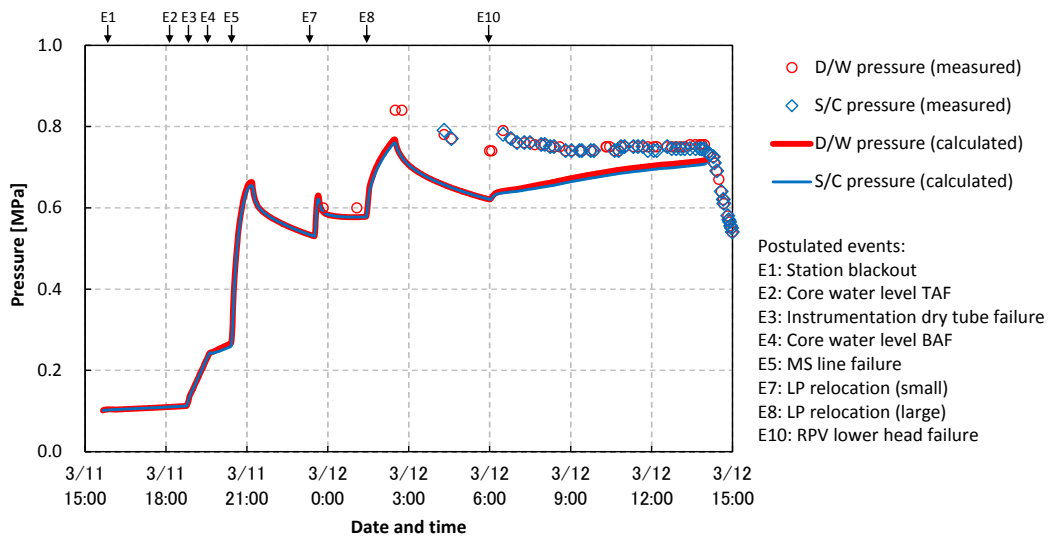
Figure 8 Comparisons between the analysis results and measured values of containment vessel pressures (base case)

Figure 8 compares the analysis results and measured values of D/W pressures and S/C pressures. In the analysis, the PCV pressures show a large increase until 21:15 on March 11<sup>th</sup> mainly due to hydrogen discharge to the S/C and steam/hydrogen mixture discharge from the main steam line. Thereafter, the pressures decrease in accordance with the ambient temperature (Figure 4). It increases again due to steam generated by the debris relocation (assumed as having occurred at 23:30) in a limited amount to the lower plenum, and then the pressures remain roughly constant due to stable steam leaks by decay heat. The pressures quickly increase after the debris relocation in a large amount to the lower plenum assumed as having occurred at 01:30 on March 12<sup>th</sup>. The pressures decrease gradually thereafter in accordance with the temperature decrease, and they turn upward due to the temperature increase of the PCV upon the debris relocation at around 06:00.

The comparison in Figure 8 shows the pressures of 0.6MPa[abs] observed at 23:50 on March 11<sup>th</sup> and 01:05 on March 12<sup>th</sup> are well reproduced in the analysis. The pressures over this time span remain roughly constant because the ambient temperature in the PCV in this

The observed pressures show an increase, by about 0.05MPa, from 06:00 to 06:30, but the pressure increase by the analysis during that time is less. If the RPV lower head was damaged and molten debris flowed out at this timing, non-condensable gas generated by the molten debris – concrete interaction (MCCI) would increase the pressure. The current analysis did not simulate the gas generation by MCCI, and this may have caused underestimation of the pressure increase. Thereafter the observed pressures remain roughly constant, while the analysis results show an increasing trend. This is probably because no leaks from the PCV were assumed in the analysis.

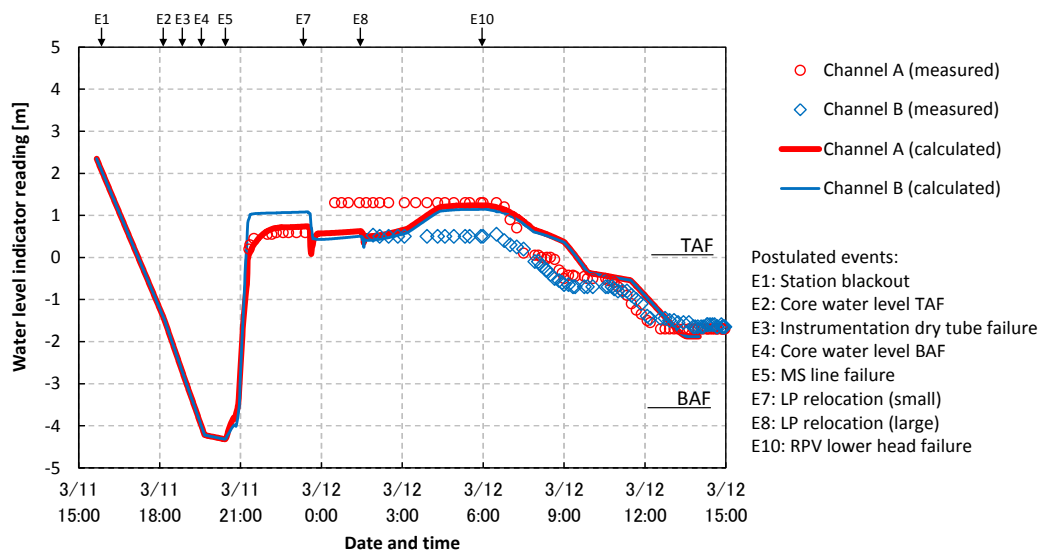
Figure 9 Comparison between the analysis results and measured values of water level indicator readings (sensitivity analysis case)

A sensitivity analysis, assuming a leak at the SRV position, was conducted in order to check the dependence of analysis results on the leak location. As the leaked gas

temperature from SRV to D/W, 620 deg C was set as a value which could reproduce well the reactor water level indicator readings of Channel A up to the time of 22:20 on March 11<sup>th</sup>. Figure 9 presents the analysis results of water level indicator readings. After the debris relocation to the lower plenum, assumed at 23:30 the water level in the variable leg falls and the analysis does not reproduce the measured levels. This can be explained by the geometric configuration of the equipment involved. As illustrated in Figure 3, the SRV is located close to the variable leg. The leaked gas raises the variable leg temperature quickly, evaporating the water therein. Another point to note is that the water level of Channel B decreases faster than that of Channel A. The reference leg of Channel B has a routing path of about 3m in the circumferential direction near the PCV penetration. The water in this portion of piping evaporates at high temperatures, causing a faster level decrease in the upper portion. This is also different from the data observed. Such difference is not seen in the base case, in which the leak position was located high in the PCV. These findings suggest that the main leak position from the RPV to D/W will be, if based on the estimated accident progression scenario, somewhere in the upper part of the PCV.

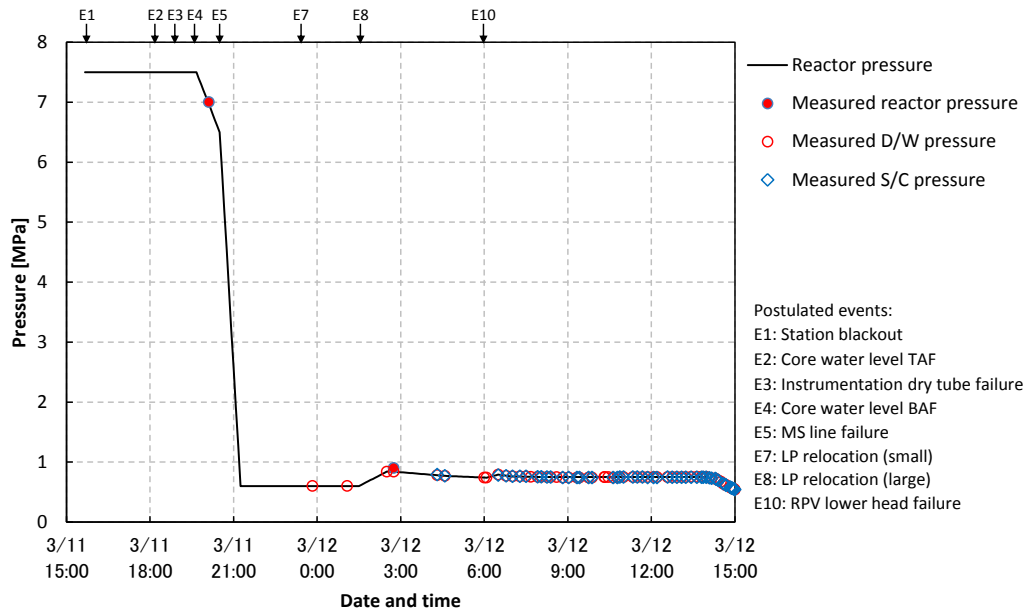
Reference Figure 1 Setting of reactor pressure changes

Reference Figure 1 explains how the reactor pressures were set in the current analysis. The reactor pressures from the time of station blackout till 19:40 on March 11<sup>th</sup>, when the reactor water level was lowered to the level BAF, were set as constant at 7.5MPa[abs] for simplicity by assuming that the reactor pressure was maintained at the pressure setpoint of the SRV safety function. The reactor pressure was assumed to decrease gradually to about 7MPa[abs], the measured pressure at 20:07, because, once the water level reached BAF, evaporation in the core was reduced and leakage through the instrumentation line took place. It was further assumed that a leak had occurred at 20:30 from the main steam line and, by 21:15, the pressure had decreased to 0.6MPa[abs] (the PCV pressure measured at 23:50). Thereafter, it was assumed that the pressure had shown only a small change for a while followed by an increase to 0.84MPa[abs] by 02:30 on March 12<sup>th</sup> as a result of debris relocation to the lower plenum in a large amount at 01:30, and then it accompanied the PCV pressure. The timings of the leak from the main steam line, ending of depressurization and debris relocation in a large amount to the lower plenum, respectively in the above transition, were decided through the preliminary analysis.

Some other analyses have reported that, upon the debris relocation in a large amount to the lower plenum, the reactor pressure showed a sharp increase [3][4][6][7]. But the current analysis did not consider such a pressure increase because of its large uncertainties<sup>3</sup>.

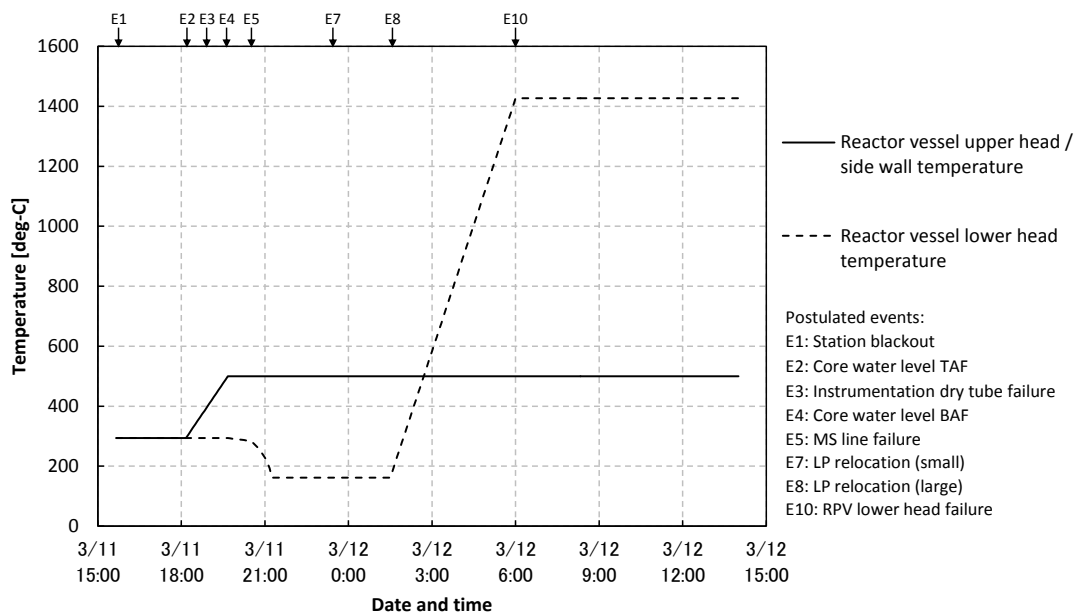
Reference Figure 2 RPV inner wall temperatures

Upon the station blackout, the D/W coolers stopped and the D/W temperatures increased gradually by heat being transferred through the heat insulation material between the RPV wall and D/W atmosphere. Reference Figure 2 shows the RPV inner wall temperatures set in the current analysis. Until 18:10 on March 11<sup>th</sup>, the reactor water level was above TAF. Therefore, the RPV inner wall temperatures were set as the saturation temperatures corresponding to the RPV pressures. Thereafter, the inner wall temperatures above the reactor water level would increase due to superheated steam or heat radiation from the core. In the current evaluation, reference was made to the MAAP analysis results [3][4] and the RPV side wall temperatures after 19:40 above the lower plenum were assumed as 500 deg C, while from 18:10 to 19:40 they were linearly interpolated. Concerning the lower plenum inner wall, its temperatures were set as the saturation temperatures corresponding to the RPV pressures set above, until 01:30 on March 12<sup>th</sup>, when the debris relocation in a large amount was estimated to have occurred. After that, the lower plenum temperatures were considered to increase due to the molten debris leaked in. Reference was made to the analysis results [5], and the lower plenum temperatures were assumed to increase linearly

up to 1700 deg K, the melting temperature of stainless steel, till 06:00, when the RPV lower head failure was assumed, and they remained at that temperature thereafter. The heat transfer coefficients of insulation materials were estimated from the heat transfer from the reactor under the normal reactor operation conditions.

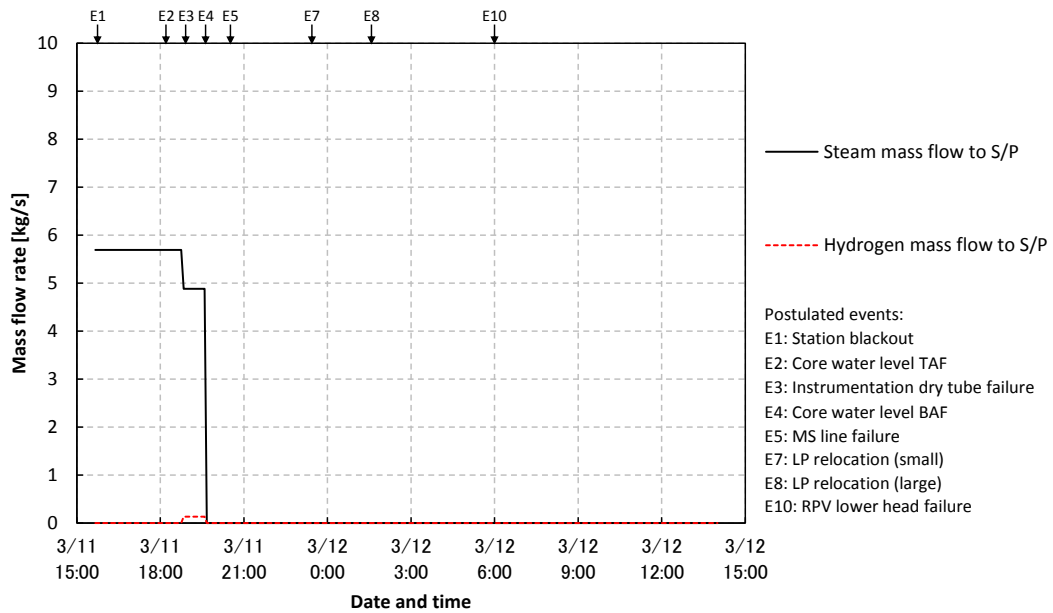
Reference Figure 3 Gas flow rates from SRV

Reference Figure 3 illustrates gas flow rates to the S/C through the SRV that were set in the analysis. It was assumed that the water inventory between BAF and the level at the station blackout (close to the level at normal operations) had flowed out as steam at a constant flow rate over about a 4 hour period to 19:40 on March 11<sup>th</sup>. The leakage rate through the instrumentation line assumed after 18:50 (described later) was subtracted from the steam flow rate above. Hydrogen gas generation was assumed to have started at 18:50 and 400kg of hydrogen gas, half of the total hydrogen gas assumed as having been generated, was assumed to have flowed out at a constant rate through the SRV during 50 minutes till 19:40. This assumption of 50% release of the total hydrogen gas generated was based on the MAAP analysis finding [3][4] that about 60% of the total hydrogen gas was generated before depressurization and the remaining 40% was generated during it. The discharged gas temperatures were assumed to be the saturation temperatures at the corresponding pressures. It should be noted that the temperatures of gas discharged to the S/C have little influence on the analysis of water level in the water level indicator lines.

It should be noted that when integrated, the steam leak rates in Reference Figures 3 to 5 is equal to the water inventory in the RPV (excluding the water in the recirculation loop line) at the time of the station blackout.

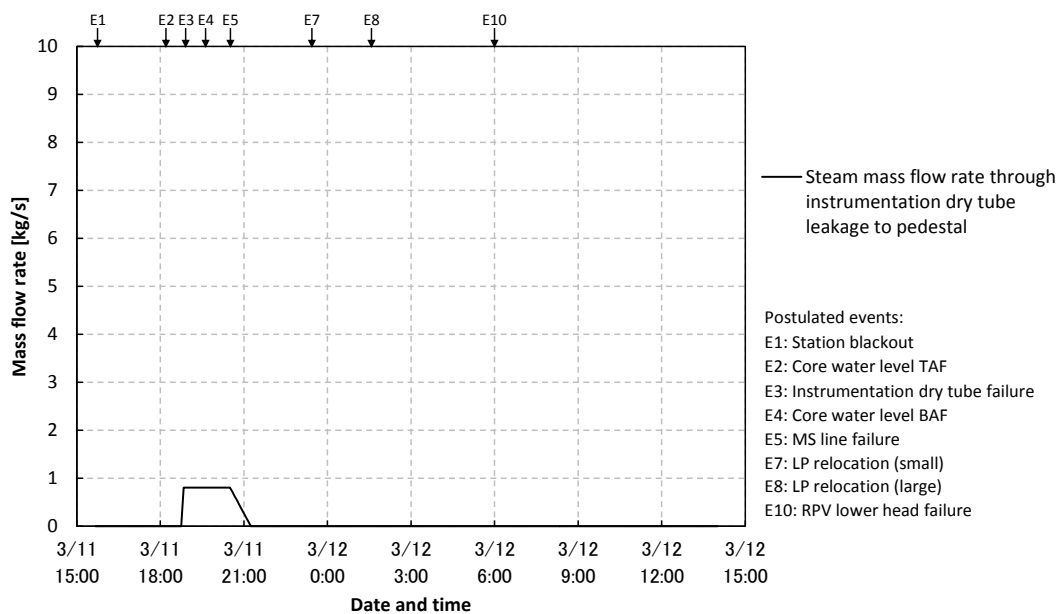
Reference Figure 4 Leak rates through instrumentation line

Reference Figure 4 illustrates the mass leak rates to the pedestal through the instrumentation line that were set in the analysis. The leak through this line was assumed only as steam and hydrogen gas was assumed to flow out only through the SRV. The steam mass generated upon depressurization was obtained in the following equation.

The SRV was assumed to have closed at 19:40 on March 11<sup>th</sup>, when the reactor water level was estimated to have decreased to BAF, and then steam was assumed to have

leaked through the instrumentation line, depressurizing the reactor from 7.5MPa[abs] at 19:40 to 7.0MPa[abs] at 20:07. Thus, the amount of evaporation was estimated at about 1,300kg from Equations (1) and (2). This led to the average leak rate of about 0.8kg/s. This leak rate was assumed to remain constant for simplicity from 18:50, when the leak through the instrumentation line was assumed to have started, to 20:30, when the leak from the main steam line was assumed to have started. Thereafter, until 21:15, when the leak from the instrumentation line was assumed to have stopped, the leak rate was assumed to have decreased linearly. The leaked gas temperatures were assumed to be the saturation temperature at the RPV pressure estimated. This was based on the deliberation that the leaked gas would be cooled down by the reactor water around the instrumentation line.

Equations (1) and (2), from which, by subtracting the leak amount through the instrumentation line shown in Reference Figure 4, the steam amount leaked through the main steam line was estimated at about 20,000kg. In order to simulate the leak rate changes responding to the rapid pressure decrease, the leak rates were assumed to have decreased linearly from the value at 20:30 when leaking began to the value at 21:15, while the total leaked amount was kept at the volume estimated above (20,000kg). In the meantime, 400kg of hydrogen out of the estimated total hydrogen gas generated (800kg) was assumed to have leaked to the D/W. The steam generated upon depressurization is heated up as it goes through the core or downcomer, and therefore the leaked gas temperatures from the main steam line become more or less elevated. But the temperatures have big uncertainties. In consequence, a fixed temperature of 600 deg C was set as the leaked gas temperatures, since this value reproduced the observed values best in the preliminary analysis.

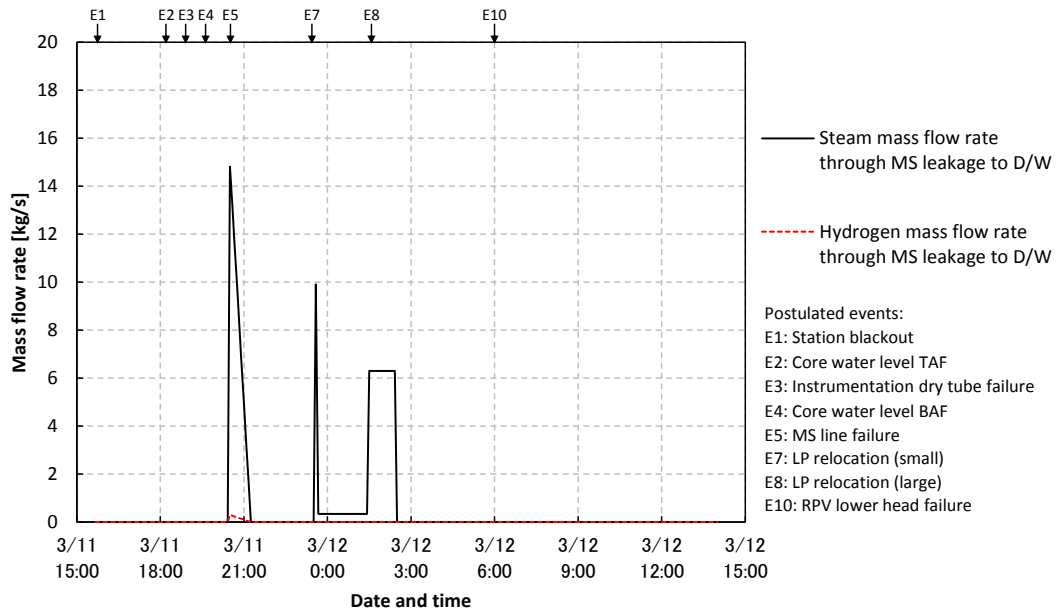
Reference Figure 5 Leak rates at the main steam line

Reference Figure 5 illustrates the leaked gas flow rates to the D/W through the main steam line that were set in the analysis. The leaks occurred mainly in three phases: flashing upon depressurization from 20:30 on March 11<sup>th</sup>, when the main steam line was damaged, till 21:15; steam generation upon debris relocation in a limited amount (set at 23:30 based on the preliminary analysis); and steam generation upon debris relocation in a large amount at 01:30 on March 12<sup>th</sup>. The leak rates during each time period were set as explained below.

The leak rates from 20:30 to 21:15 on March 11<sup>th</sup> were set as follows. The amount of evaporation while the pressure was lost from 7.5MPa[abs] to 0.6MPa[abs] was evaluated by

At the time of molten debris relocation in a limited amount to the lower plenum at 23:30, part of the whole core was assumed to have moved to the lower plenum as molten debris. When relocating, the debris was assumed to be quickly cooled in fine grain forms. The amount of water evaporation in the lower plenum was estimated by dividing by latent heat of evaporation the calorific heat of debris (2500 deg K in molten state and 300J/kg-K as specific heat were assumed) being cooled down to the saturation temperature at 0.6MPa[abs]. The molten debris is quickly cooled in about 10 minutes, and thereafter till 01:30 on March 12<sup>th</sup>, mild evaporation due to decay heat was assumed to continue. According to the preliminary analysis about 7% of the whole molten core (10,000kg) was assumed to move to the lower plenum as molten debris. The leakage gas temperature was assumed to be constant at 450 deg C.

At the time of debris relocation in a large amount at 01:30 on March 12<sup>th</sup>, all of the residual molten material in the core was assumed to relocate to the lower plenum. From this relocation, all the residual water in the lower plenum was assumed to evaporate by 02:30 and its evaporation rate was set as the average rate over the time period. The temperature of leaked steam was assumed to be the saturation temperature at the corresponding reactor pressure. This was because the generated steam was considered as not easily heated up until it reached the leak outlet, because all molten fuel relocated to the lower plenum.
