Rising trend in accumulated water levels in the northeastern area of the Fukushima Daiichi Unit 3 reactor building (Continued report II)

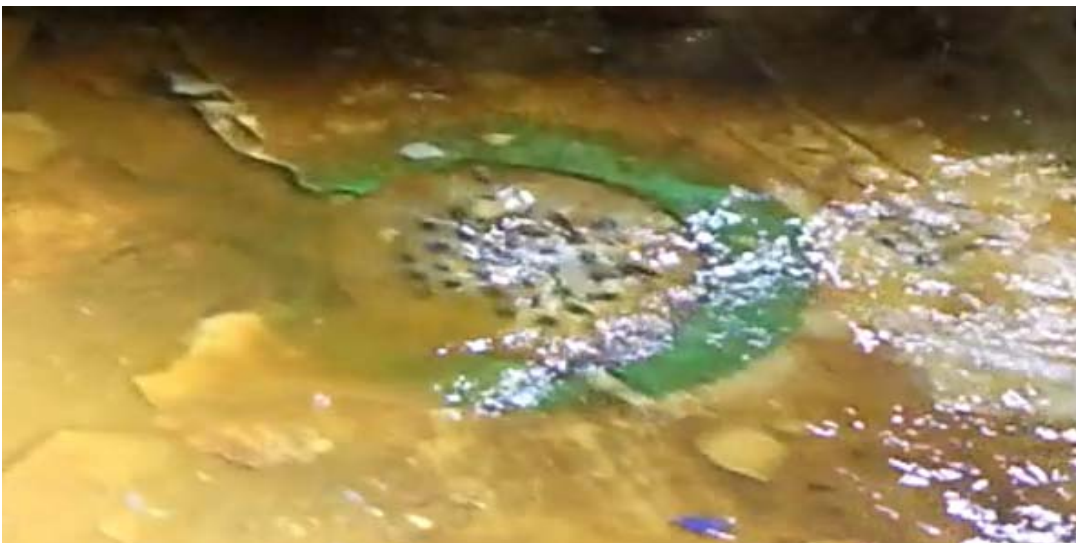
Water flowing again through cleaned funnels
(Water is flowing into the southeast
triangular corner of the subfloor)

(Already announced on March 10)
- In conjunction with the increase in water level in the aforementioned area, a field investigation of the first floor of the Unit 3 reactor building was conducted yesterday (March 10) around 8:30 AM. In the past we have found water from inside the primary containment vessel (PCV) leaking through the first floor main steam isolation valve (MSIV) into two funnels on the north side and flowing into the southeast area (southeast triangular corner). However, the results of this investigation found that the aforementioned two funnels are clogged thereby forcing water to flow into the stairwell on the northeast side of the reactor building. The aforementioned funnels were cleaned thereby allowing water to flow through them and we confirmed thereafter that the level of accumulated water in the southeast triangular corner of the subfloor, which is where the water from the aforementioned funnels flows to, is quickly rising while the level of accumulated water in the northeast triangular corner has stopped rising and is now showing a downward trend.

○ Thereafter, temporarily installed pumps were used at noon today to pump accumulated water out of the northeast triangular corner of the subfloor. We will continue to watch water levels and pump water out as necessary if funnels clog.

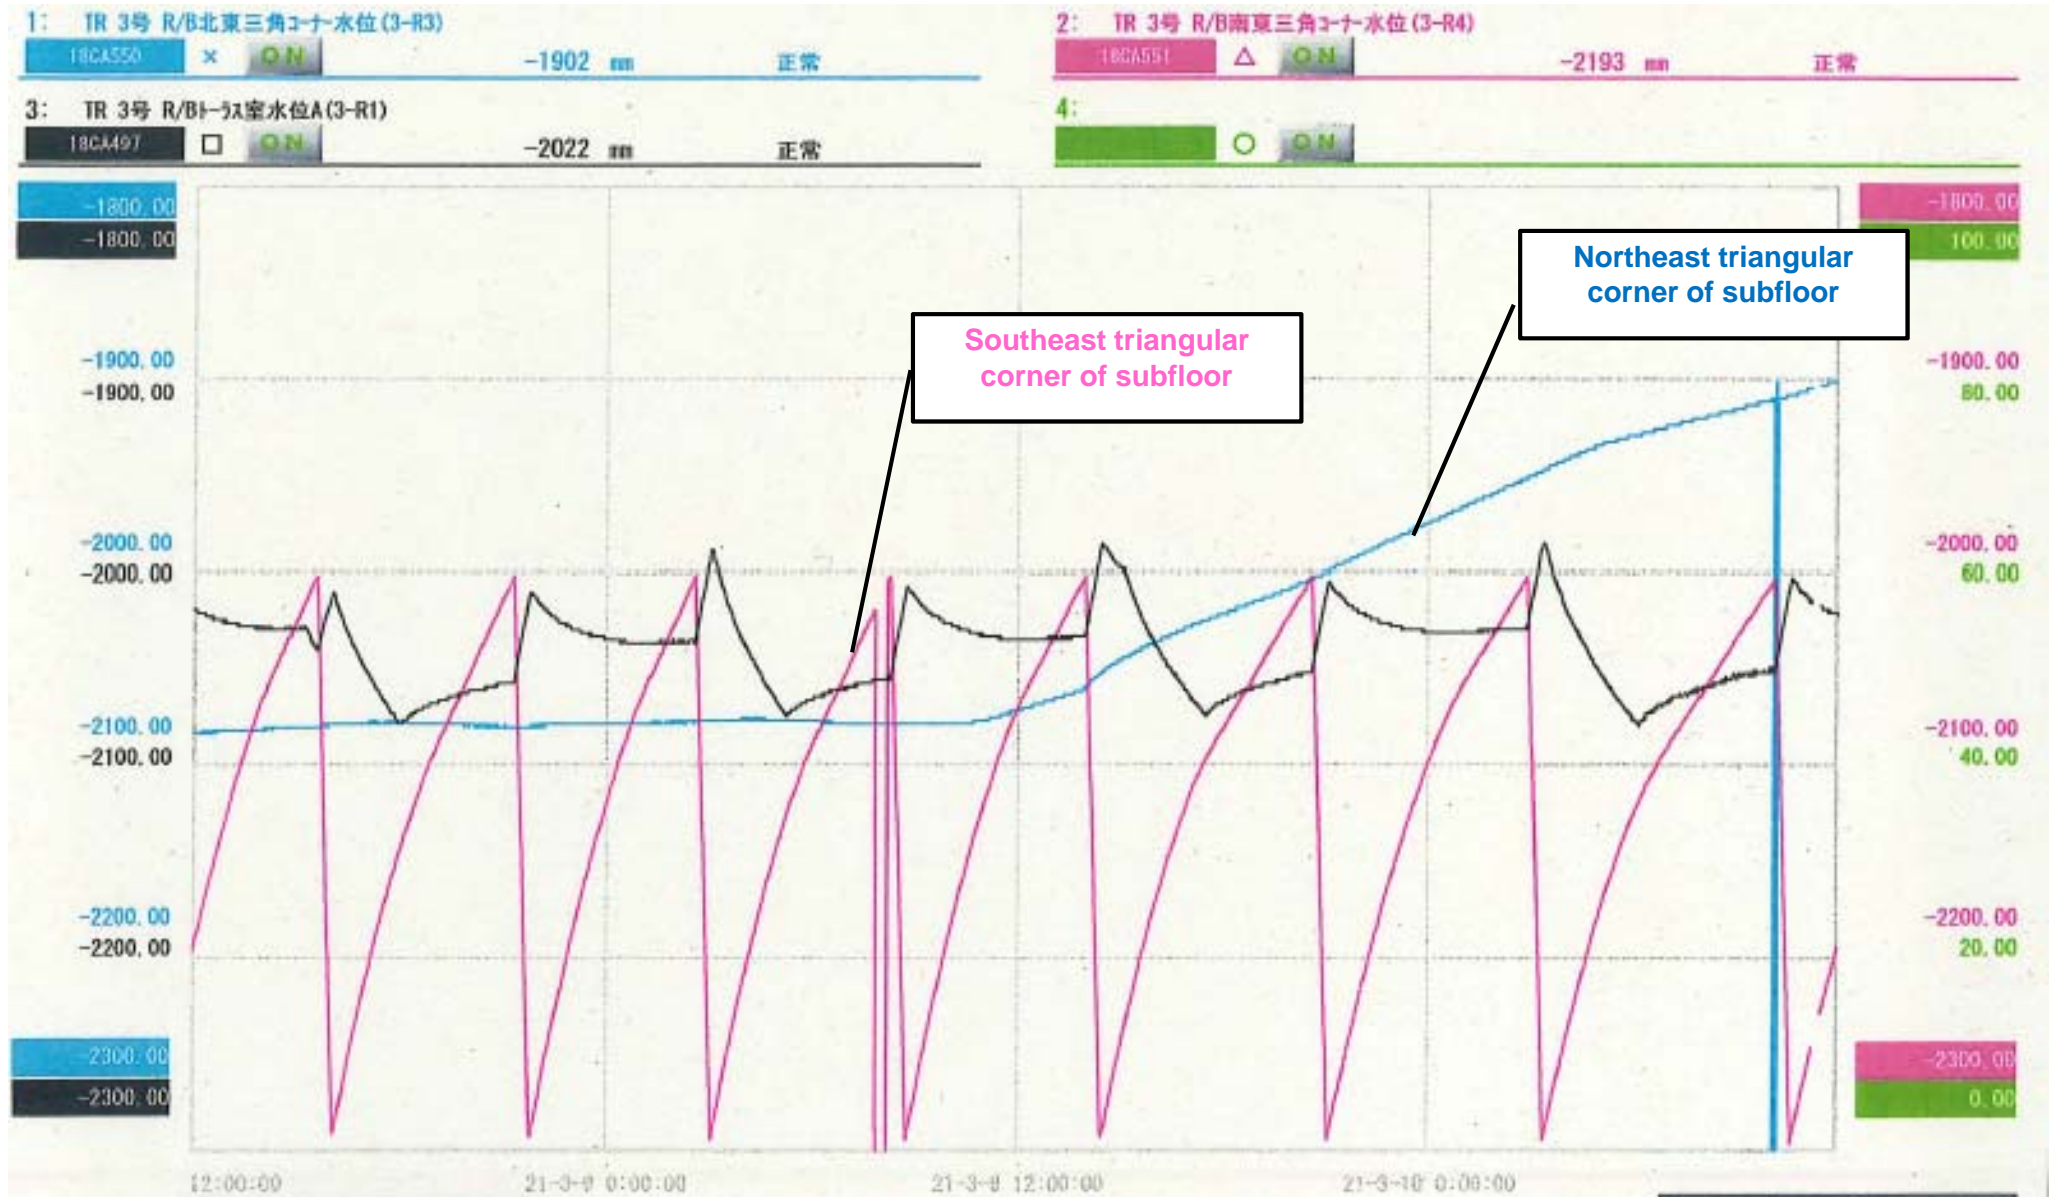
Water levels (Since March 10)

- The water level of accumulated water in the northeastern area (northeast triangular corner) of the first subfloor of the Unit 3 reactor building had remained stable at approximately TP -2,100mm as of 10:00 AM on March 9. However, around 10:30 AM on the same day, the water level started to rise and it was confirmed to at approximately TP -1,916mm as of 9:00 AM on March 10.

Northeast triangular corner of subfloor: Approximately TP -2,092mm

○ The rising trend that was observed in the level of accumulated water in the northeast triangular corner has started to decrease and as of 9 AM on March 11 the difference with sub-drain water levels was being maintained at approximately 1,400mm. (as of 3 PM: Approximately TP -1,500mm)

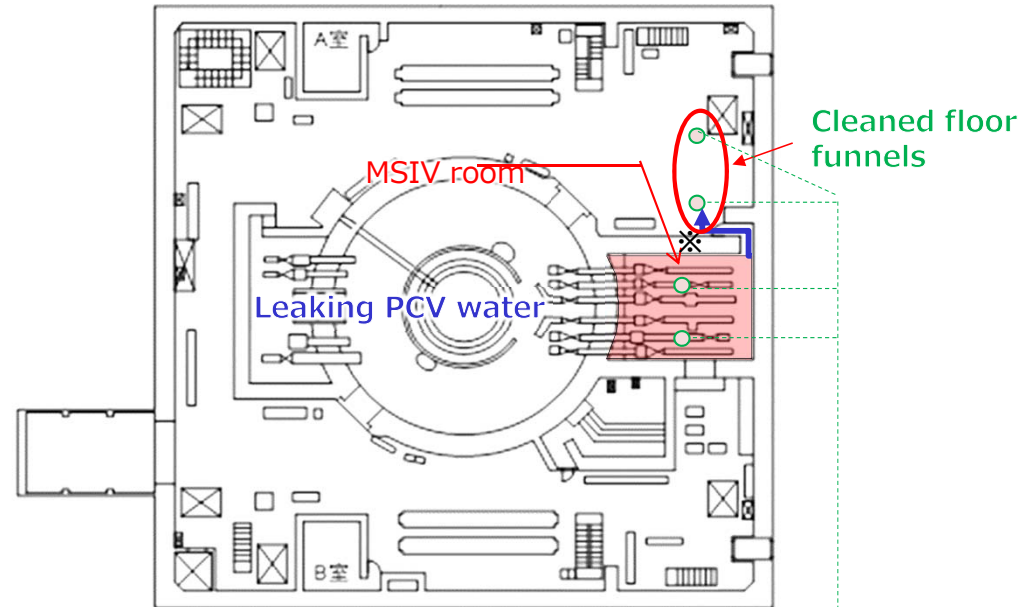
(Reference) Unit 3 reactor building (Floor diagram)

※Some water is leaking to the funnel outside the MSIV room
B1FL
