Detailed Analysis Results in the Port of Fukushima Daiichi NPS, around Discharge Channel and Bank Protection (Sampling Locations of Underground Water Obtained at Bank Protection)

Detailed Analysis Results in the Port of Fukushima Daiichi NPS, around Discharge Channel and Bank Protection (1/4)
Underground Water Obtained at Bank Protection

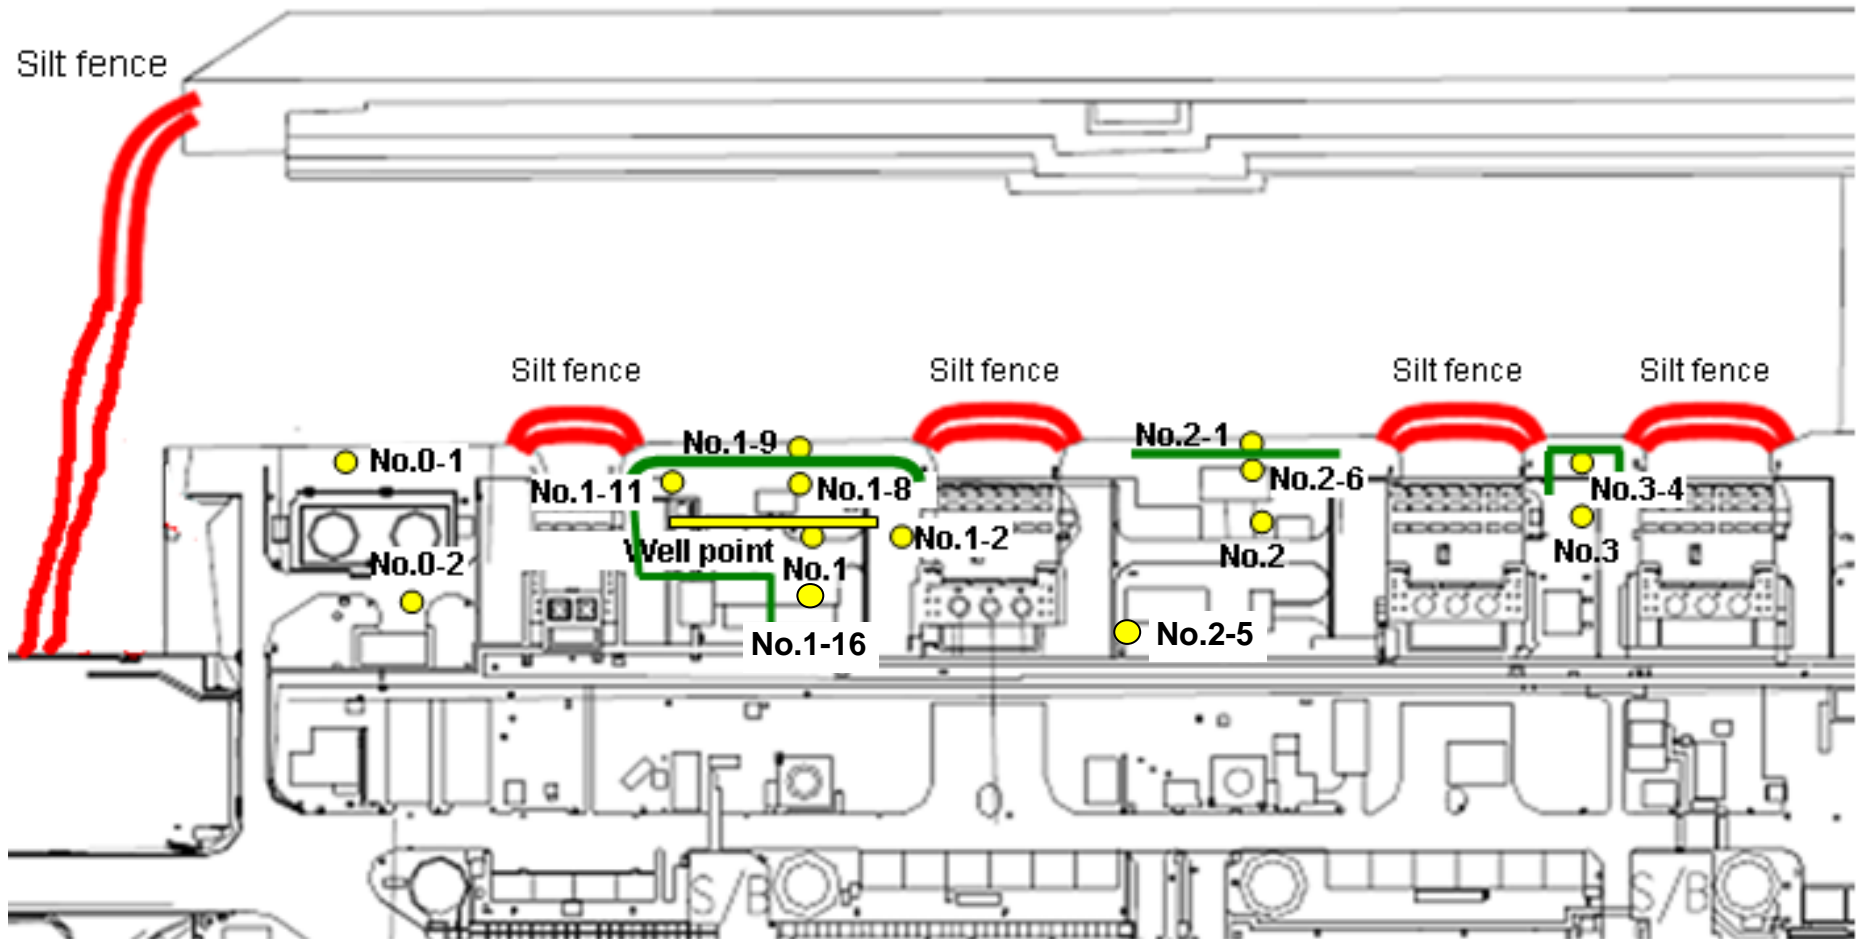
● Sampling locations of underground water obtained at bank protection

East seawall break

— : Location where ground improvement work was completed, or being implemented (as of September 27)
