West Gate of Fukushima Daiichi Nuclear Power Station  
Results of Dust Nuclide Analysis (Bq/cm<sup>3</sup>)

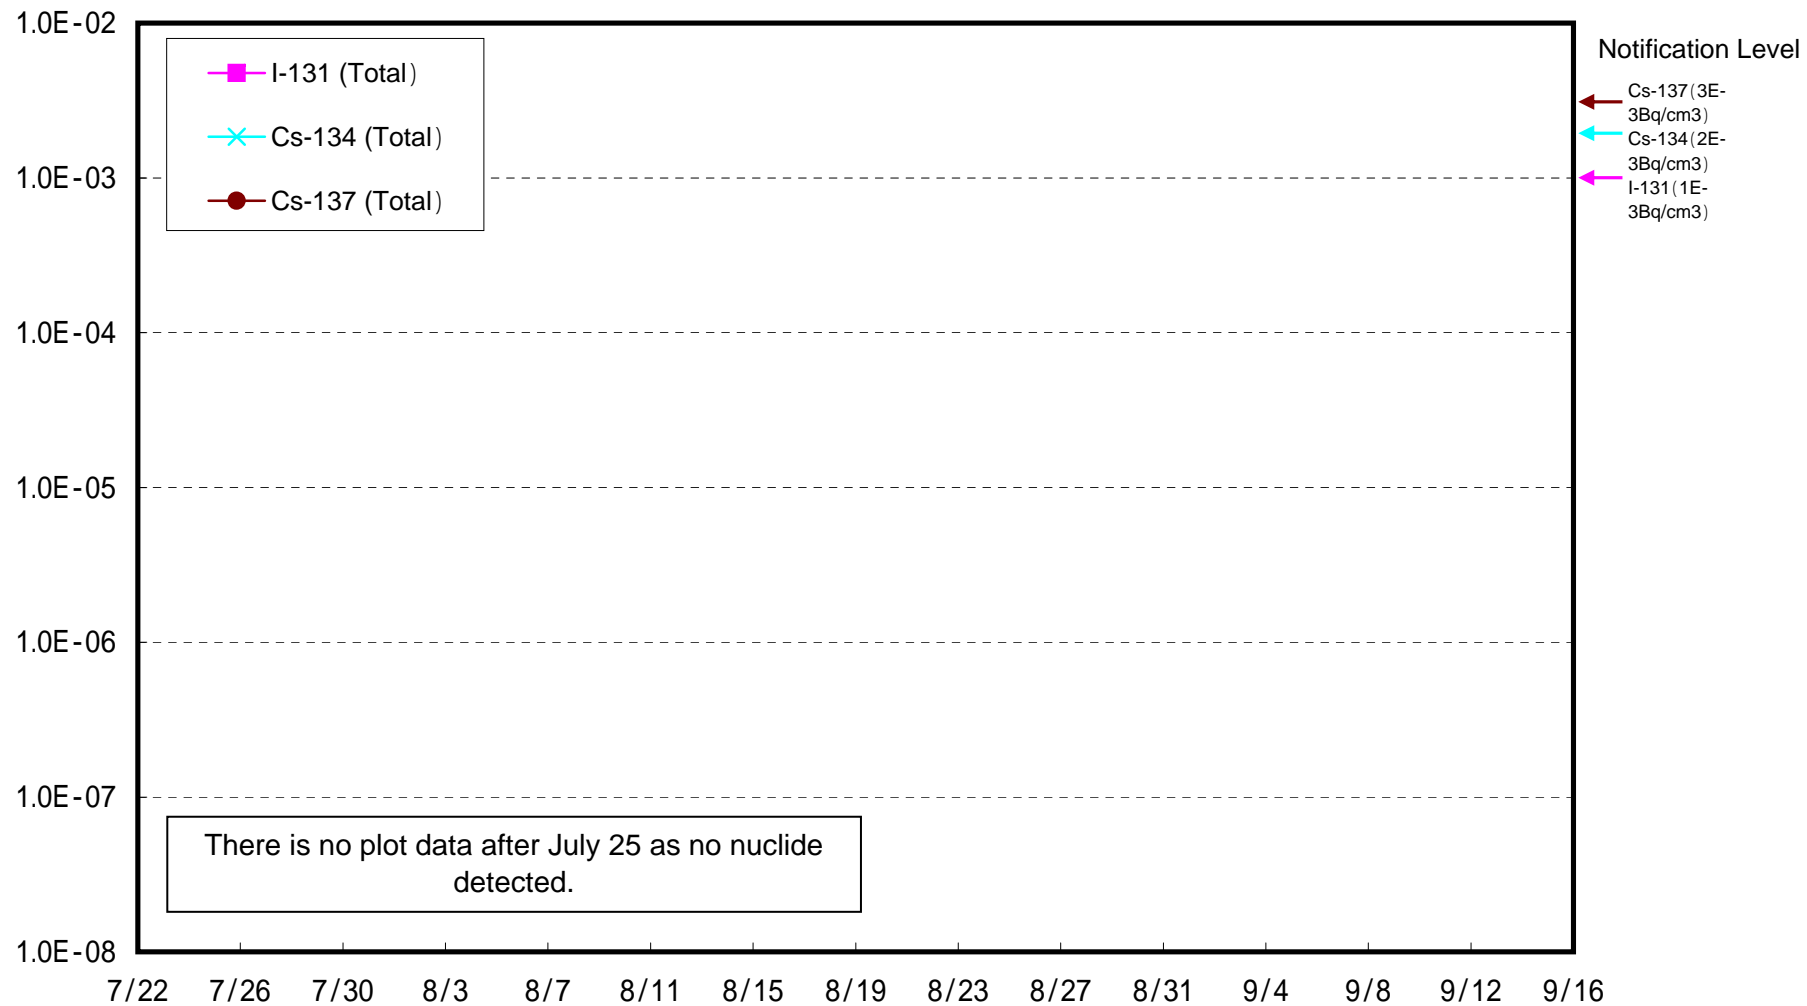
Environment Monitoring Building of Fukushima Daiichi  
Results of Dust Nuclide Analysis (Bq/cm<sup>3</sup>)

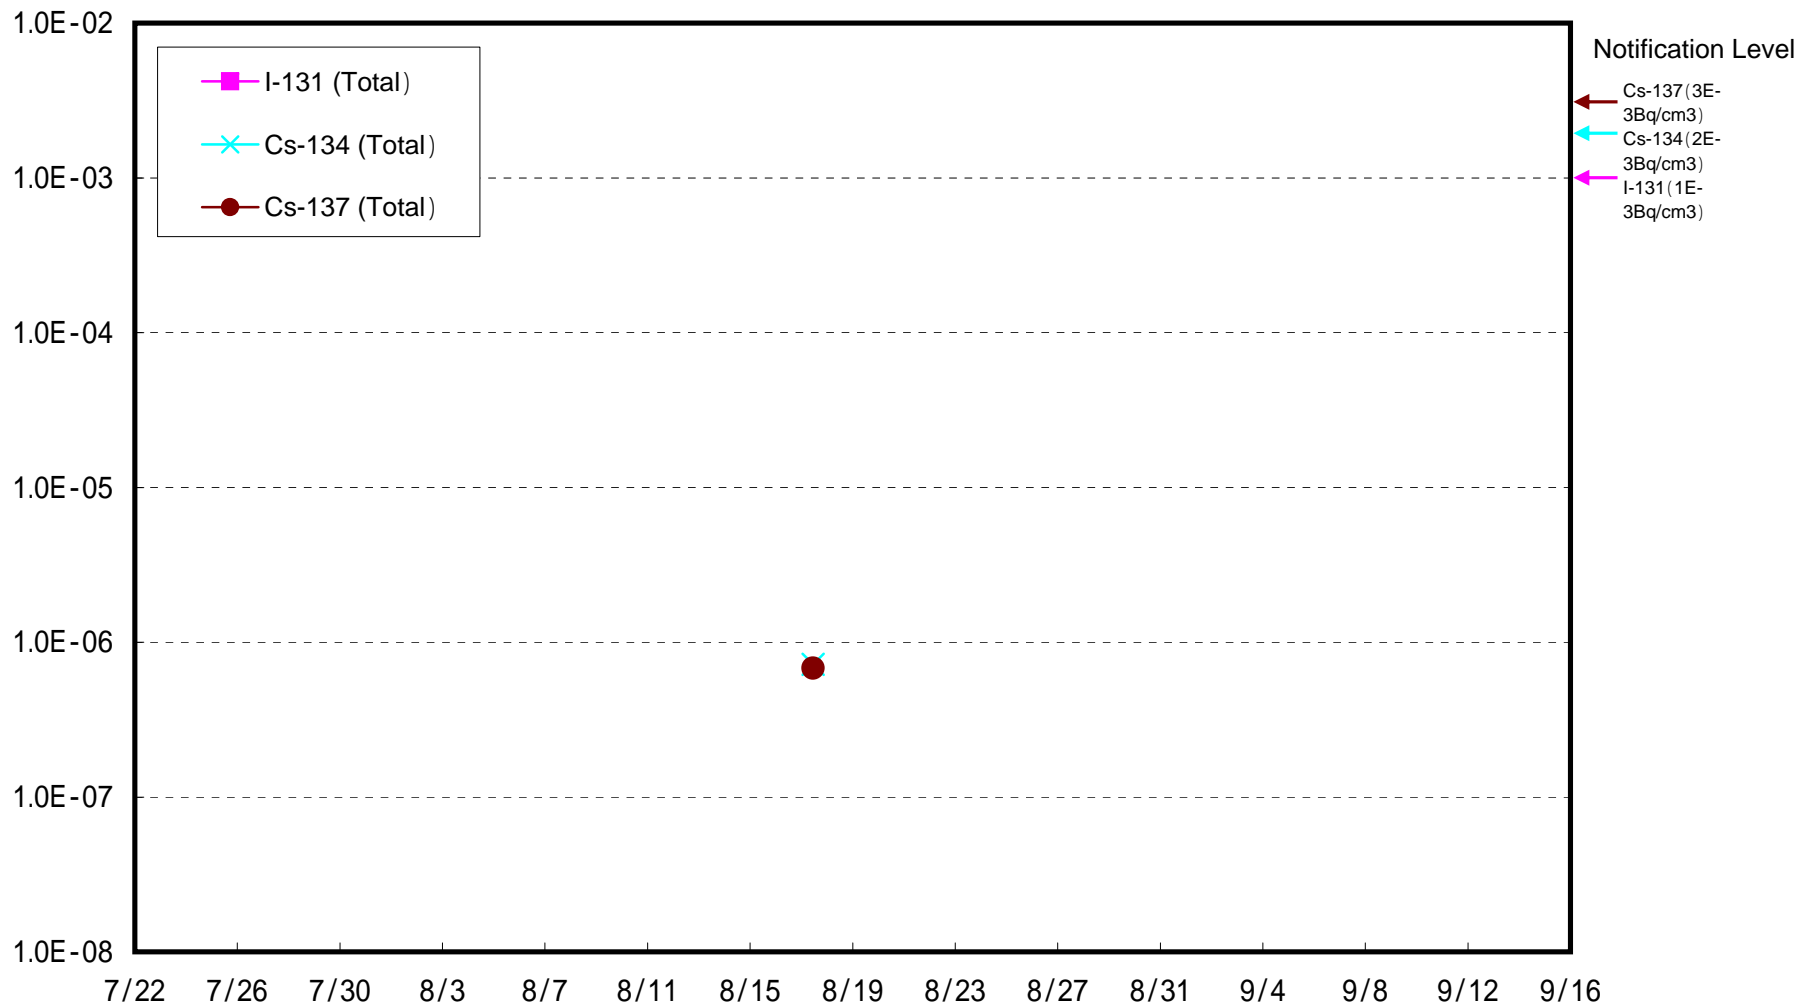
Water Treatment Building of Fukushima Daiichi  
Results of Dust Nuclide Analysis (Bq/cm<sup>3</sup>)
