Estimation of accident progression based on the data measured for Unit-1 and the analyses available to date

* This document is generated based on the proposal and evaluation by TEPCO Systems Corporation [1] concerning the changes of water level indicator readings (Unit-1/Issue-3) in Attachment 2 “List of issues”.

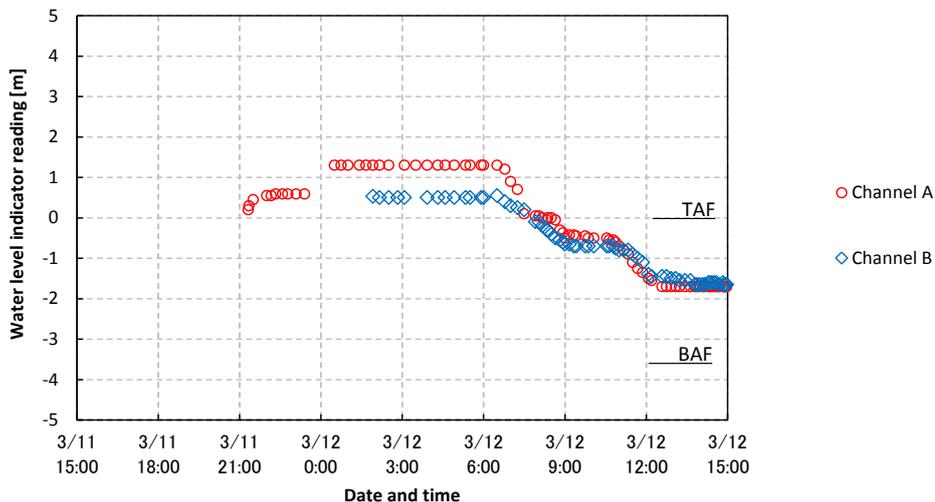
Figure 1 Fuel range water level indicator readings

Figure 1 shows the fuel range water level indicator readings from the station blackout till about 24 hours later. The water level indicator (Channel A) gave its reading of TAF+0.2m at 21:19 on March 11th, but by that time no water was being injected into the reactor which means the actual water level in the reactor was considered to have dropped below BAF by then. That is, the reading overstated the actual water level. Further, it should be noted that the readings were increasing at that time. But the only possible reason for increasing readings with no water injection into the reactor would be a decrease of the water level in the piping on the reference water chamber side (reference leg). From these deliberations the water level in the reference leg was considered to have largely dropped by this time and that it was further decreasing.

At around 21:30 the increase in the readings became slower and eventually stopped at 22:20 and stayed constant at TAF+0.59m till 23:24. In other words, changes in conditions to cause the water level decrease in the reference leg probably ceased by around 21:00 to 22:20 (a ground for Event E6 in Table 1). Thereafter at 00:30 on March 12th, the reading rose to TAF+1.3m and stayed there till around 06:00. The water level indicator readings at this time coincided roughly with the value for the situation in which the water level in the reference leg drops to the elevation of the PCV penetration, while the piping on the reactor side (variable leg) is almost completely filled and the reactor water level is below the connection part of the variable leg. Thereafter, the readings were gradually lowered to TAF-1.7m by around 12:00 and stayed there. The reading at this time coincided roughly with the value for the situation in which the water in the variable leg is completely lost by evaporation. Meanwhile, the PCV temperature measured on March 21st was about 400 deg C [2]. At this temperature the water in the water level indicators was likely to have completely evaporated. In addition, the water level indicator readings were almost constant by that time. Putting these together, it would mean that no water was left in the water level indicator piping by around 12:00 on March 12th. On the other hand, the water level indicator (Channel B) had been working since 02:30 on March 12th and its reading stayed roughly constant at about TAF+0.5m till around 06:00. Its reading was about 0.8m lower than that of Channel A. This might mean that the Channel B reference leg still had water to about an 80cm height at this time. Further it could be considered that, after 06:00 on March 12th the water in the variable leg evaporated as in Channel A and that by around 12:00 water in the variable leg as well as in the reference leg was completely lost.

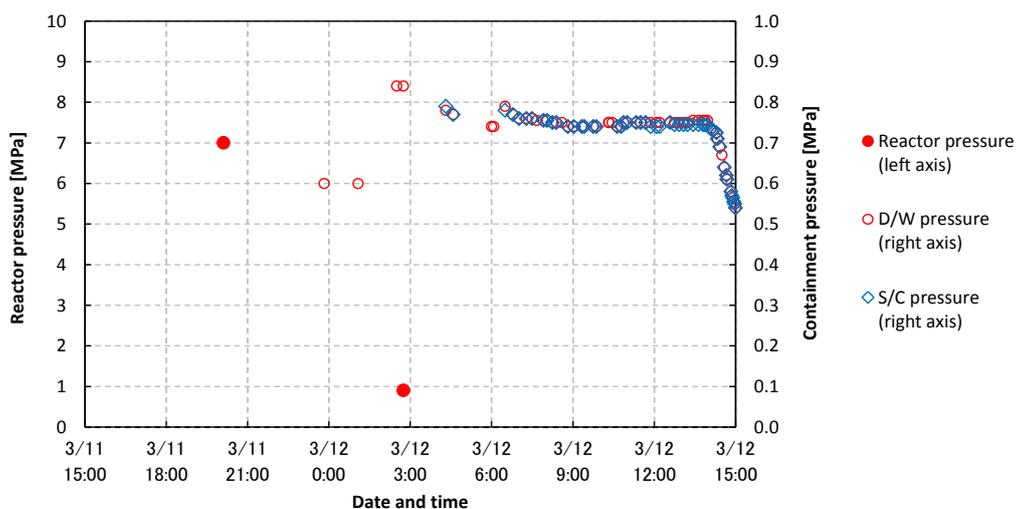
Figure 2 Measured reactor and PCV pressures

Figure 2 shows the reactor pressures and PCV pressures from the station blackout till

about 24 hours later. The measured reactor pressures were 7MPa[abs] at 20:07 on March 11th and 0.9MPa[abs] at 02:45 on March 12th. After the station blackout, the safety function of the safety relief valves (SRV) worked. The working pressure was about 7.7MPa[abs] [9]. The reactor pressure as of 20:07 on March 11th was likely to be slightly below the minimum value of the SRV working pressures. This might indicate the possibility that at this time the RPV was already leaking (Event E3 in Table 1). As possible leakage causes, in-core instrumentation line damage or line melting and main steam line damage have been suggested [3][4][5][6].

The measured PCV pressures were 0.6MPa[abs] at 23:50 on March 11th and 01:05 on March 12th. Such pressures cannot be reached without leakage from the RPV to the D/W, as explained below in Section 2.2, i.e., leakage from the RPV to the D/W seems likely to have occurred by 23:50 on March 11th. Later at 02:30 on March 12th the measured PCV pressure was 0.84MPa[abs], which roughly balanced with the RPV pressure of 0.9MPa[abs] at 02:45 on March 12th. Thereafter, the PCV pressure gradually decreased and then to increase at around 06:00 on March 12th. In the current estimation, the RPV lower head failure was considered to have occurred at around 06:00 on March 12th, and therefore the PCV pressure increase at this time was considered to be caused by the relocation of molten debris to the PCV in the wake of RPV damage. In other words, the pressure increase prior to this time point was estimated to be caused by some other reasons, and the pressure increase at this particular period from 01:05 to 02:30 on March 12th was estimated to be caused by the large amount of molten debris relocation to the lower plenum (Event E8 in Table 1).

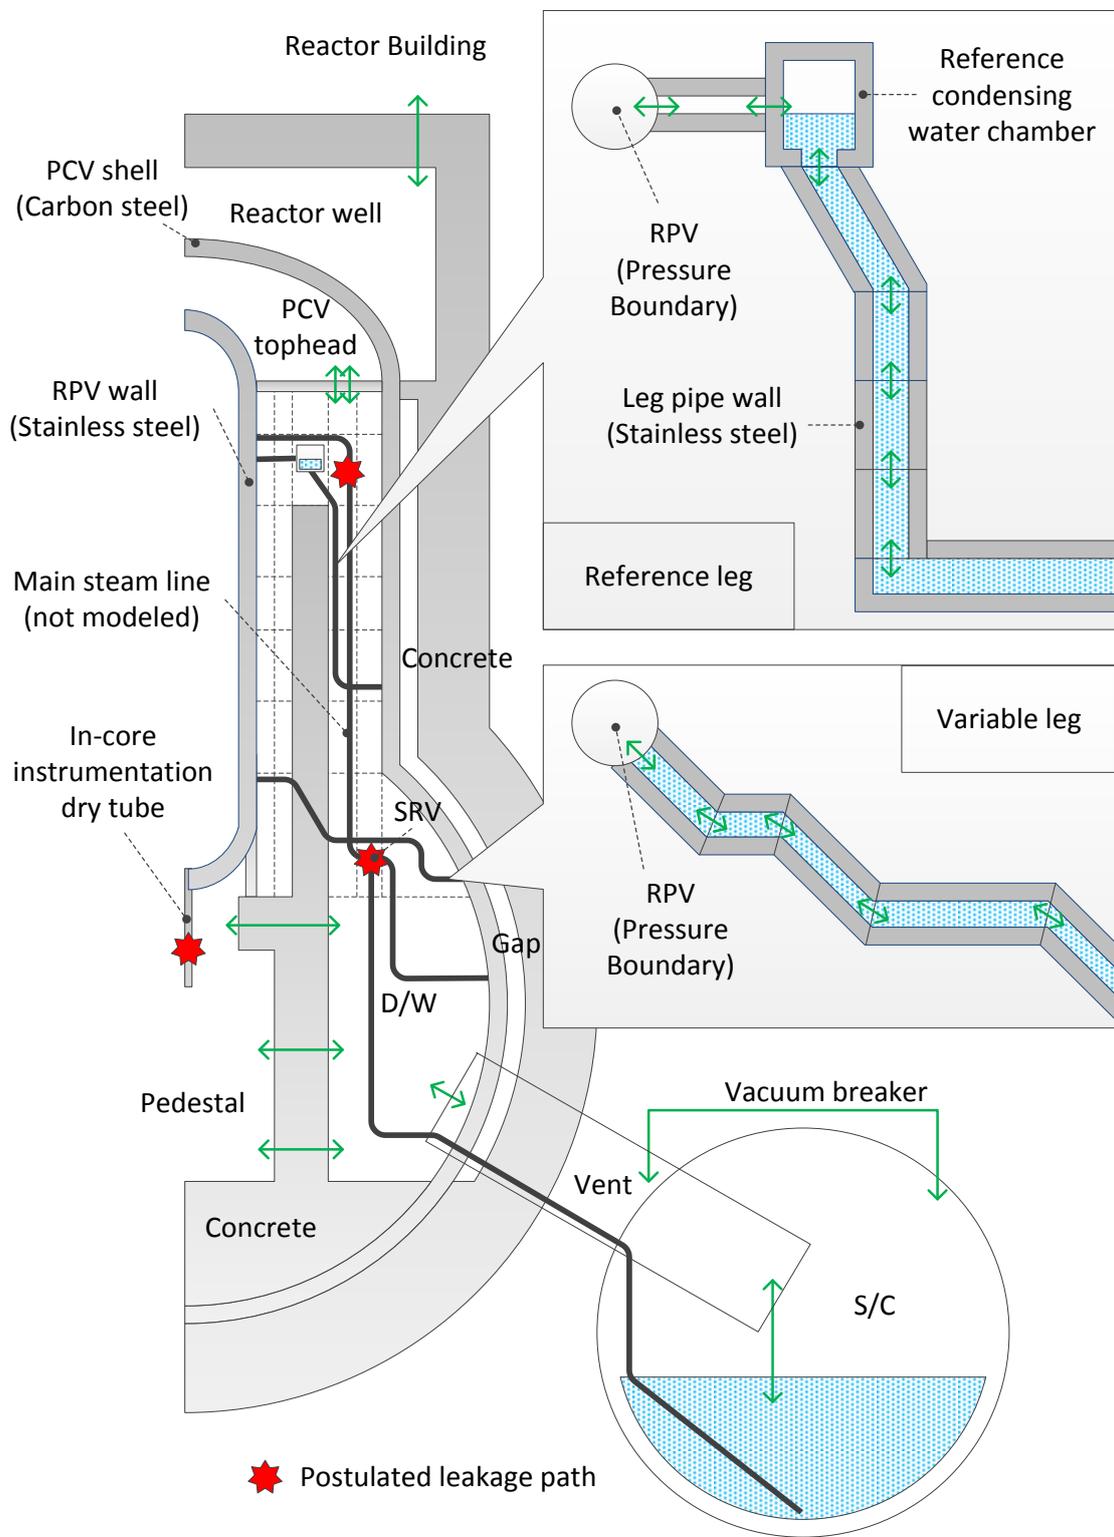
Figure 3 Geometry for analysis

Figure 3 shows the geometry for analysis¹. The water level indicator line and PCV were modeled in several regions, flow paths (arrows) and heat structures (colored). Each heat structure exchanges heat with the adjacent region. The core internals in the RPV were not modeled. The temperature boundaries were the RPV inner wall and the space in the reactor building.

The water level indicator line was modeled in the PCV space as several regions and heat structures in the geometry, so that the water level changes therein due to evaporation could be simulated. The configuration was defined based on the design data. The PCV space was further divided as illustrated within the dashed lines in the figure in order to simulate temperature distribution and natural convection around the water level indicator line. This enabled simulation of the PCV temperatures as a function of elevation, etc. Although not illustrated in the figure, the regions were divided also along the circumferential direction (the direction into the page), and thus reference legs of Channel A and Channel B were separately modeled in different regions along the circumferential direction. This enabled simulation of the behavior difference in Channel A and Channel B water level indicator lines. Variable legs were modeled to the same for both channels, for simplicity.

The star marks in the figure represent the leak locations assumed in the current estimation. The leak location from the instrumentation line to pedestal corresponded to the leak in a limited amount from RPV in Table 1 (Event E3). As the location of the main leak

from the RPV, the upper side of the main steam line was assumed in the base case below in the current estimation. For comparison, the leak was assumed at the SRV position as well. It should be noted that the main steam line was not modeled in the analysis, but it is illustrated in the figure in order to help visualize positional relations in the simulation.

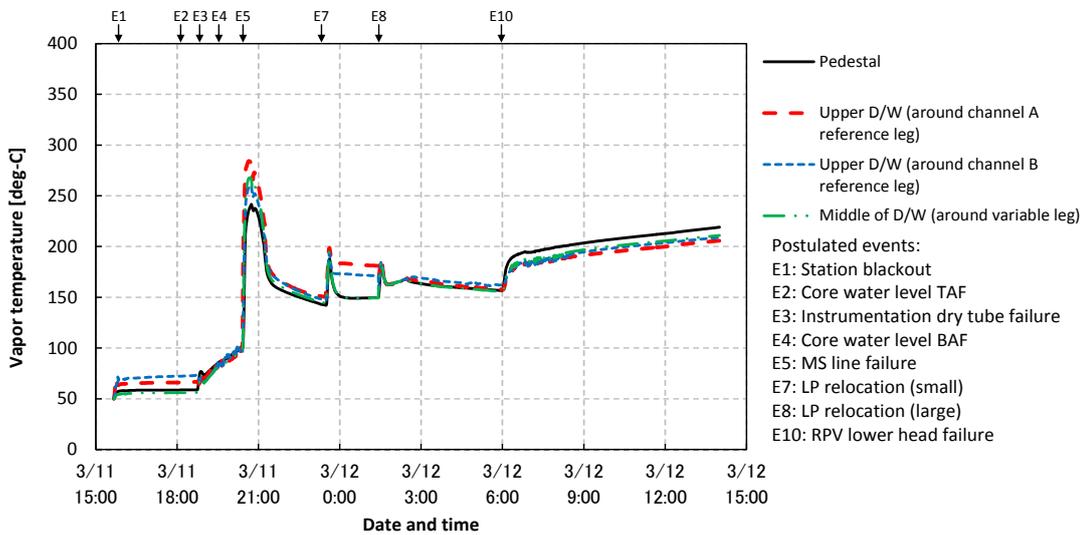
Figure 4 Temperature changes in the D/W (base case)

Figure 4 presents the analysis results of temperature changes in the atmosphere surrounding the pedestal, the upper part of the D/W (near the reference legs of Channel A and Channel B), and the central part of the D/W (near the variable legs)². The temperature increase is relatively gradual until 18:50 on March 11th, when a leak through the in-core instrumentation line was assumed. Further, even after the leak to the pedestal started, the temperature increase in the PCV atmosphere is at most about 100 deg C, not significantly high enough to evaporate water in the water level indicator line. This is because it is hard to increase the atmosphere temperature due to the low heat radiation from the RPV, the limited gaseous leaks to the pedestal, and the large heat capacity of heat structures in the PCV. Thereafter, upon initiation of large quantity, high temperature steam leaks from the main steam line at 20:30, all the PCV temperatures increase quickly. As the leaked amount decreases with time, the atmosphere temperature decreases because heat is absorbed by heat structures therein. Similar temperature changes of a spike-shape increase followed by a decrease are also noticed at 23:30 (March 11th) at the time of debris relocation in a limited amount and 01:30 on March 12th at the time of debris relocation in a big amount. Thereafter at 06:00 on March 12th, when the molten debris relocated because the RPV lower head had failed, heat from the molten debris is directly transferred to the atmosphere and it continues to increase the PCV temperatures.

Upon occurrence of leaks from the main steam line, the peak temperature of Channel A reaches a higher value than that of Channel B. The actual value of their difference is subject to the leak position. The position assumed in the current estimation was the upper side of the main steam line and it was close to the condensing water chamber of Channel B. In other words, in the analysis the leak above the Channel B piping raises the Channel A piping

temperature. This is because the high temperature leaked gas causes upward and horizontal flows of gas above Channel B piping and these gas flows raise the temperature around Channel A piping. Figure 5 shows the temperature distribution in the gas phase in the D/W at 20:35 on March 11th, when the temperatures in the gas phase in the D/W peaked. The area around the variable leg is located at a fairly lower elevation than the leak position and therefore its peak temperature becomes lower than that around the reference leg, because the high temperature leaked gas loses some heat due to the surrounding structures before flowing down to the area around the variable leg.

period remained roughly constant (see Figure 4). This comes from the balanced heat supplied from the leaked steam generated by decay heat and heat loss absorbed by surrounding structures in the PCV. The pressure increases sharply at 01:30 on March 12th, when the debris relocation in a large amount was assumed, but it does not reach 0.84MPa[abs] measured at 02:30. In the current analysis, no hydrogen generation was assumed upon the debris relocation to the lower plenum. This may have led to underestimation of the containment pressures. In another existing analysis, hydrogen was newly generated upon debris relocation [5].

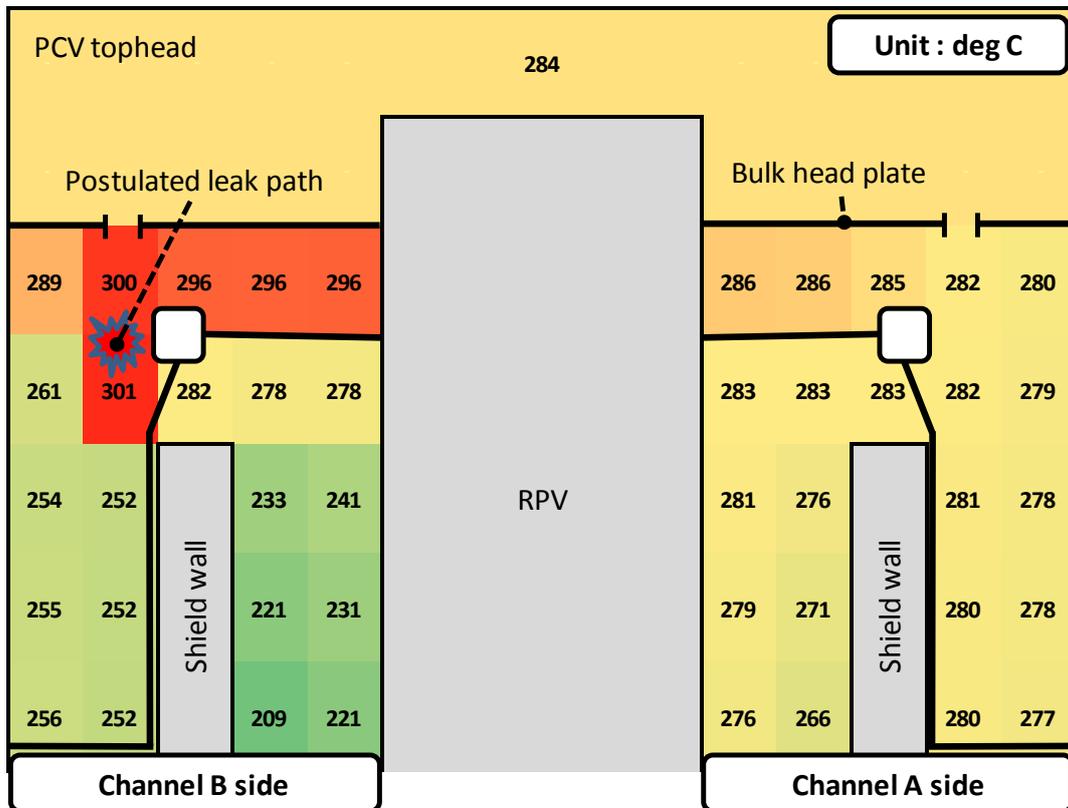
Figure 5 Temperature profile in the gas phase in the D/W at 20:35 on March 11th (base case)

temperature around Channel B is relatively lower than that of Channel A (Figure 5). At some of the timings, the water level shows a spike-shaped increase. This is because the volume fraction of gaseous phase in the horizontal portion of the piping increases due to evaporation of water therein and this raises the water level in the upper portion of the piping temporarily.

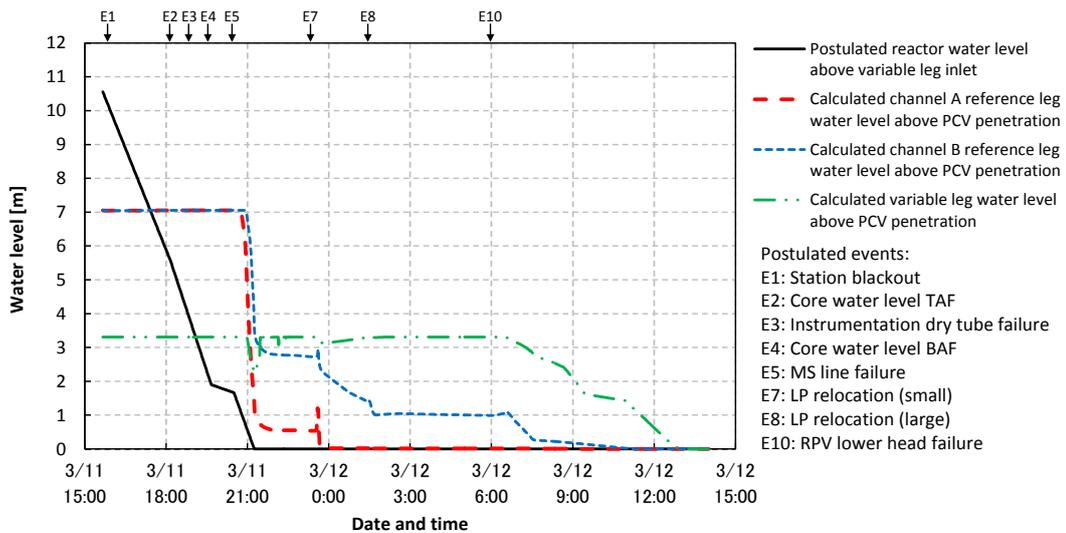
Figure 6 Water levels in the core and water level indicator piping (base case)

Figure 6 presents the postulated reactor water levels and the analyzed water level changes in the piping of reference and variable legs. The reactor water level is assumed based on the estimated accident progression. The reactor water level is assumed to reach approximately the elevation of the variable leg inlet at the timing when the RPV depressurization ended and it maintains this level until 23:30 on March 11th when the debris relocation took place in a limited amount. The reactor water level changes estimated now are used to evaluate the water level indicator readings.

The PCV atmosphere temperature increase raises the water temperature in the water level indicator lines. When this water temperature exceeds the saturation temperature, which was lowered by reactor depressurization, the water in the reference leg starts to evaporate. The temperature of the whole reference leg rises, and water levels decrease drastically by about 22:00 due to evaporation at its various parts. The water level further decreases thereafter due to the debris relocation to the lower plenum two times. Calculated water level decrease of Channel B is less than that of Channel A, because the ambient

On the other hand, the variable leg remains almost completely filled with water until about 06:00 on March 12th when the RPV lower head failure was assumed and then the variable leg water level gradually decreases until all its water is lost at around 12:00. The water level drops a few times after 21:00 on March 11th. This is due to a temporary temperature increase because of the gaseous leak from the main steam line. The water level in the variable leg recovers thereafter. This is because the temperature increase due to leaked gas is limited in time, as seen in Figure 4, the ambient temperature around the variable leg piping falls and this condenses the steam coming from the pressure boundary.

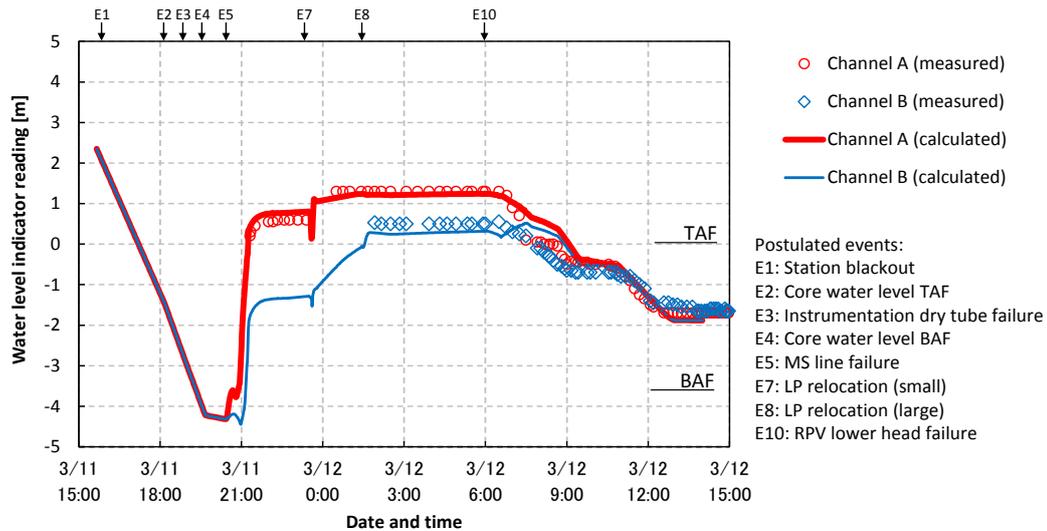
Figure 7 Comparison between water level indicator readings and water levels measured (base case)

The water level changes in Figure 6 are converted to the water level indicator readings in Figure 7 and compared with the measured values. It should be noted that the fuel range water level indicators are calibrated to the correct water level at room temperature and atmospheric pressure, and therefore its reading is different from the real water level even if the water level indicator line is filled with water. The results obtained from the analysis, based on boundary conditions set from the accident progression assumed in Table 1, can reproduce approximately the general trend of measurement results including the

difference in readings between Channel A and Channel B. The decreasing trend of readings becomes gradual at around 09:00 to 11:00 on March 12th. This time period corresponds to the timing when the water level in the variable leg was at the level of the variable leg horizontal portion. In the analysis, by modeling this horizontal portion of the water level indicator line, this gradual transition of water level indicator readings can be reproduced.

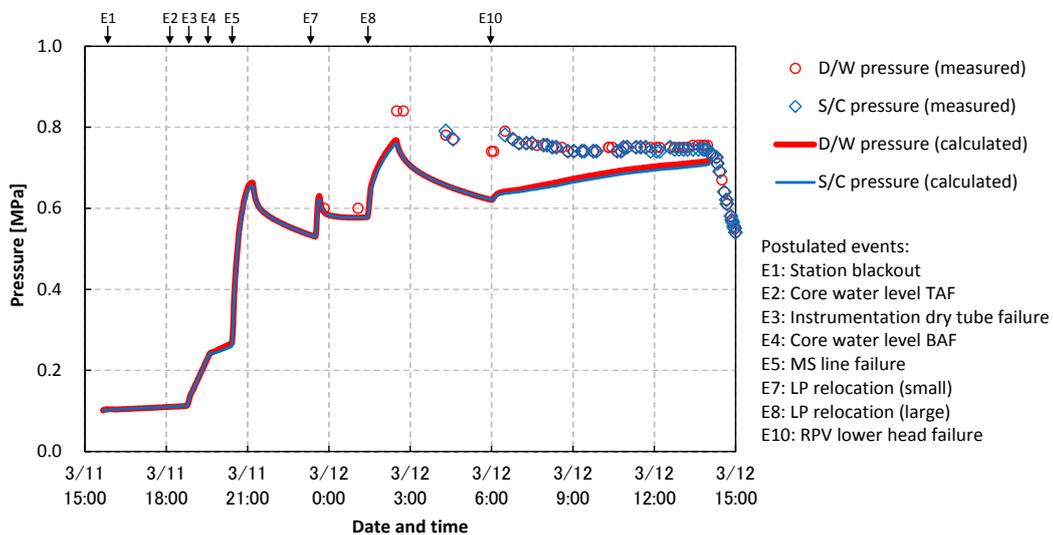
Figure 8 Comparisons between the analysis results and measured values of containment vessel pressures (base case)

Figure 8 compares the analysis results and measured values of D/W pressures and S/C pressures. In the analysis, the PCV pressures show a large increase until 21:15 on March 11th mainly due to hydrogen discharge to the S/C and steam/hydrogen mixture discharge from the main steam line. Thereafter, the pressures decrease in accordance with the ambient temperature (Figure 4). It increases again due to steam generated by the debris relocation (assumed as having occurred at 23:30) in a limited amount to the lower plenum, and then the pressures remain roughly constant due to stable steam leaks by decay heat. The pressures quickly increase after the debris relocation in a large amount to the lower plenum assumed as having occurred at 01:30 on March 12th. The pressures decrease gradually thereafter in accordance with the temperature decrease, and they turn upward due to the temperature increase of the PCV upon the debris relocation at around 06:00.

The comparison in Figure 8 shows the pressures of 0.6MPa[abs] observed at 23:50 on March 11th and 01:05 on March 12th are well reproduced in the analysis. The pressures over this time span remain roughly constant because the ambient temperature in the PCV in this

The observed pressures show an increase, by about 0.05MPa, from 06:00 to 06:30, but the pressure increase by the analysis during that time is less. If the RPV lower head was damaged and molten debris flowed out at this timing, non-condensable gas generated by the molten debris – concrete interaction (MCCI) would increase the pressure. The current analysis did not simulate the gas generation by MCCI, and this may have caused underestimation of the pressure increase. Thereafter the observed pressures remain roughly constant, while the analysis results show an increasing trend. This is probably because no leaks from the PCV were assumed in the analysis.

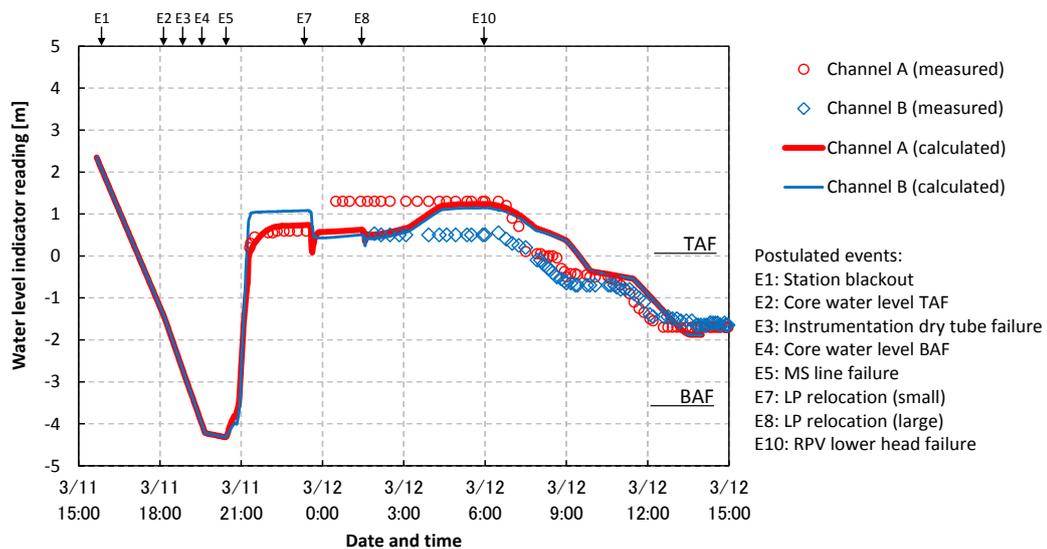
Figure 9 Comparison between the analysis results and measured values of water level indicator readings (sensitivity analysis case)

A sensitivity analysis, assuming a leak at the SRV position, was conducted in order to check the dependence of analysis results on the leak location. As the leaked gas

temperature from SRV to D/W, 620 deg C was set as a value which could reproduce well the reactor water level indicator readings of Channel A up to the time of 22:20 on March 11th. Figure 9 presents the analysis results of water level indicator readings. After the debris relocation to the lower plenum, assumed at 23:30 the water level in the variable leg falls and the analysis does not reproduce the measured levels. This can be explained by the geometric configuration of the equipment involved. As illustrated in Figure 3, the SRV is located close to the variable leg. The leaked gas raises the variable leg temperature quickly, evaporating the water therein. Another point to note is that the water level of Channel B decreases faster than that of Channel A. The reference leg of Channel B has a routing path of about 3m in the circumferential direction near the PCV penetration. The water in this portion of piping evaporates at high temperatures, causing a faster level decrease in the upper portion. This is also different from the data observed. Such difference is not seen in the base case, in which the leak position was located high in the PCV. These findings suggest that the main leak position from the RPV to D/W will be, if based on the estimated accident progression scenario, somewhere in the upper part of the PCV.

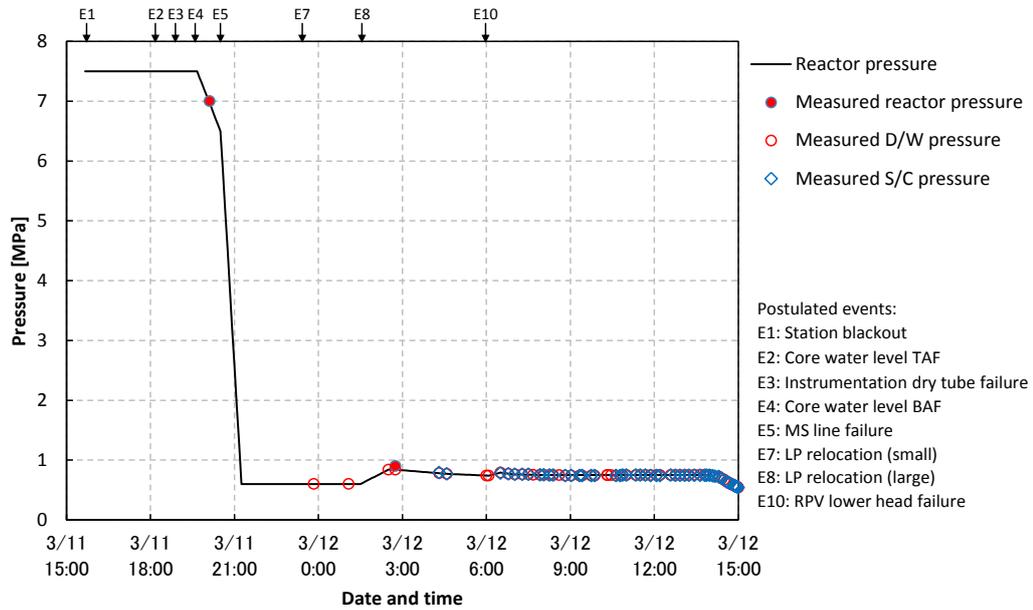
Reference Figure 1 Setting of reactor pressure changes

Reference Figure 1 explains how the reactor pressures were set in the current analysis. The reactor pressures from the time of station blackout till 19:40 on March 11th, when the reactor water level was lowered to the level BAF, were set as constant at 7.5MPa[abs] for simplicity by assuming that the reactor pressure was maintained at the pressure setpoint of the SRV safety function. The reactor pressure was assumed to decrease gradually to about 7MPa[abs], the measured pressure at 20:07, because, once the water level reached BAF, evaporation in the core was reduced and leakage through the instrumentation line took place. It was further assumed that a leak had occurred at 20:30 from the main steam line and, by 21:15, the pressure had decreased to 0.6MPa[abs] (the PCV pressure measured at 23:50). Thereafter, it was assumed that the pressure had shown only a small change for a while followed by an increase to 0.84MPa[abs] by 02:30 on March 12th as a result of debris relocation to the lower plenum in a large amount at 01:30, and then it accompanied the PCV pressure. The timings of the leak from the main steam line, ending of depressurization and debris relocation in a large amount to the lower plenum, respectively in the above transition, were decided through the preliminary analysis.

Some other analyses have reported that, upon the debris relocation in a large amount to the lower plenum, the reactor pressure showed a sharp increase [3][4][6][7]. But the current analysis did not consider such a pressure increase because of its large uncertainties³.

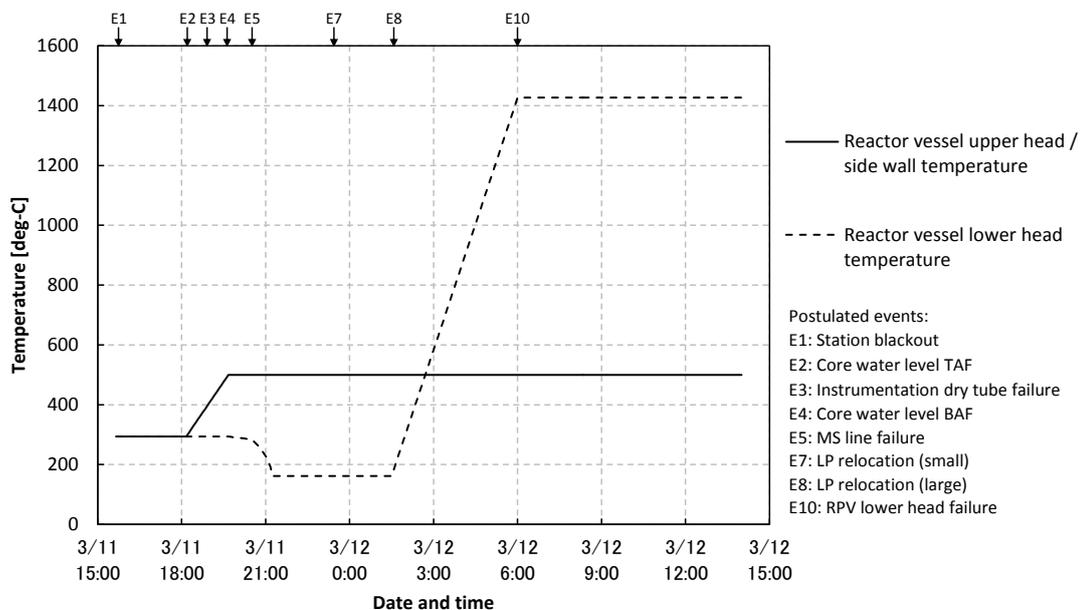
Reference Figure 2 RPV inner wall temperatures

Upon the station blackout, the D/W coolers stopped and the D/W temperatures increased gradually by heat being transferred through the heat insulation material between the RPV wall and D/W atmosphere. Reference Figure 2 shows the RPV inner wall temperatures set in the current analysis. Until 18:10 on March 11th, the reactor water level was above TAF. Therefore, the RPV inner wall temperatures were set as the saturation temperatures corresponding to the RPV pressures. Thereafter, the inner wall temperatures above the reactor water level would increase due to superheated steam or heat radiation from the core. In the current evaluation, reference was made to the MAAP analysis results [3][4] and the RPV side wall temperatures after 19:40 above the lower plenum were assumed as 500 deg C, while from 18:10 to 19:40 they were linearly interpolated. Concerning the lower plenum inner wall, its temperatures were set as the saturation temperatures corresponding to the RPV pressures set above, until 01:30 on March 12th, when the debris relocation in a large amount was estimated to have occurred. After that, the lower plenum temperatures were considered to increase due to the molten debris leaked in. Reference was made to the analysis results [5], and the lower plenum temperatures were assumed to increase linearly

up to 1700 deg K, the melting temperature of stainless steel, till 06:00, when the RPV lower head failure was assumed, and they remained at that temperature thereafter. The heat transfer coefficients of insulation materials were estimated from the heat transfer from the reactor under the normal reactor operation conditions.

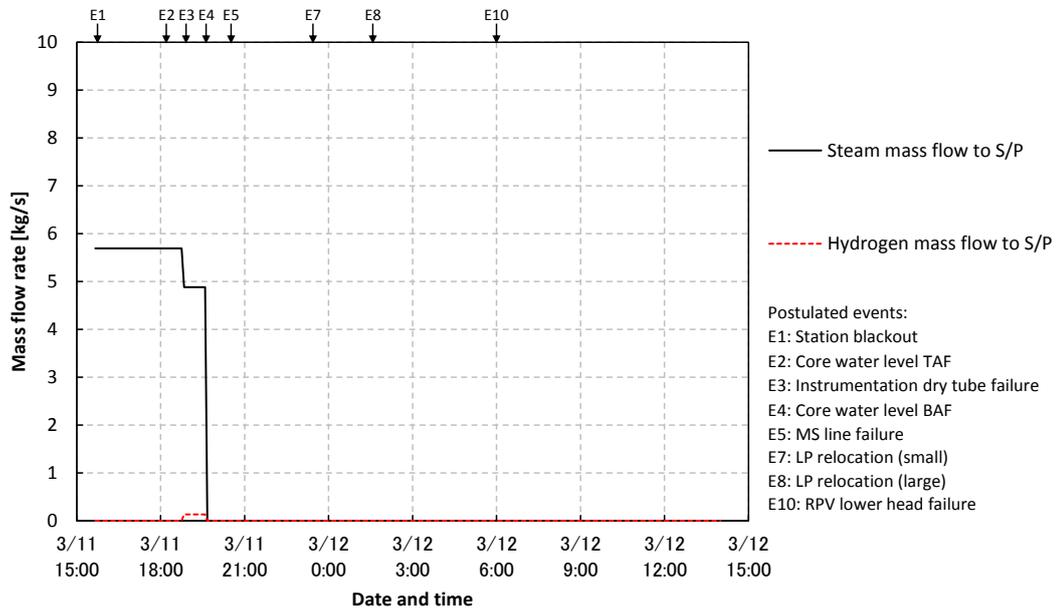
Reference Figure 3 Gas flow rates from SRV

Reference Figure 3 illustrates gas flow rates to the S/C through the SRV that were set in the analysis. It was assumed that the water inventory between BAF and the level at the station blackout (close to the level at normal operations) had flowed out as steam at a constant flow rate over about a 4 hour period to 19:40 on March 11th. The leakage rate through the instrumentation line assumed after 18:50 (described later) was subtracted from the steam flow rate above. Hydrogen gas generation was assumed to have started at 18:50 and 400kg of hydrogen gas, half of the total hydrogen gas assumed as having been generated, was assumed to have flowed out at a constant rate through the SRV during 50 minutes till 19:40. This assumption of 50% release of the total hydrogen gas generated was based on the MAAP analysis finding [3][4] that about 60% of the total hydrogen gas was generated before depressurization and the remaining 40% was generated during it. The discharged gas temperatures were assumed to be the saturation temperatures at the corresponding pressures. It should be noted that the temperatures of gas discharged to the S/C have little influence on the analysis of water level in the water level indicator lines.

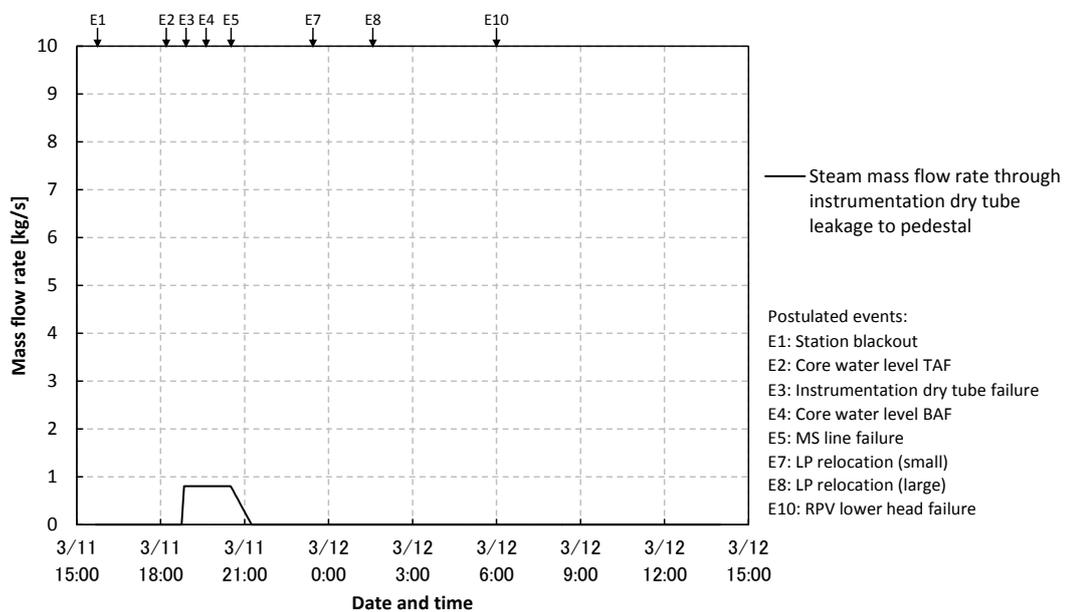
Reference Figure 4 Leak rates through instrumentation line

Reference Figure 4 illustrates the mass leak rates to the pedestal through the instrumentation line that were set in the analysis. The leak through this line was assumed only as steam and hydrogen gas was assumed to flow out only through the SRV. The steam mass generated upon depressurization was obtained in the following equation.

The SRV was assumed to have closed at 19:40 on March 11th, when the reactor water level was estimated to have decreased to BAF, and then steam was assumed to have

leaked through the instrumentation line, depressurizing the reactor from 7.5MPa[abs] at 19:40 to 7.0MPa[abs] at 20:07. Thus, the amount of evaporation was estimated at about 1,300kg from Equations (1) and (2). This led to the average leak rate of about 0.8kg/s. This leak rate was assumed to remain constant for simplicity from 18:50, when the leak through the instrumentation line was assumed to have started, to 20:30, when the leak from the main steam line was assumed to have started. Thereafter, until 21:15, when the leak from the instrumentation line was assumed to have stopped, the leak rate was assumed to have decreased linearly. The leaked gas temperatures were assumed to be the saturation temperature at the RPV pressure estimated. This was based on the deliberation that the leaked gas would be cooled down by the reactor water around the instrumentation line.

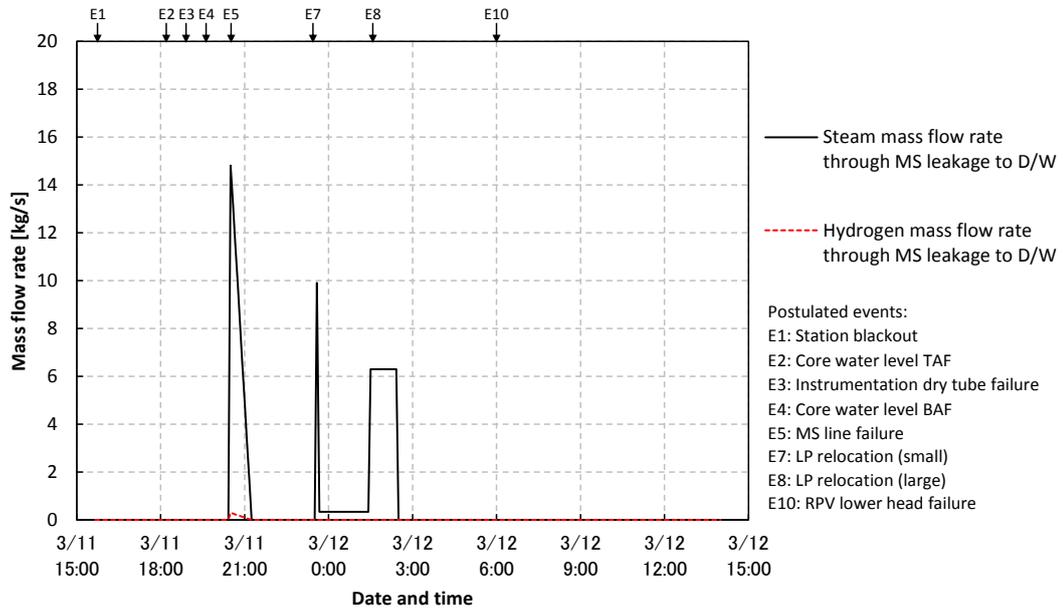
Reference Figure 5 Leak rates at the main steam line

Reference Figure 5 illustrates the leaked gas flow rates to the D/W through the main steam line that were set in the analysis. The leaks occurred mainly in three phases: flashing upon depressurization from 20:30 on March 11th, when the main steam line was damaged, till 21:15; steam generation upon debris relocation in a limited amount (set at 23:30 based on the preliminary analysis); and steam generation upon debris relocation in a large amount at 01:30 on March 12th. The leak rates during each time period were set as explained below.

The leak rates from 20:30 to 21:15 on March 11th were set as follows. The amount of evaporation while the pressure was lost from 7.5MPa[abs] to 0.6MPa[abs] was evaluated by

Equations (1) and (2), from which, by subtracting the leak amount through the instrumentation line shown in Reference Figure 4, the steam amount leaked through the main steam line was estimated at about 20,000kg. In order to simulate the leak rate changes responding to the rapid pressure decrease, the leak rates were assumed to have decreased linearly from the value at 20:30 when leaking began to the value at 21:15, while the total leaked amount was kept at the volume estimated above (20,000kg). In the meantime, 400kg of hydrogen out of the estimated total hydrogen gas generated (800kg) was assumed to have leaked to the D/W. The steam generated upon depressurization is heated up as it goes through the core or downcomer, and therefore the leaked gas temperatures from the main steam line become more or less elevated. But the temperatures have big uncertainties. In consequence, a fixed temperature of 600 deg C was set as the leaked gas temperatures, since this value reproduced the observed values best in the preliminary analysis.

At the time of molten debris relocation in a limited amount to the lower plenum at 23:30, part of the whole core was assumed to have moved to the lower plenum as molten debris. When relocating, the debris was assumed to be quickly cooled in fine grain forms. The amount of water evaporation in the lower plenum was estimated by dividing by latent heat of evaporation the calorific heat of debris (2500 deg K in molten state and 300J/kg-K as specific heat were assumed) being cooled down to the saturation temperature at 0.6MPa[abs]. The molten debris is quickly cooled in about 10 minutes, and thereafter till 01:30 on March 12th, mild evaporation due to decay heat was assumed to continue. According to the preliminary analysis about 7% of the whole molten core (10,000kg) was assumed to move to the lower plenum as molten debris. The leakage gas temperature was assumed to be constant at 450 deg C.

At the time of debris relocation in a large amount at 01:30 on March 12th, all of the residual molten material in the core was assumed to relocate to the lower plenum. From this relocation, all the residual water in the lower plenum was assumed to evaporate by 02:30 and its evaporation rate was set as the average rate over the time period. The temperature of leaked steam was assumed to be the saturation temperature at the corresponding reactor pressure. This was because the generated steam was considered as not easily heated up until it reached the leak outlet, because all molten fuel relocated to the lower plenum.

It should be noted that when integrated, the steam leak rates in Reference Figures 3 to 5 is equal to the water inventory in the RPV (excluding the water in the recirculation loop line) at the time of the station blackout.
